CONSTRUCTION ADVISORY

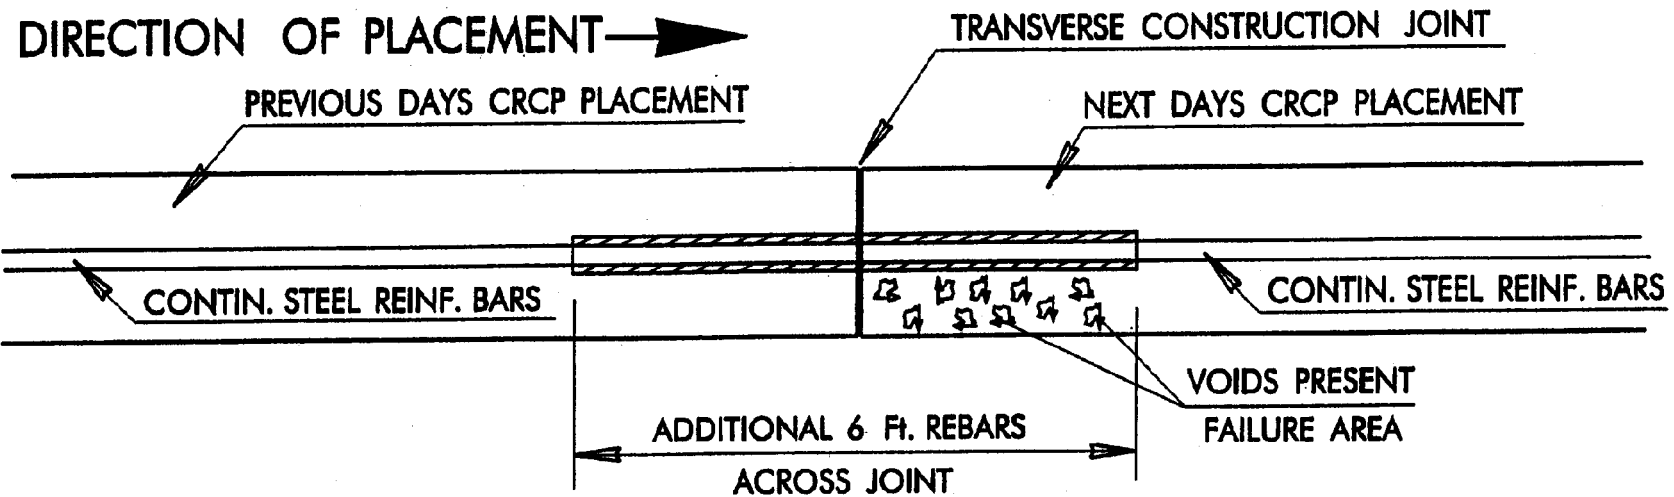
PROBLEM: Due to the additional steel reinforcement placed in header joints for continuously reinforced concrete pavement, the concrete does not always get thoroughly consolidated under the added steel. The result is failure of the joint shortly after the pavement is opened to traffic.

SOLUTION: Hand vibrate this area to ensure that the concrete placed above and below the steel reinforcement is thoroughly consolidated. Take test core(s) at each of these joint locations to inspect for this problem.
