**REPORT ON**  
**STRESS MONITORING OF THE**  
**I-40 AND LAKE EUFAULA BRIDGE**

**Chris Ramseyer, Ph. D., P.E.**  
**Assistant Professor,**  
**University of Oklahoma**

**Oklahoma Department of Transportation (ODOT)**

**June 1, 2006**

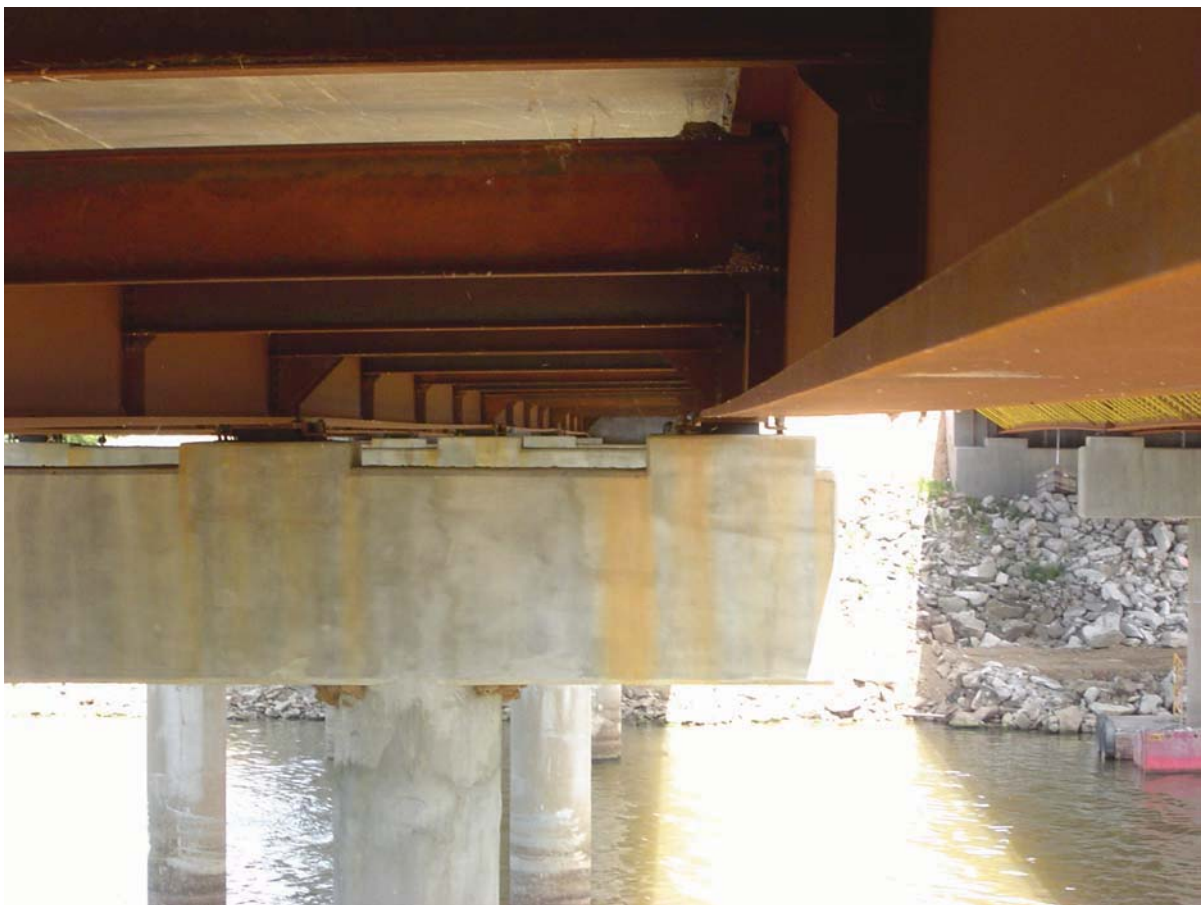
The north I-40 and Lake Eufaula Bridge is a composite steel beam with concrete deck, structure, consisting of multiple simple span sections, that was being built in the spring and summer of 2005. The steel beams were cambered at 3.5" and the deck is a standard 8 inch thick concrete made following the ODOT AA materials specification. After building the parapet walls it was noted that the finished span was deflecting excessively.

**Visible deflection of North bridge girders – Note the sag in all girders**

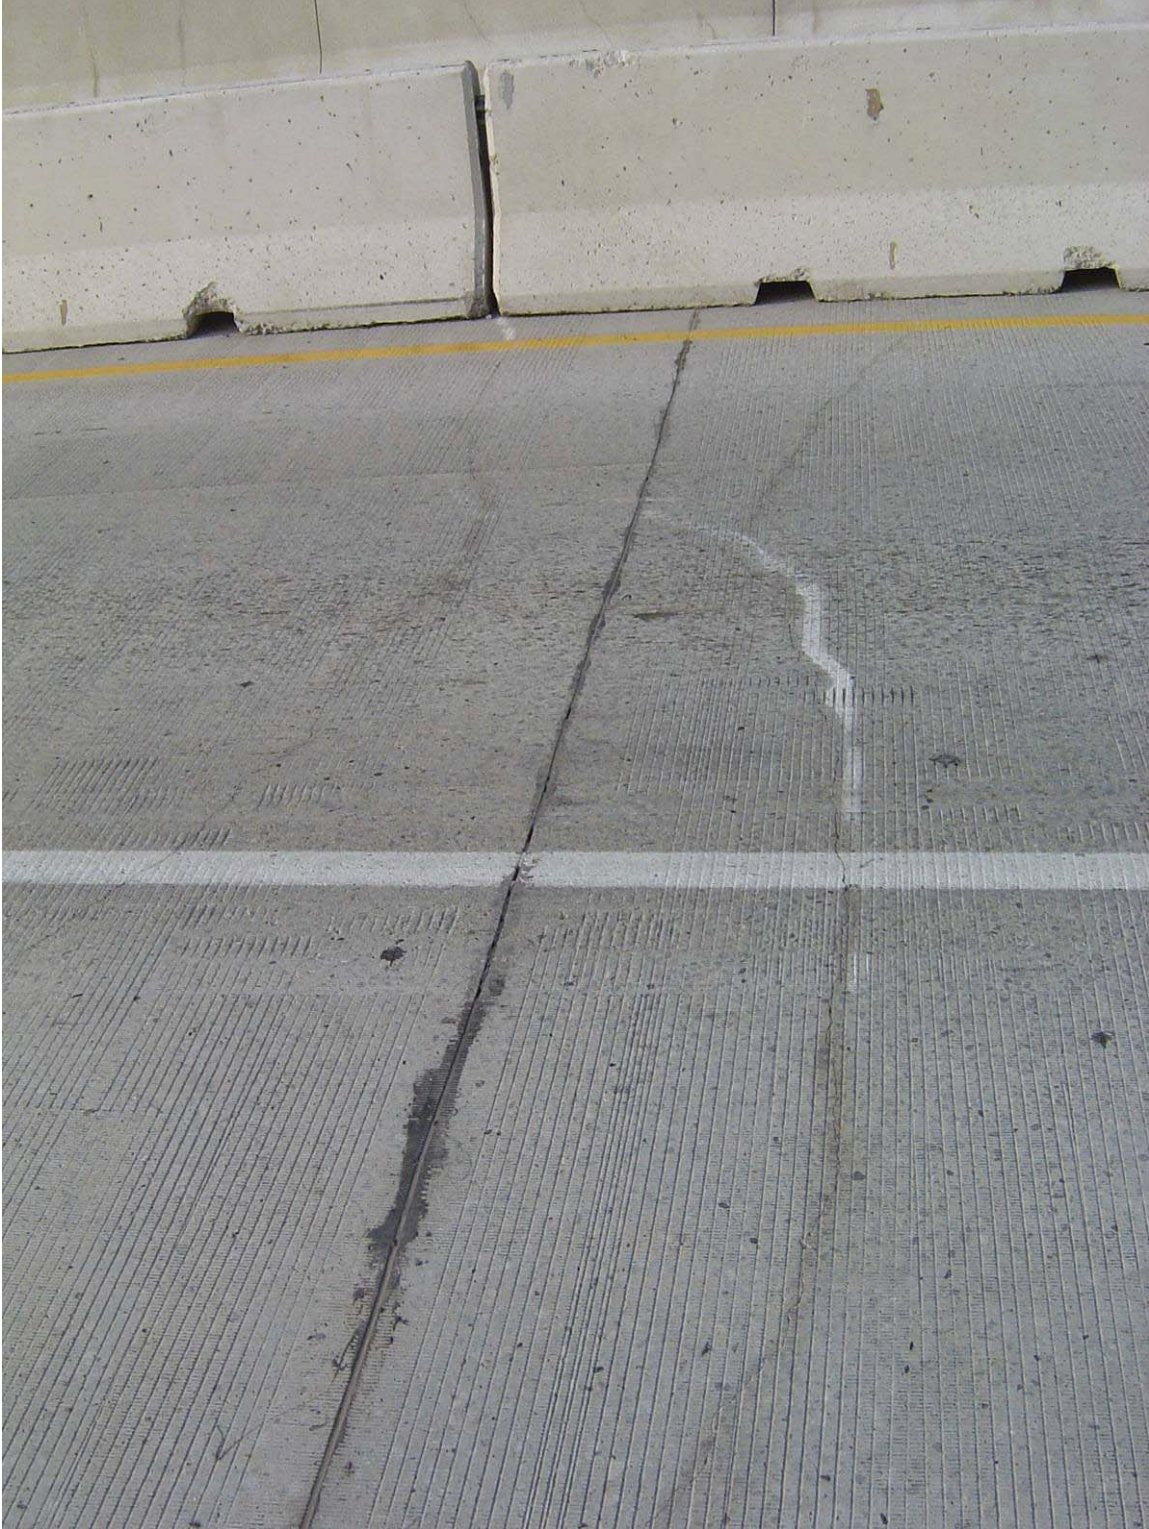
What the ODOT crews are calling "Smiley Face" cracks in deck of North Bridge at midspan North Lane - July 2005

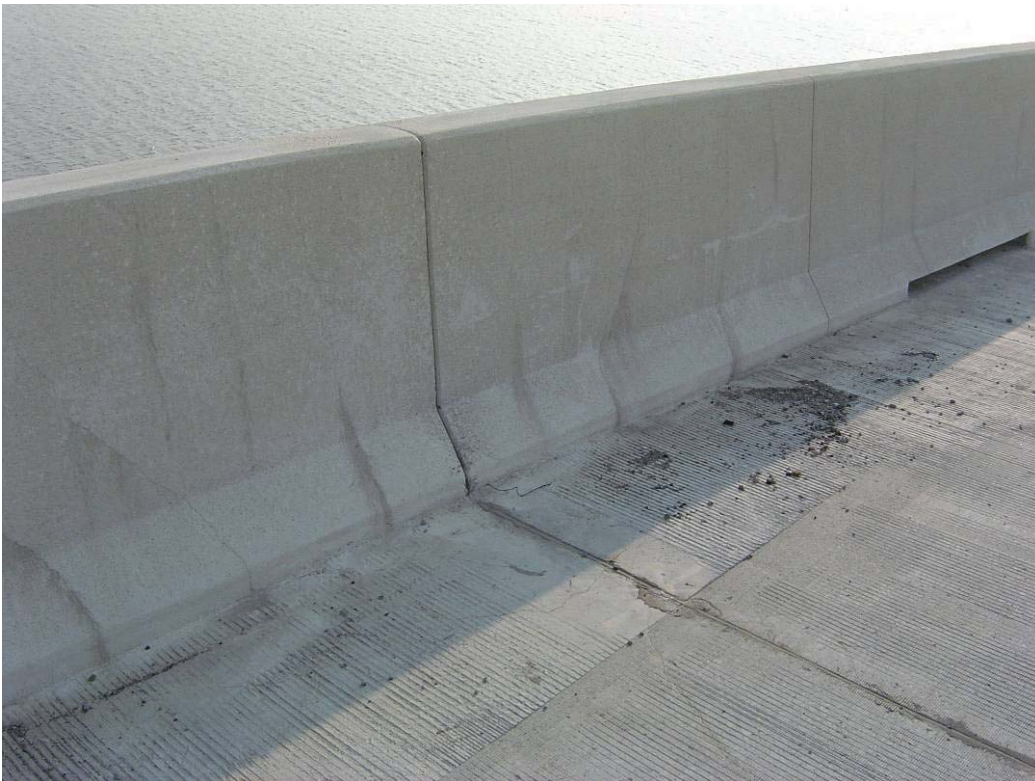
Parapet cracks in North Bridge – July 2005

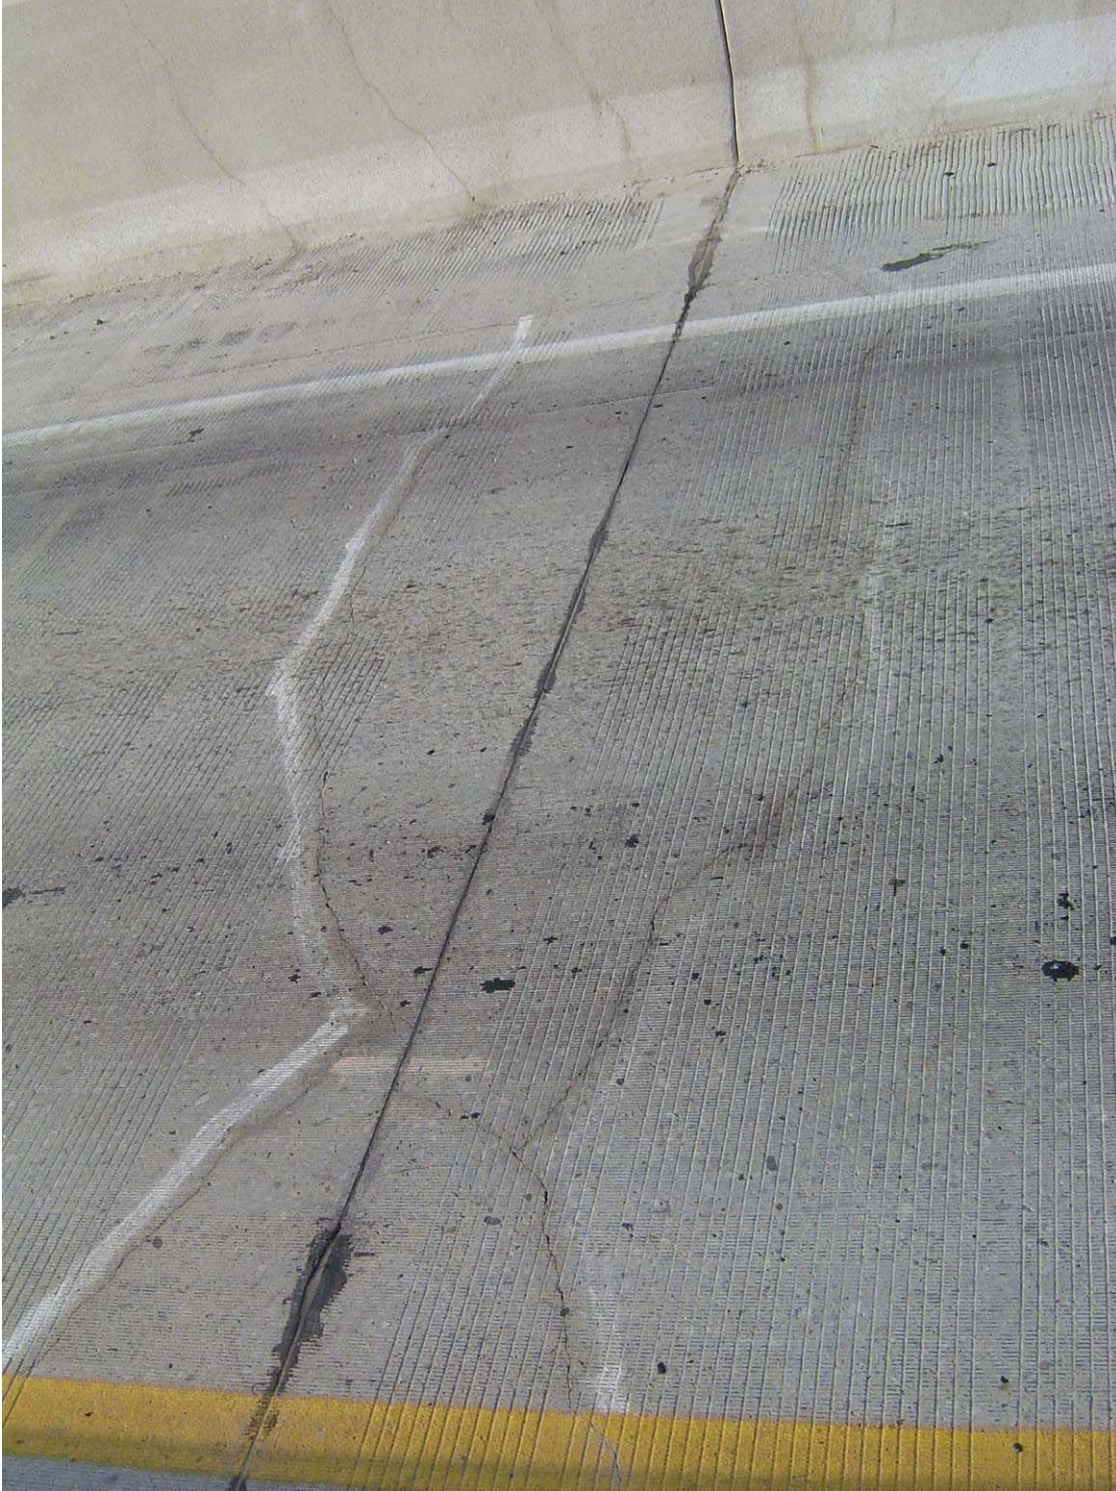
Smiley face cracks, North Bridge, north lane – July 2005

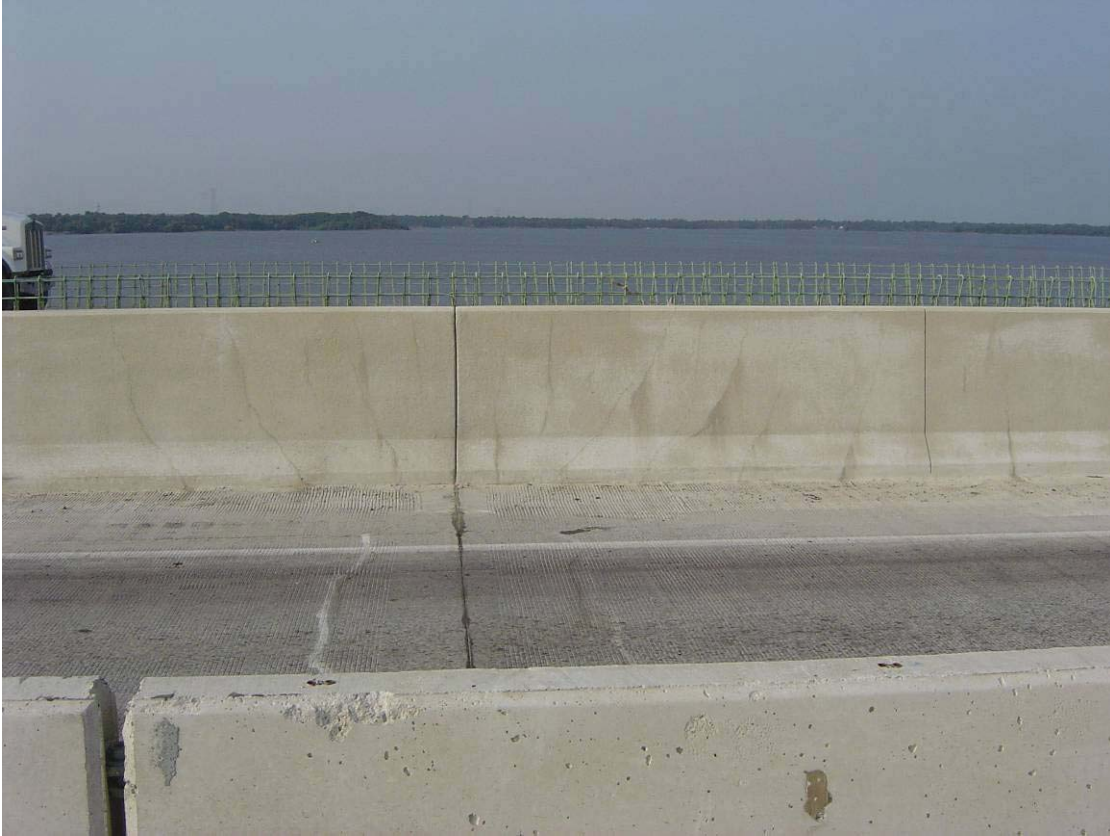
Parapet cracks in south parapet of North Bridge – July 2005

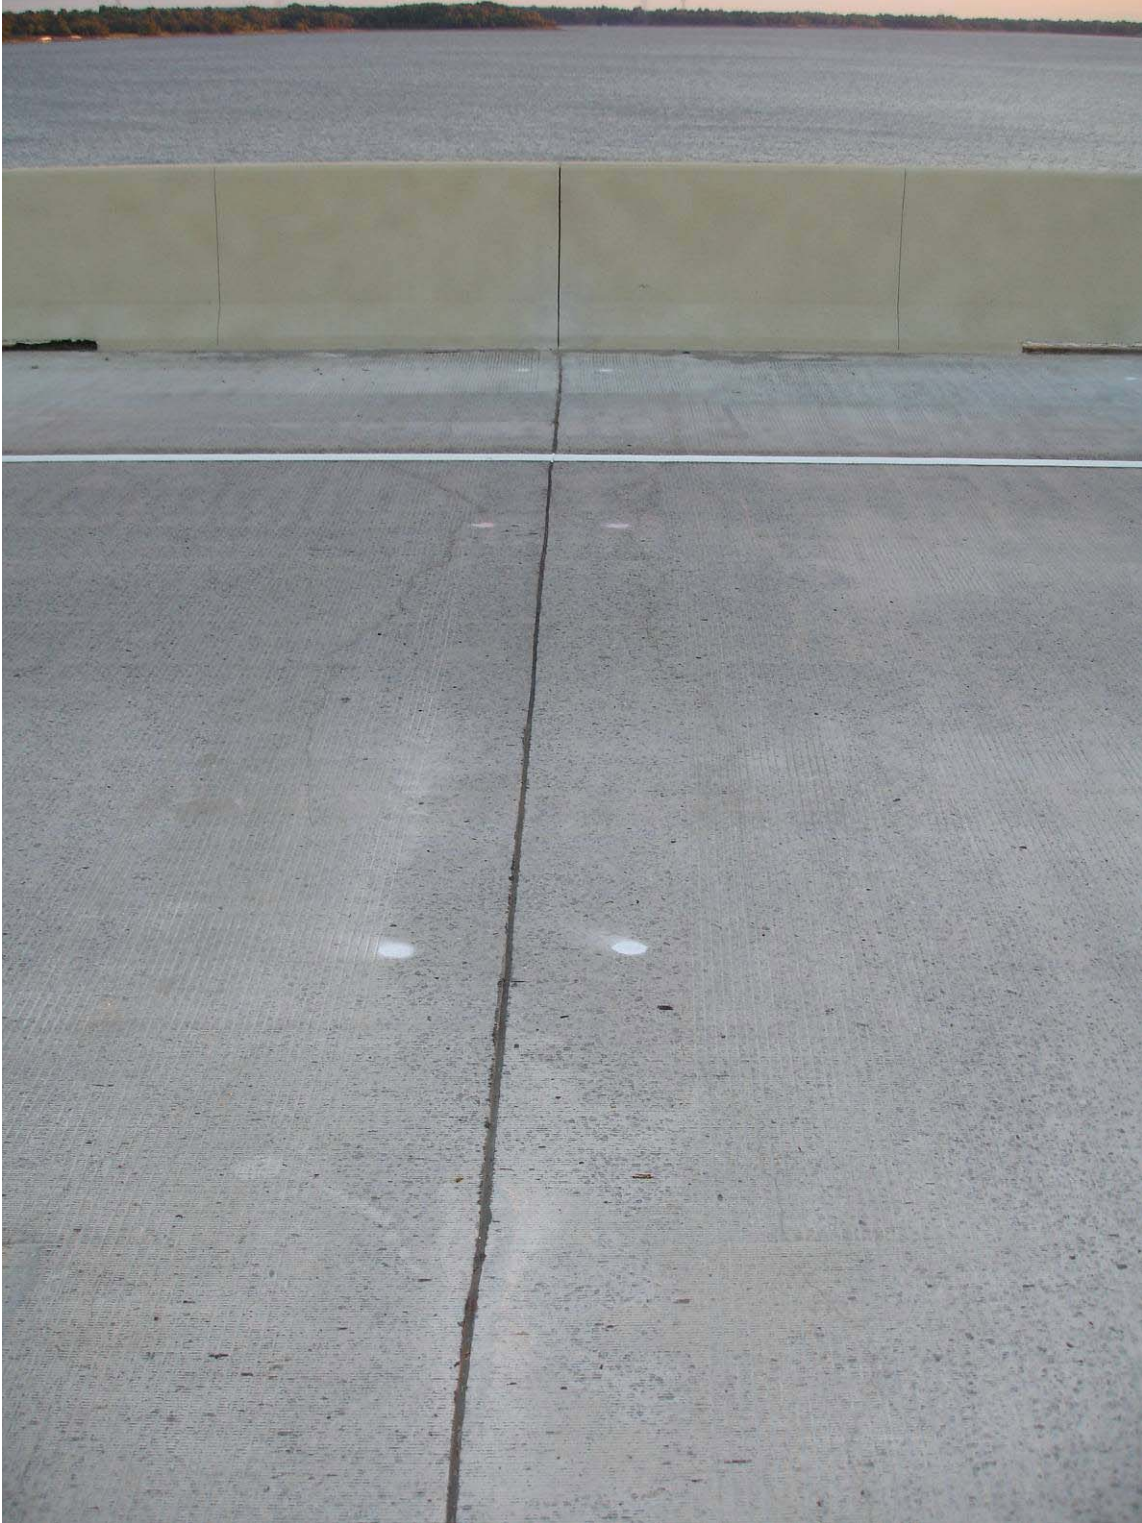
Smiley face cracks, South Bridge – Sept. 2006 (bridge is 90 days old)

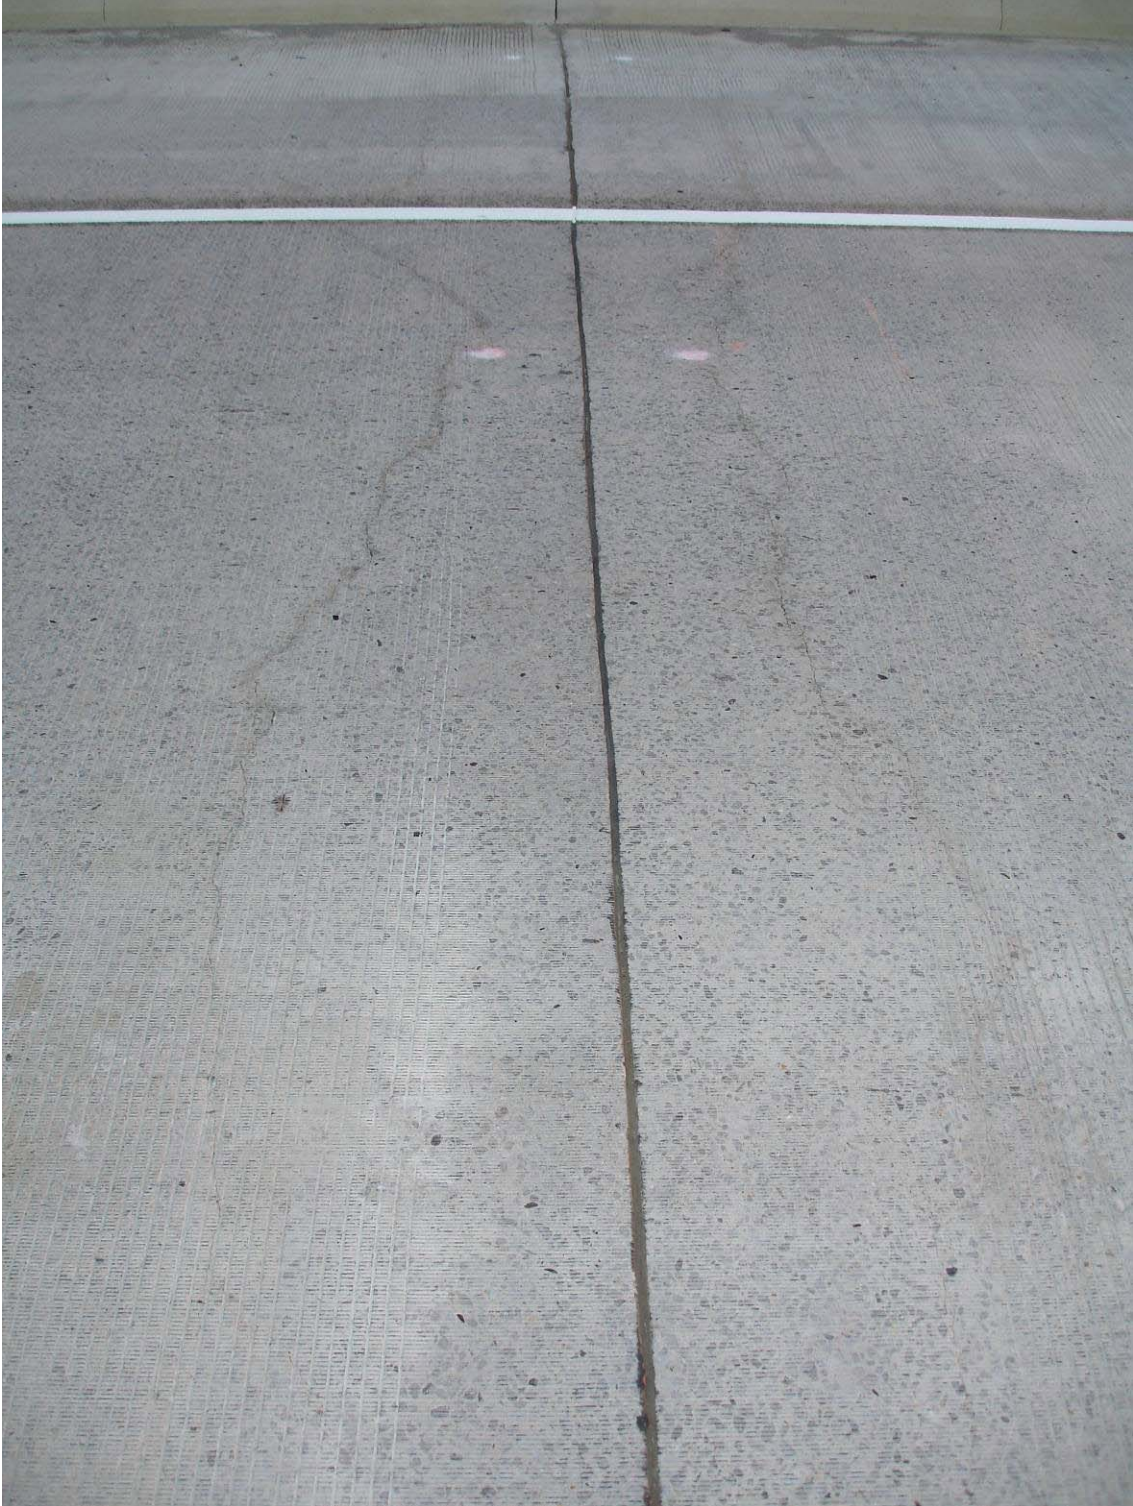
Smiley face cracks, South Bridge – Sept. 2006 (bridge is 90 days old)

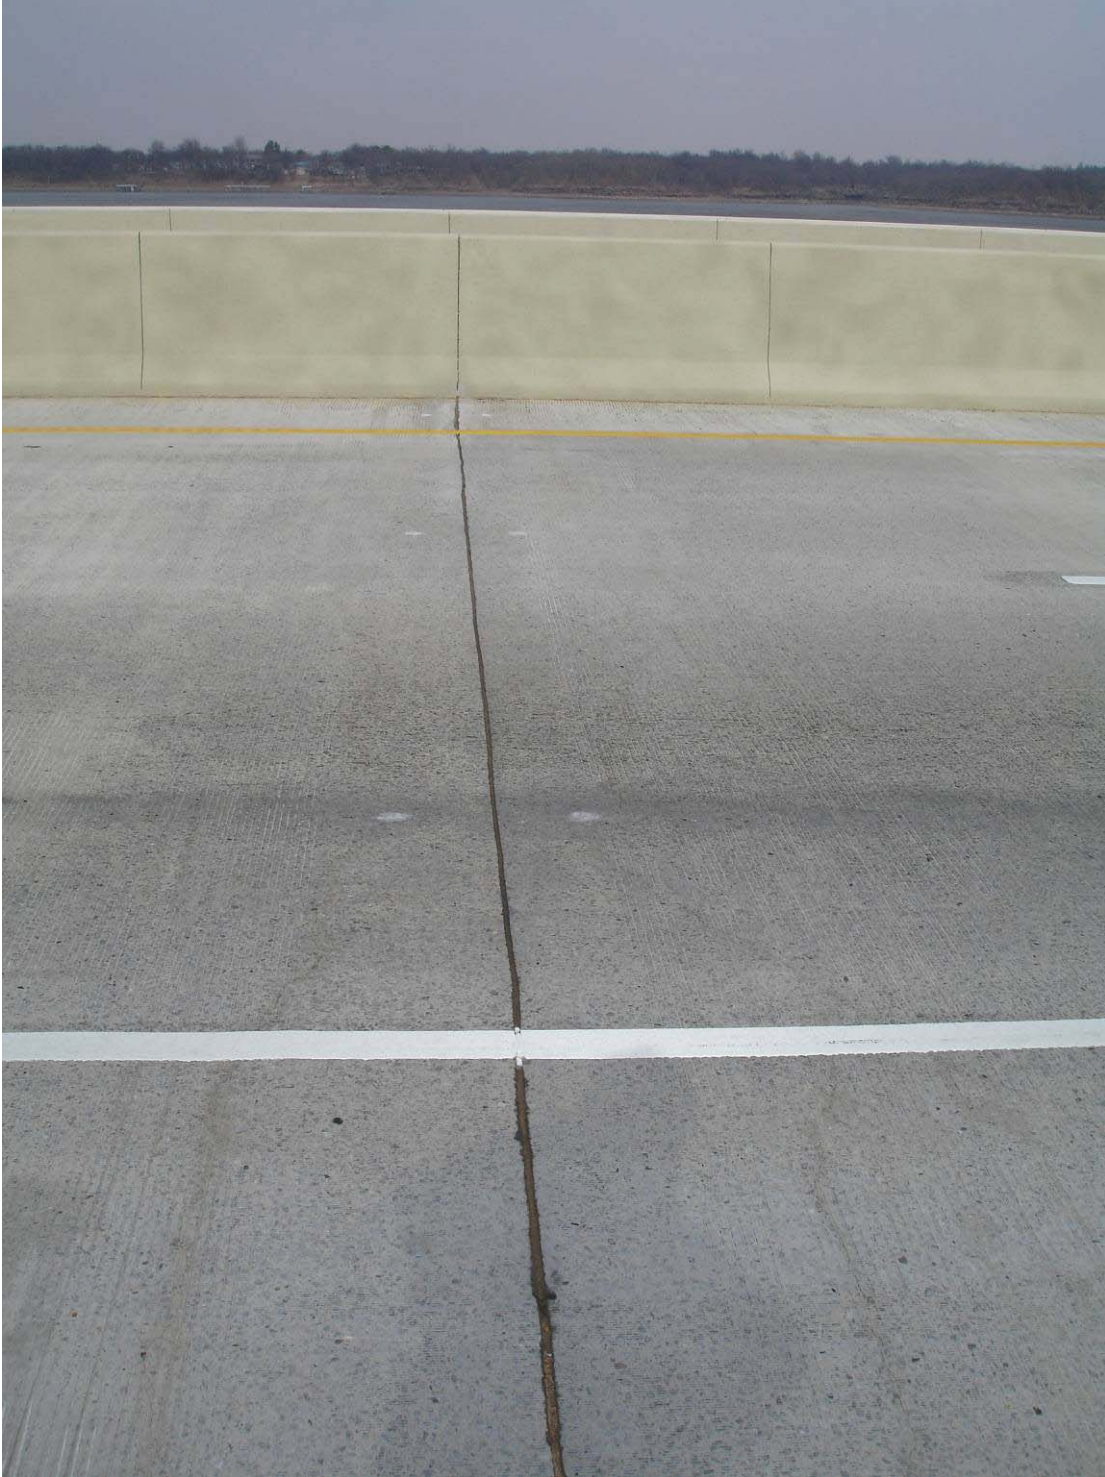
Transverse cracks on South Bridge – Jan. 2006

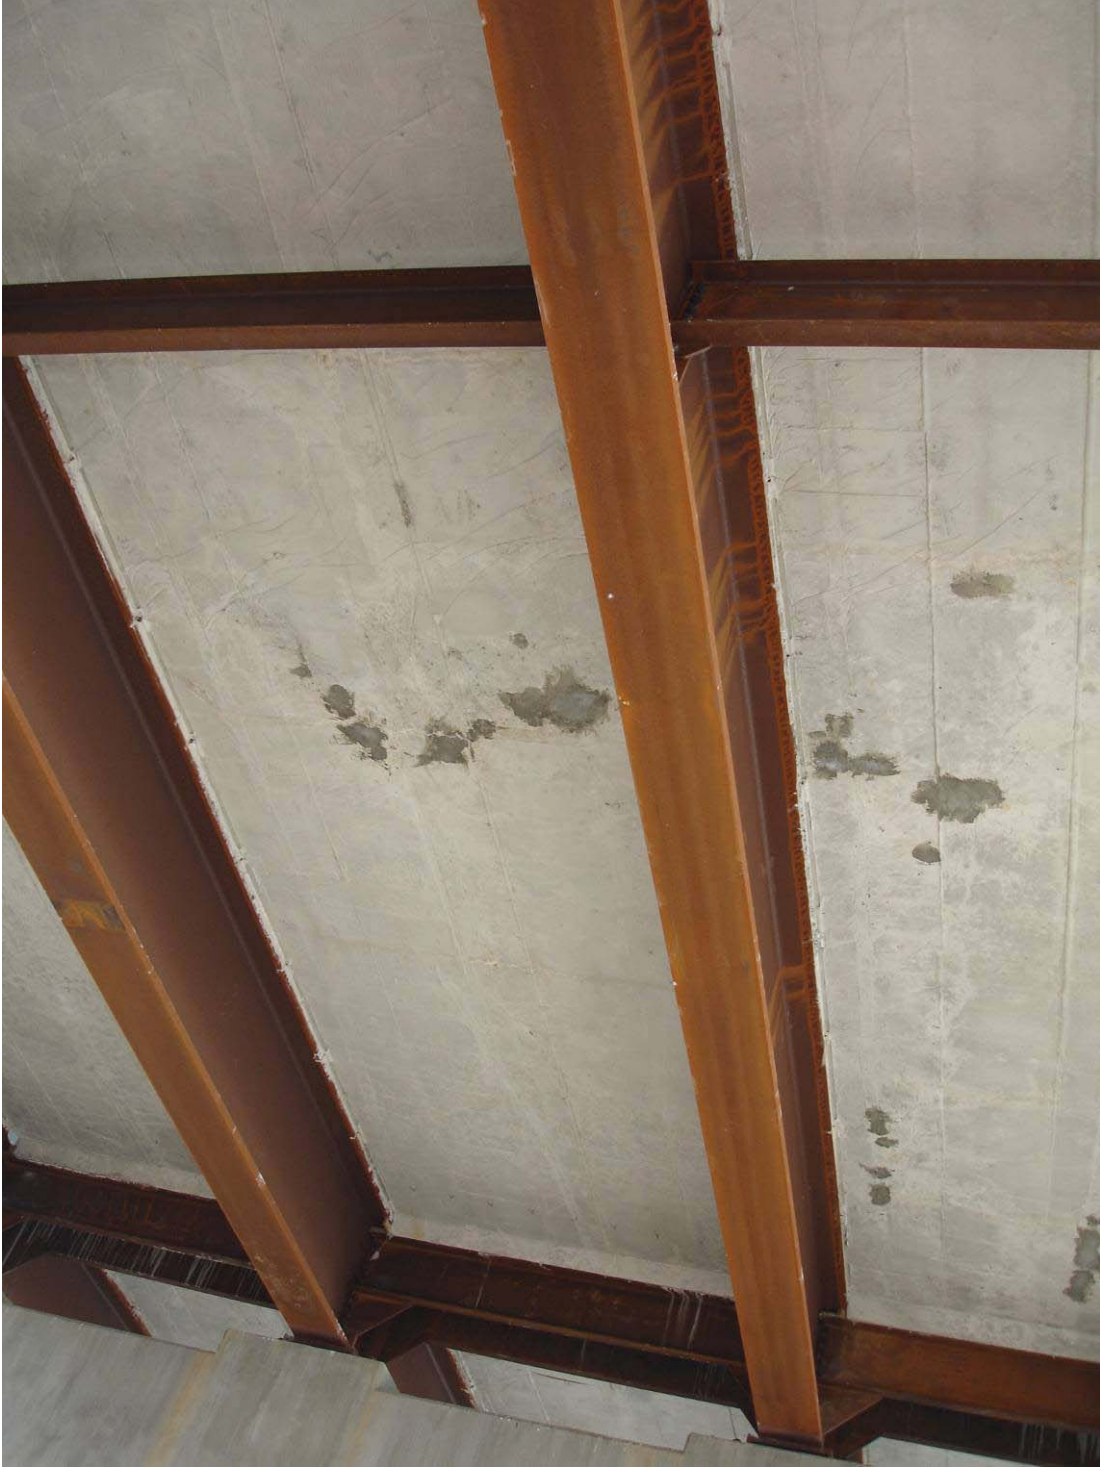
South Bridge showing water migration & cracks on bottom of deck – Jan. 2006

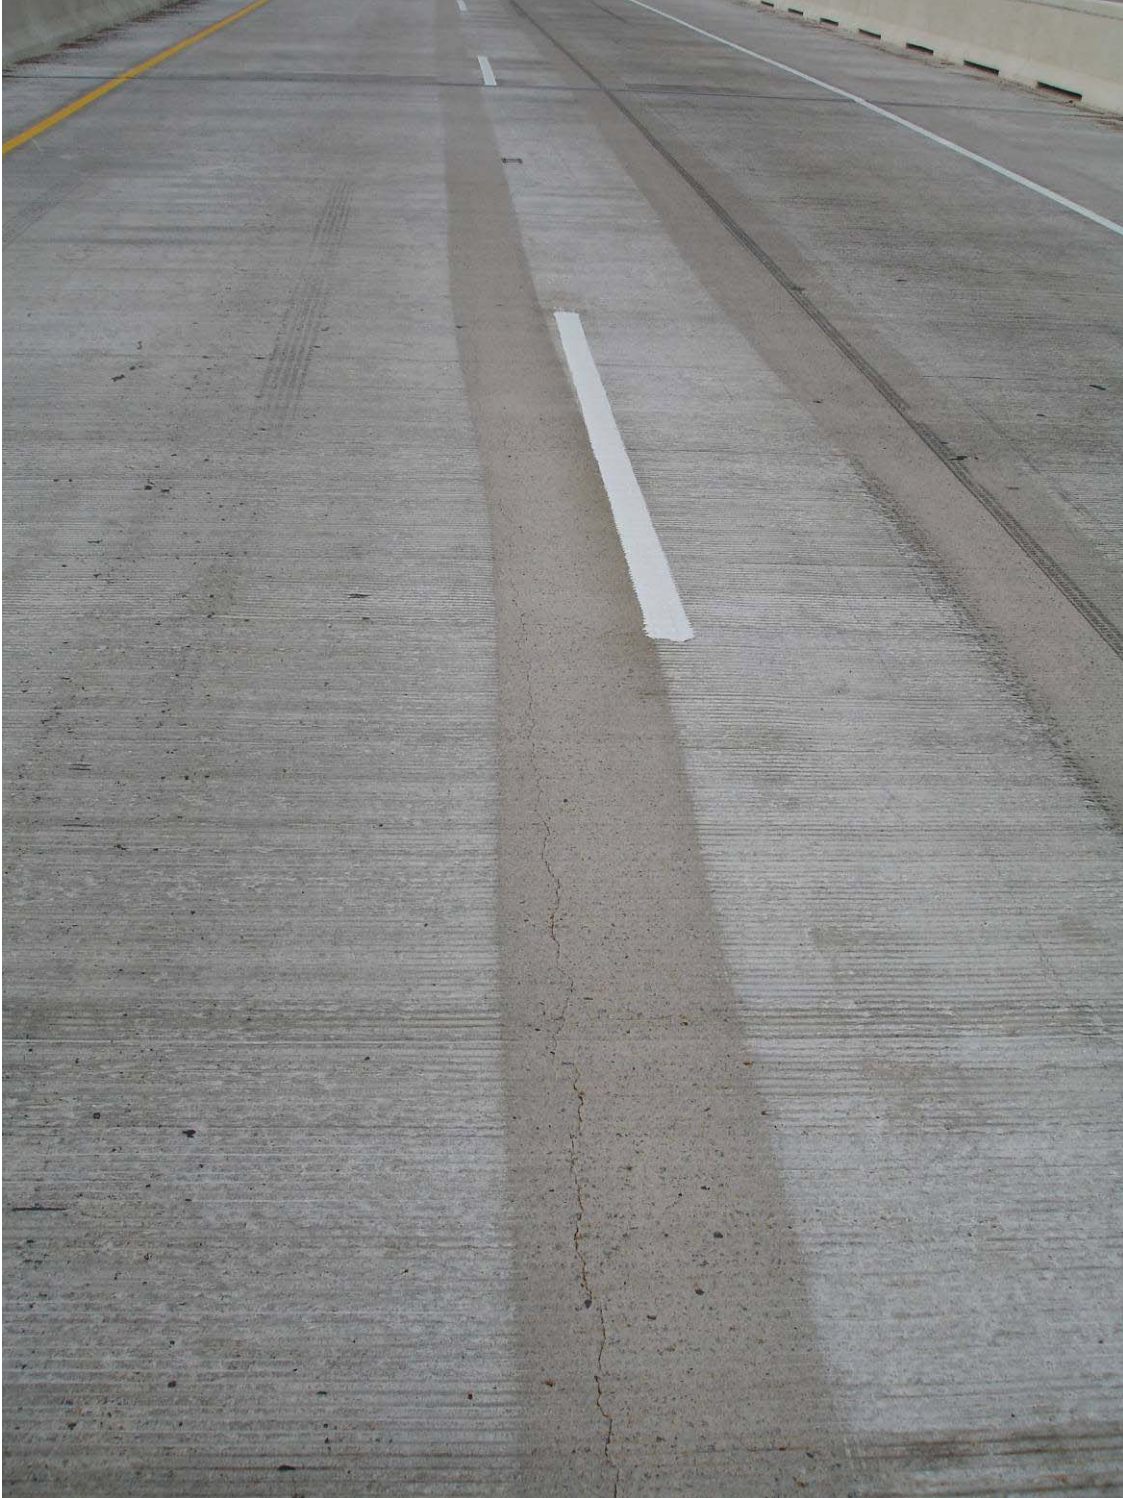
Longitudinal Cracks in North Bridge – Jan. 2006

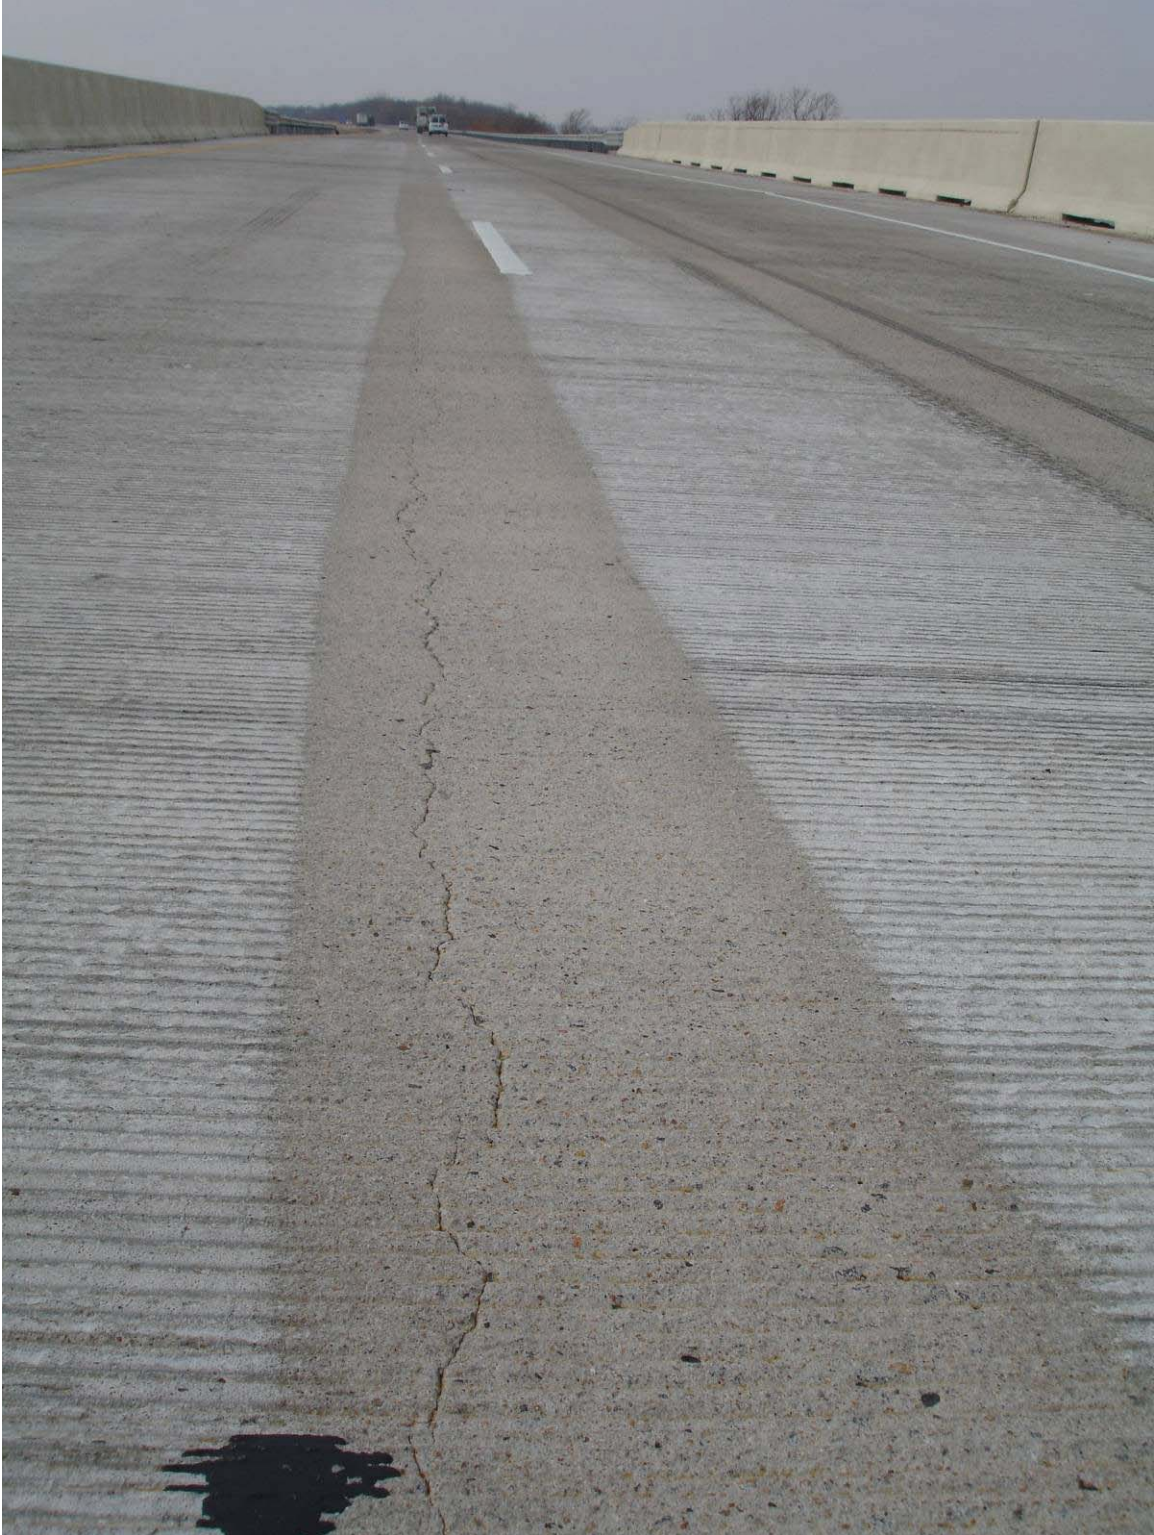
Close up of Longitudinal crack in North Bridge – Jan. 2006

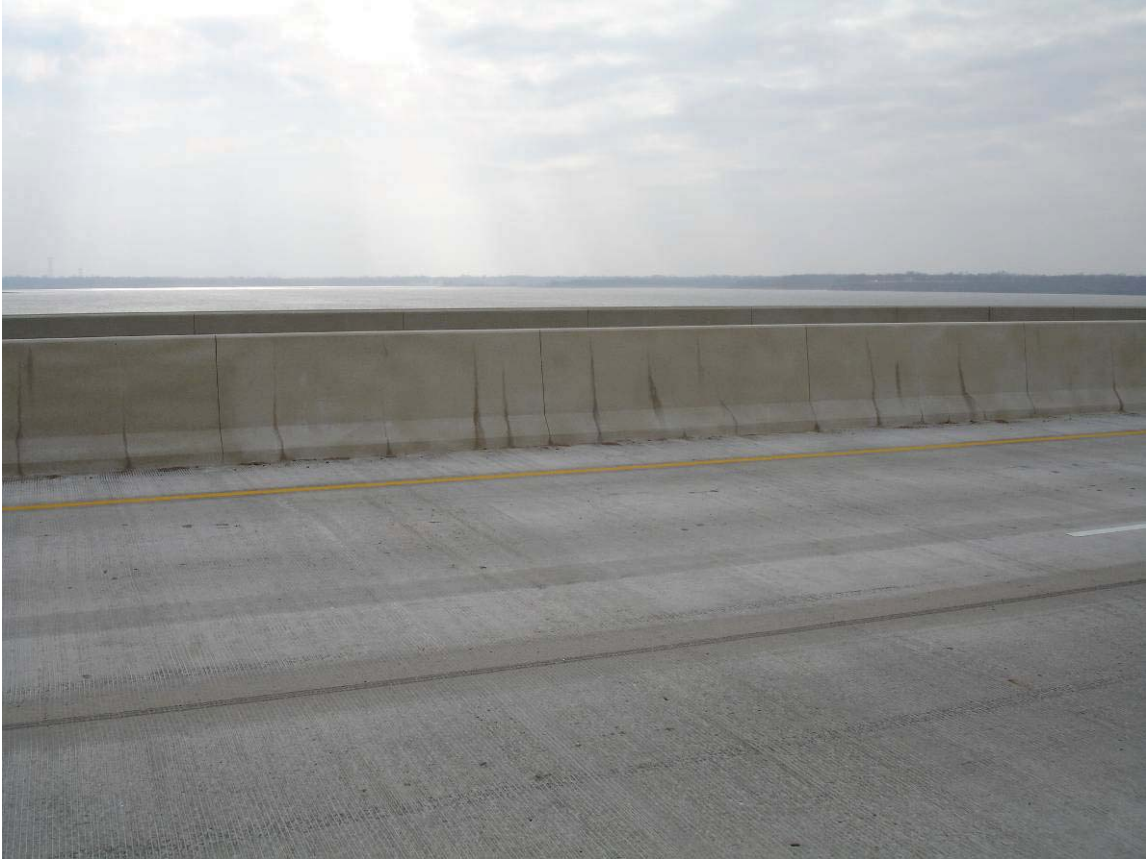
North Bridge Parapet wall showing vertical cracks – Jan. 2006

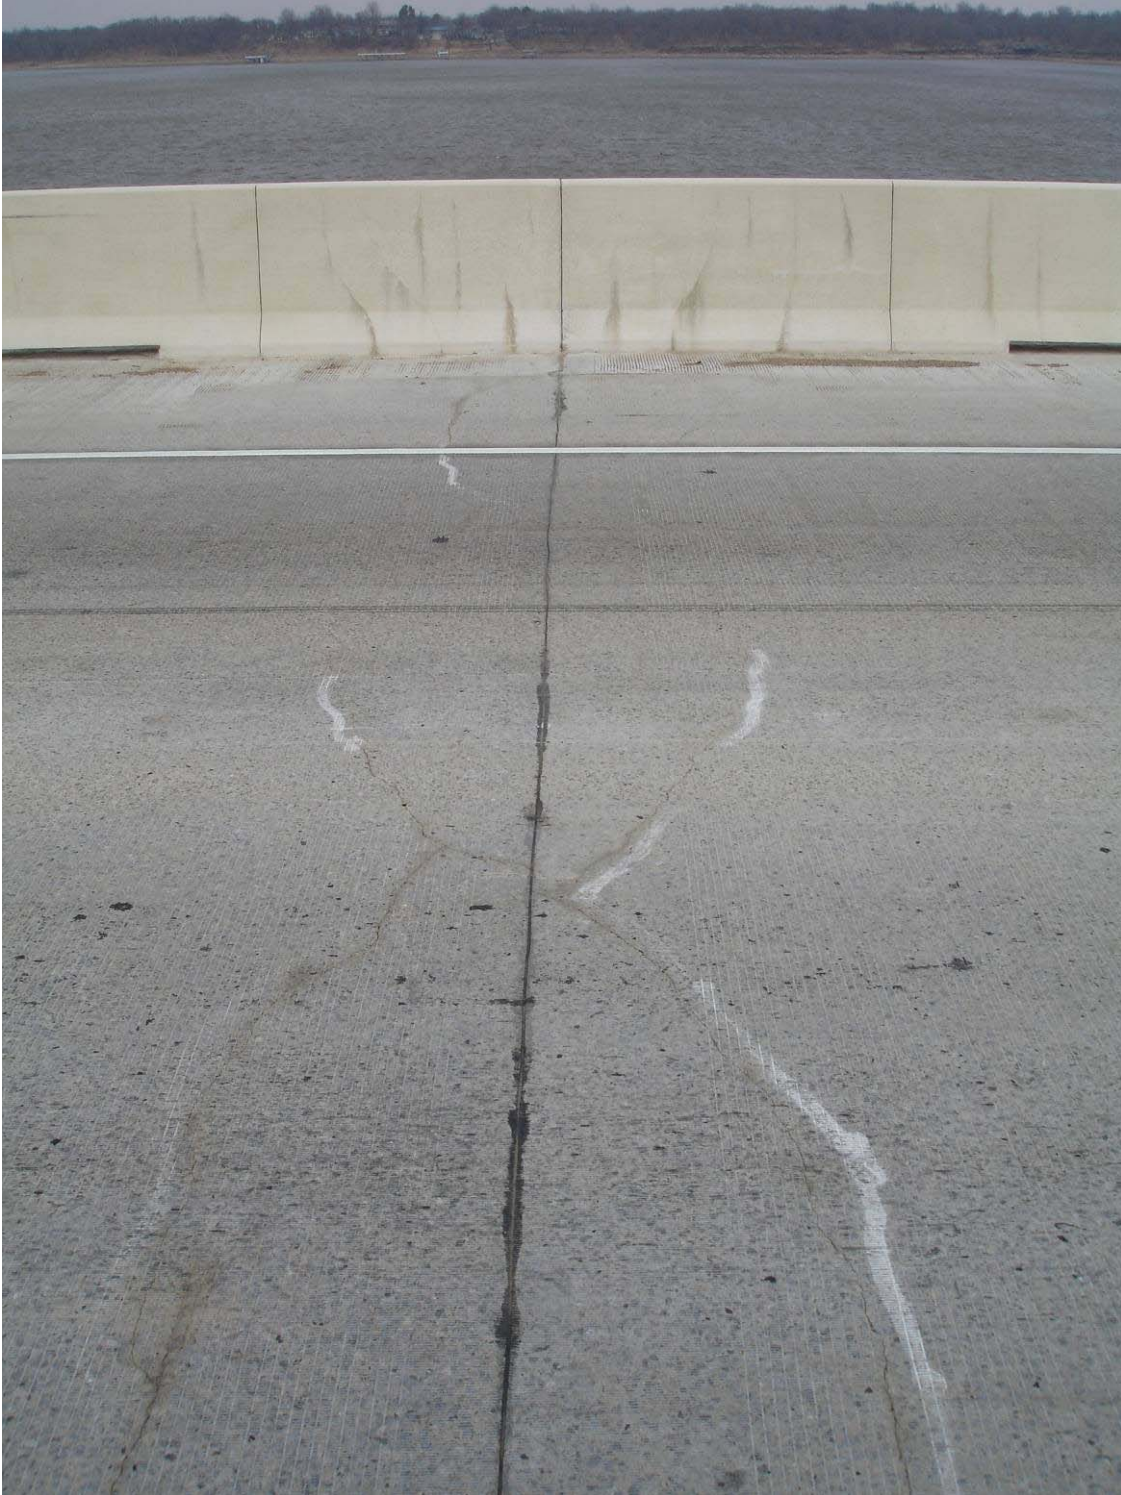
North Bridge mid-span deck "smiley face" cracks & flexure cracks in parapet – Jan. 2006

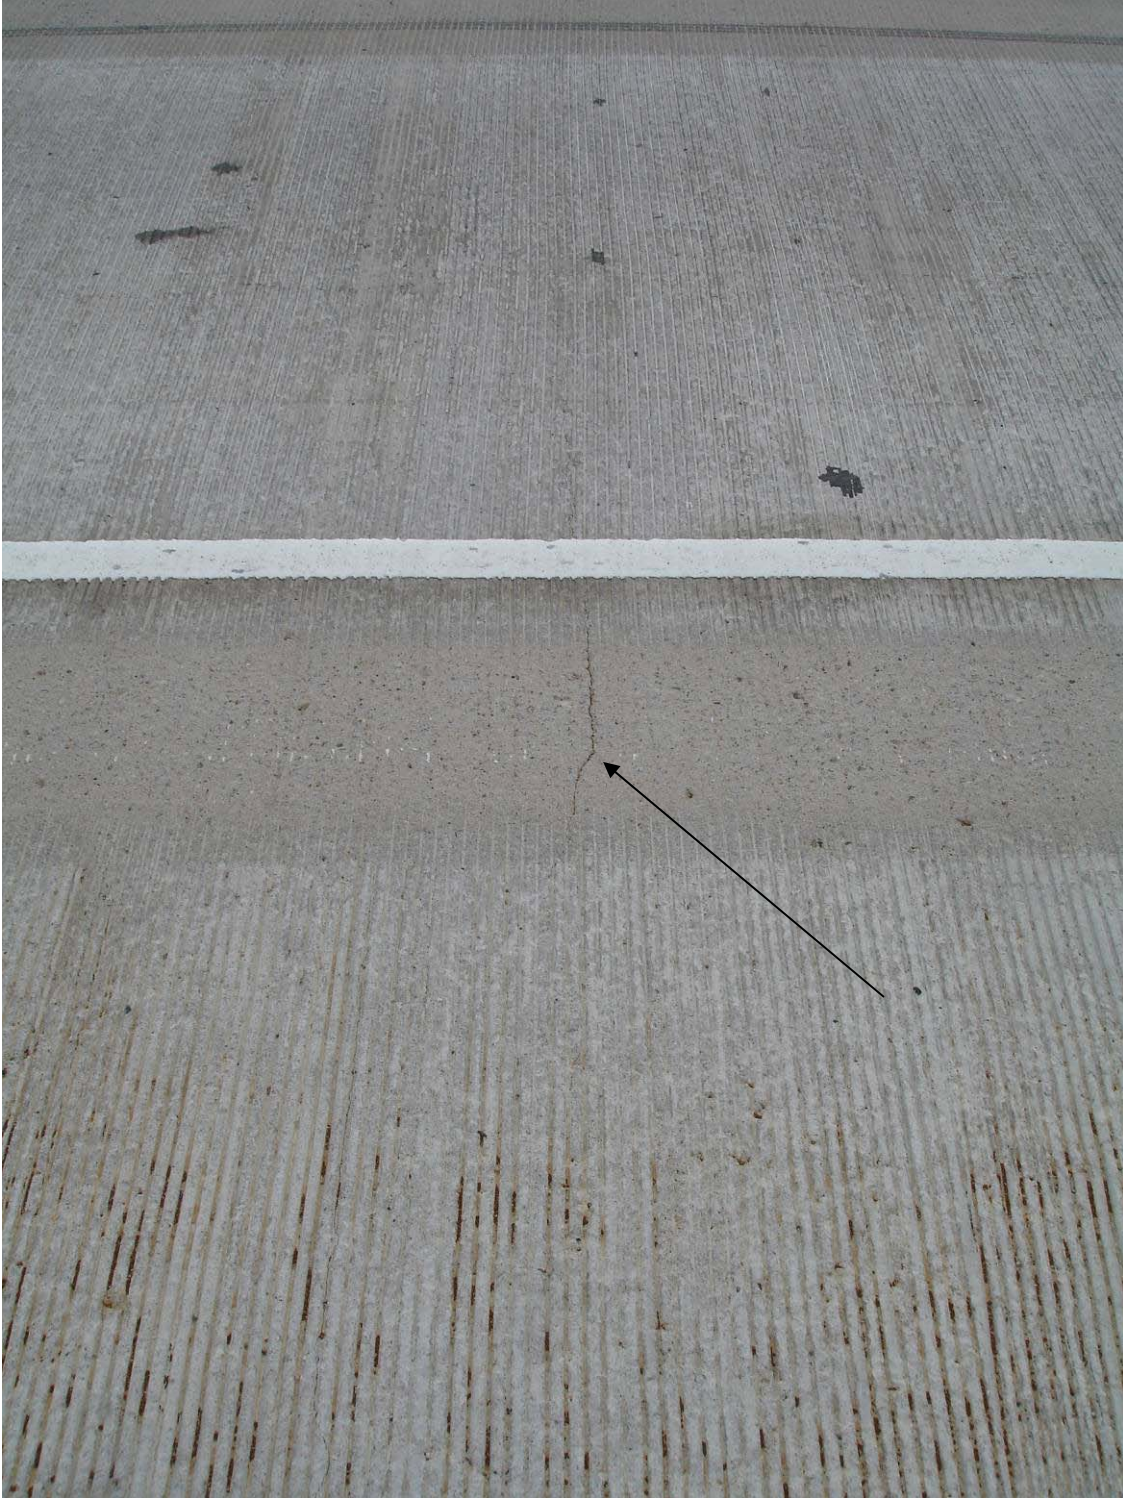
Close up of transverse crack, North bridge, span 2 from west end – Jan. 2006
