# Effect of Y-cracking on CRCP Performance

## **ANNUAL REPORT FOR FY 2011**

ODOT SPR ITEM NUMBER 2230

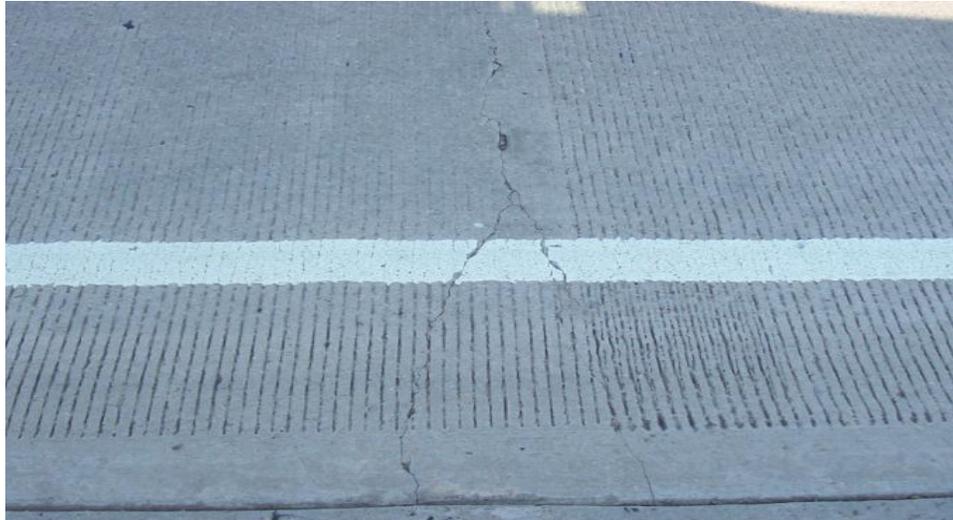
These types of cracks could severely decrease the performance and life of the CRCPs. Figure 2.2 is a picture of Y-cracking in an Oklahoma CRCP. Y-cracking is easily categorized by its very unique shape. There is a single crack, or “trunk” crack, which splits into two other cracks, called the “branch” cracks. It is not known how the crack propagates, whether the branches form and converge into one crack or the trunk forms and branches into the other two cracks.

**Figure 2.2 - Y-cracking example**

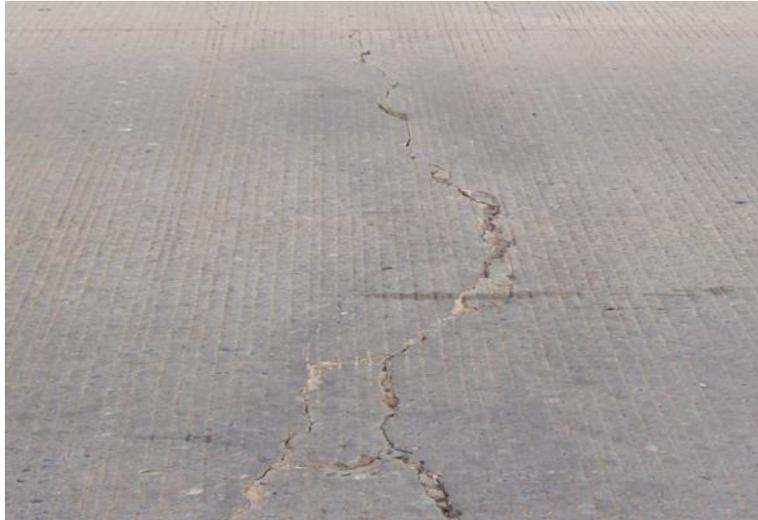
**Figure 2.3** - Example of spalling

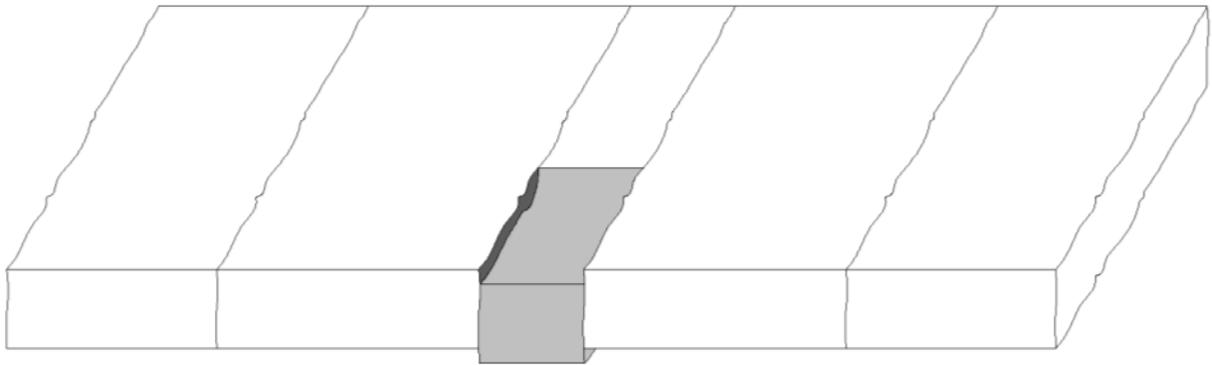
**Figure 2.4** - Example of punchout between two closely spaced transverse cracks.

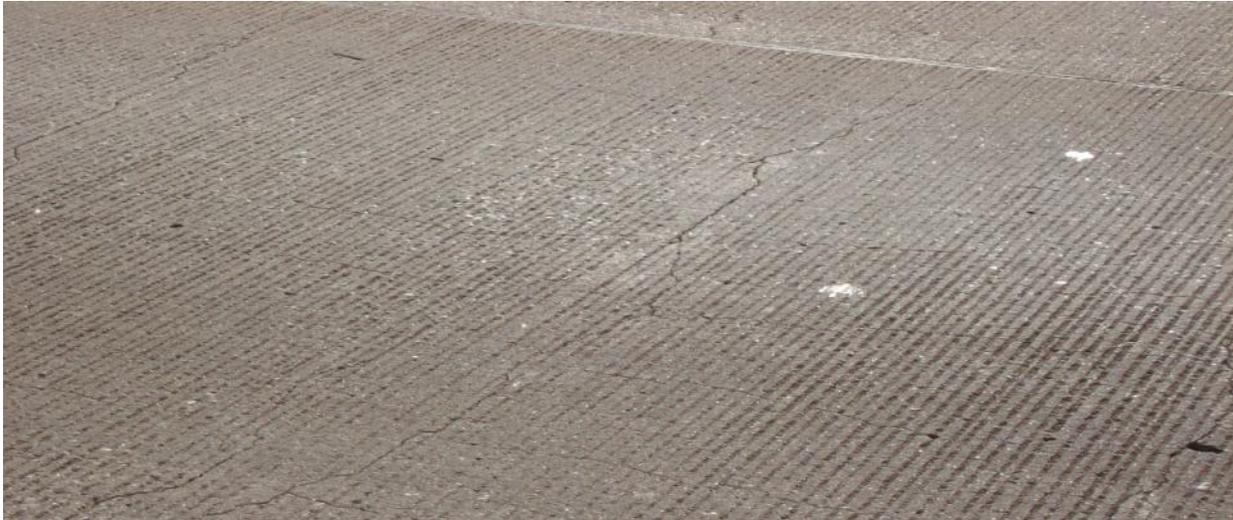
The south bound lane of his project had several more distresses and failures than the north bound lane. The south bound lane had several large areas of map cracking as seen in figure 3.2. The lane also exhibited multiple Y-cracks, or transverse cracks with several branching cracks, shown in figure 3.3 below.

**Figure 3.2** – Photo shows transverse cracks with inter-connecting longitudinal cracks.

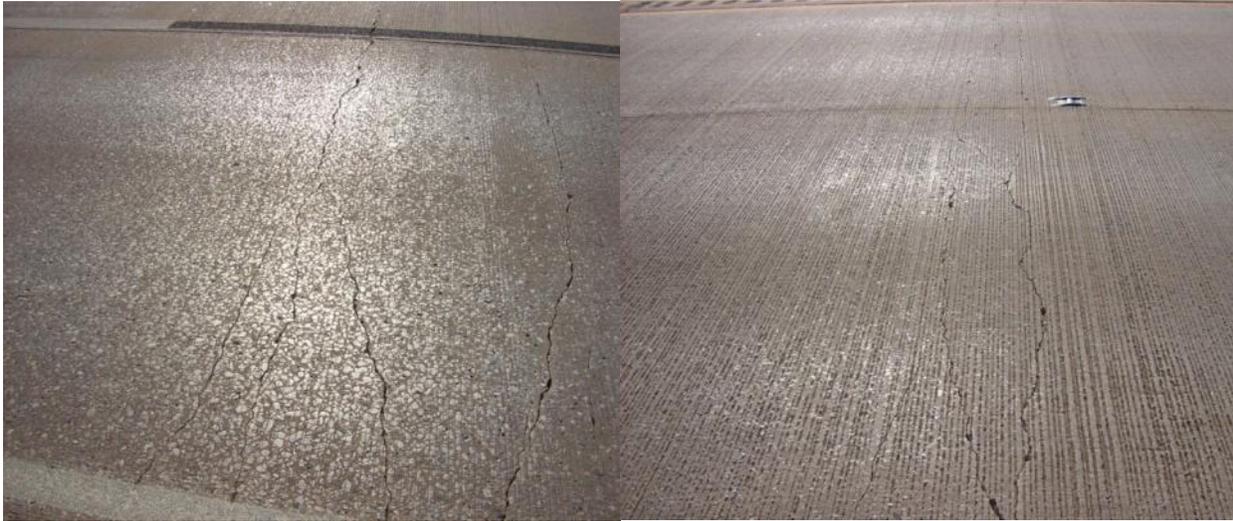
**Figure 3.3** – Photo shows Y-cracks with multiple branches

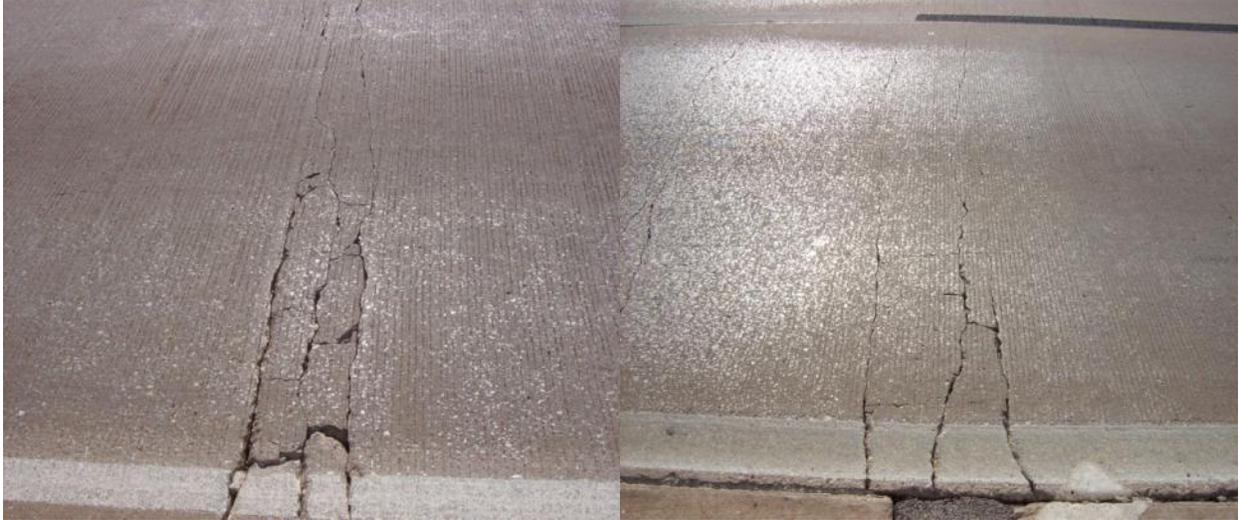
The overall crack spacing in the south bound lane was fairly irregular. Cracks seemed to range in spacing from two to ten feet. There were several instances of close transverse cracks (less than one foot) starting to break up, by way of longitudinal cracks, shown in figure 3.4. During the south bound lane inspection it was noted that areas with deeper tines made it more difficult to count Y-cracks, but seemed to make the cracks meander less.

**Figure 3.4** – Photo showing closely spaced transverse cracks developing into punch-outs

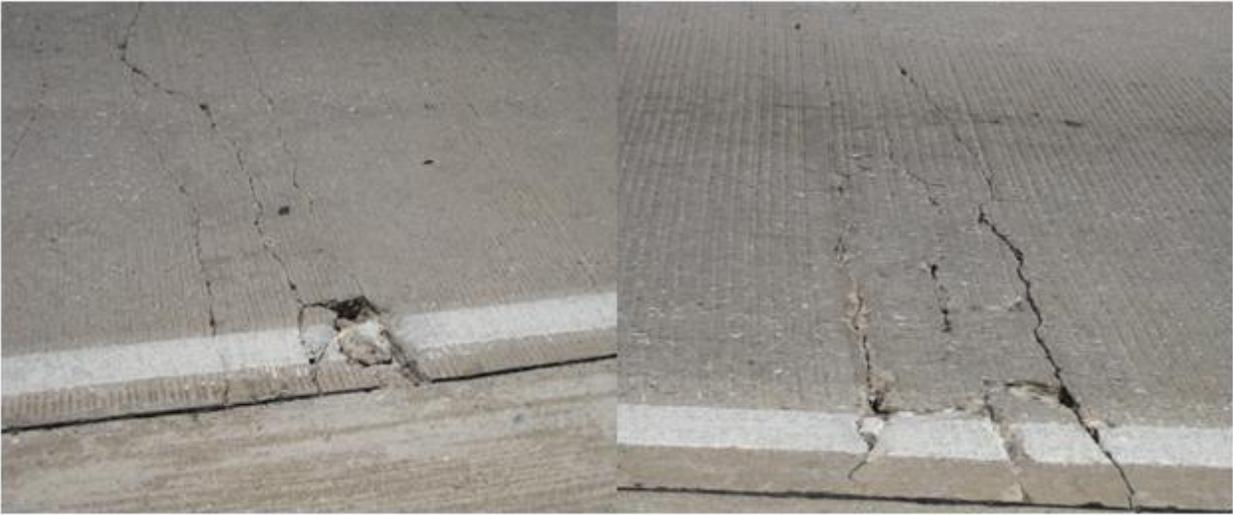
**Figure 3.5** – Developing punch-out between two close transverse cracks

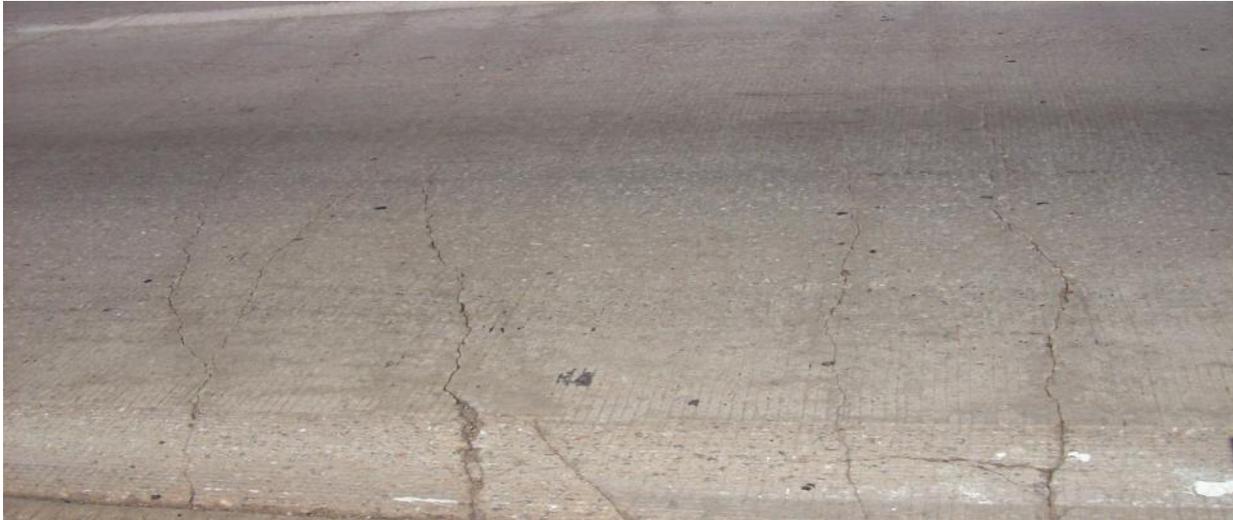
The north bound lane of this project had isolated areas of heavy Y-cracking and closely spaced transverse cracks connected by longitudinal cracks (see figure 3.7). It was noted that the crack width seemed to be very small, with a crack spacing of eight to ten feet between clusters of cracks.

**Figure 3.7** – Closely spaced transverse connected by longitudinal cracks

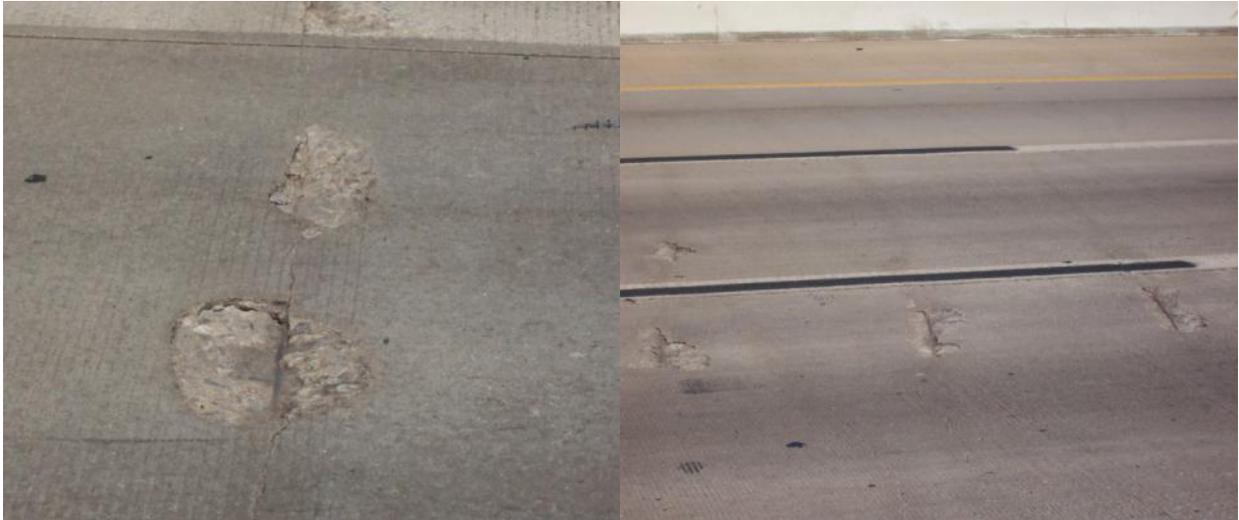
Before the project was inspected, ODOT commented that they had a particular concern within mileposts 124.1 and 124.2. Figures 3.8 and 3.9 show the distresses in this particular region. The transverse steel in this region appears to be high in the pavement, leaving only  $\frac{3}{4}$ -1 inch of concrete cover over the bar. It was also noted that the transverse steel in this region does not appear to be perpendicular to the direction of traffic. Chris Westlund, an ODOT employee, said that the steel on this project was placed with a machine during the paving process and he recalled that the machine was having problems. Nevertheless, the distresses in this section of pavement seemed to be caused by inadequate steel cover and not related to Y-cracking, or any other cracking patterns. None of the distresses caused by the transverse steel have been patched in the north bound lane. The north bound lane also exhibited several stretches where the road surface was extremely worn. The tines in the wheel paths were barely visible. Several stretches of pavement had to be skipped while performing the visual inspection due to exits, entrances, and barrier walls not providing a shoulder to conduct the inspection.

**Figure 3.8** – Distresses in ODOT’s region of concern

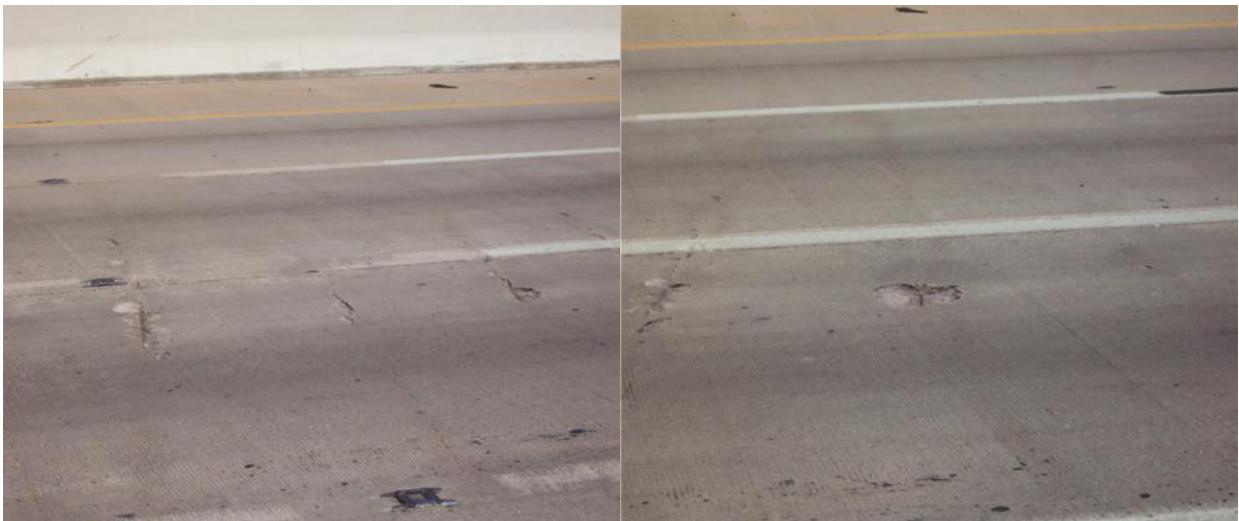
**Figure 3.9** – More distresses in ODOT’s region of concern

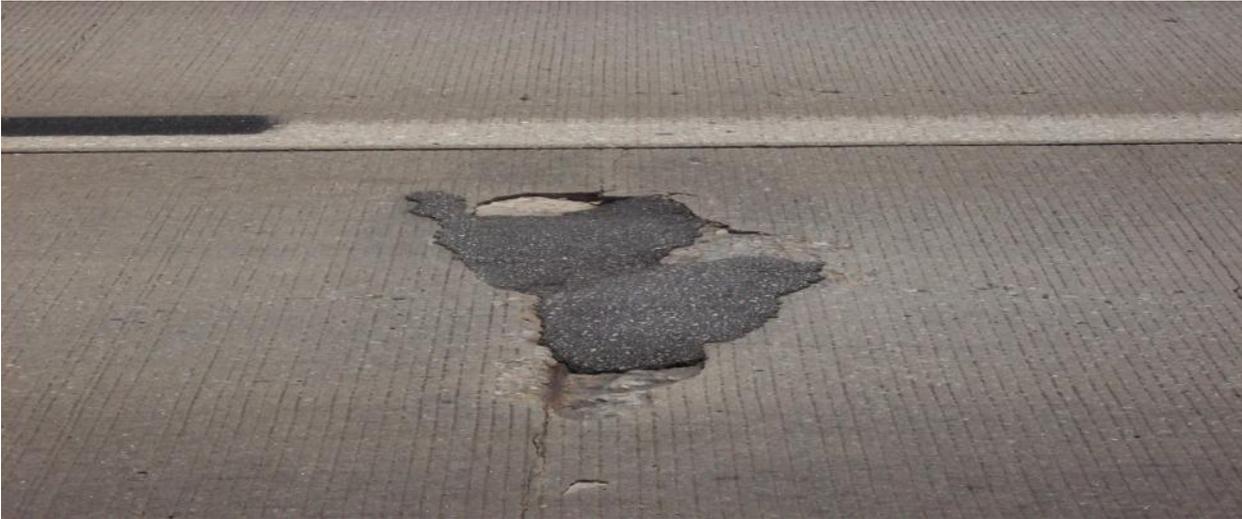
**Figure 3.10** – AC patch over a distress with exposed transverse steel

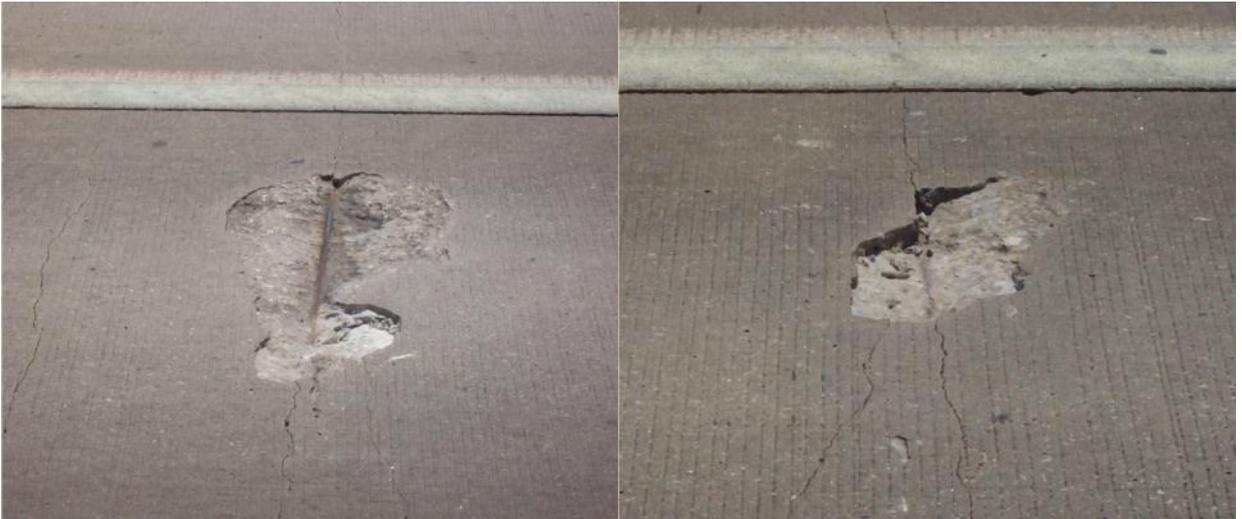
**Figure 3.11** – Possible Y-crack over shallow transverse steel

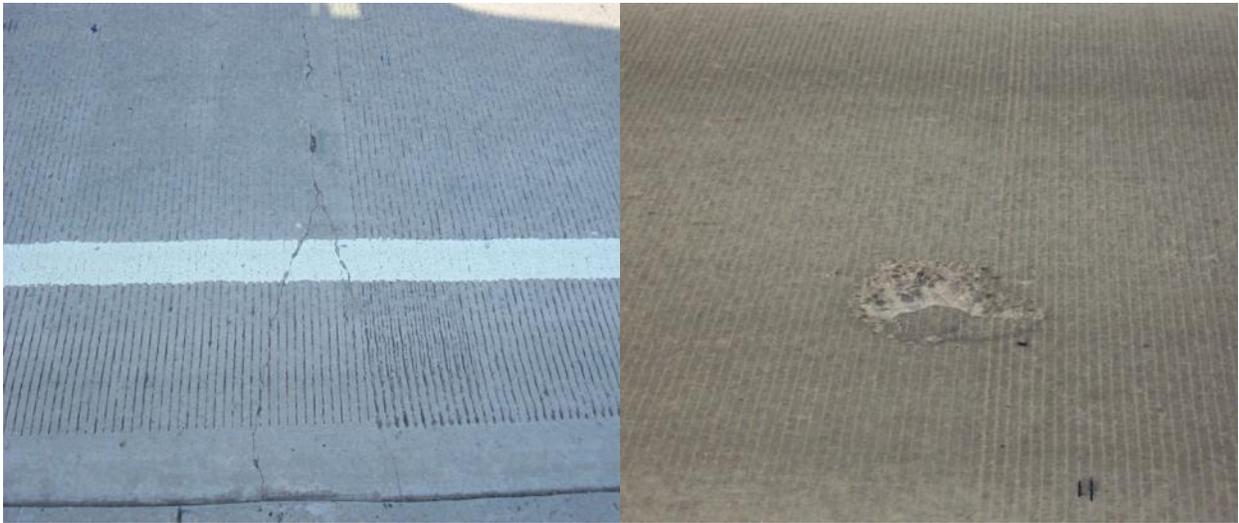
left and spalled circular area on the right. The Y-crack shown in figure 3.15 seemed to be the most common, it was noted during inspection that there were multiple Y-cracks at the pavement edge with several of them being outside the white line (approximately 40%). This was especially noticed between mileposts 125 and 126. Figure 3.16 shows two construction joints that display signs of raveling. Despite the occurrence of Y-cracks (see figure 3.17 left), more potential for distresses to develop were found by closely spaced transverse cracks (see figure 3.17 right). These cracks displayed spalling and in several instances were connected by longitudinal cracks.

**Figure 3.15** – (Left) Typical Y-crack for the region, (right) circular spalled area

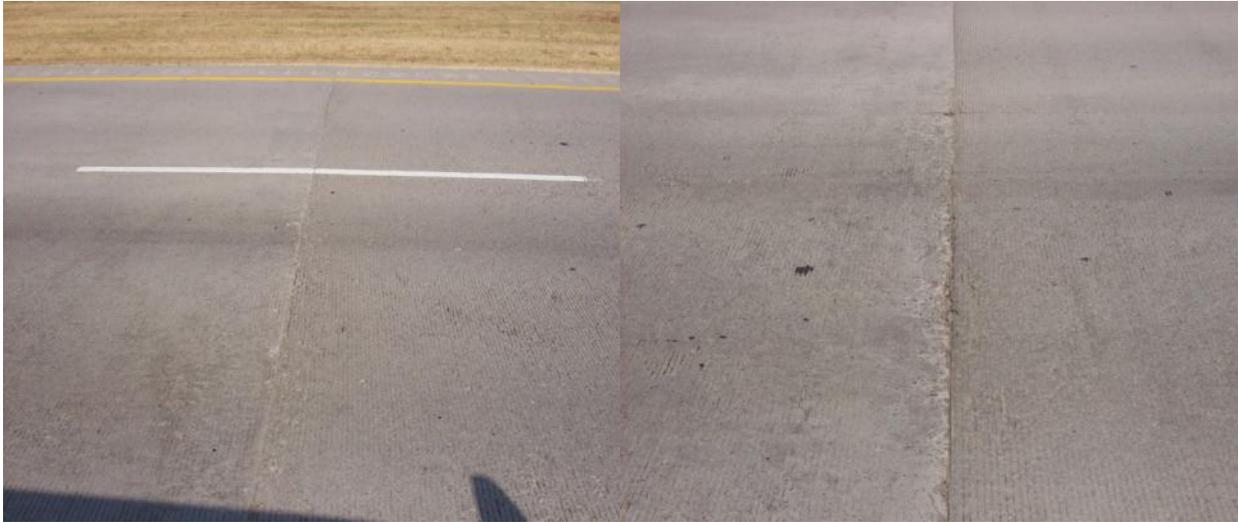
**Figure 3.16** – Two construction joints displaying signs of spalling

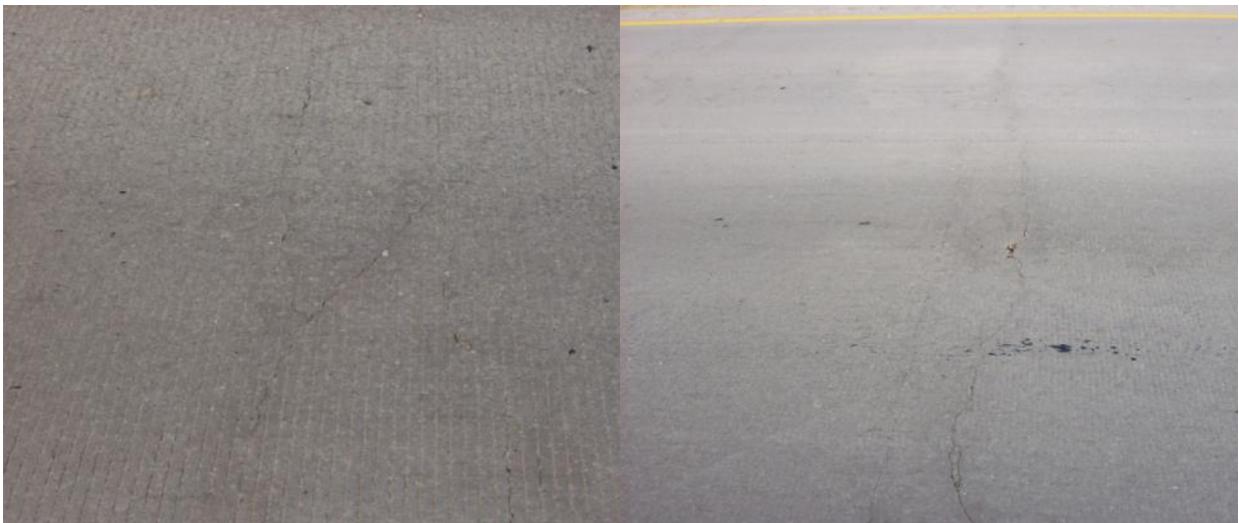
**Figure 3.17** – (Left) Y-crack located in the region; (right) two close transverse cracks showing distress

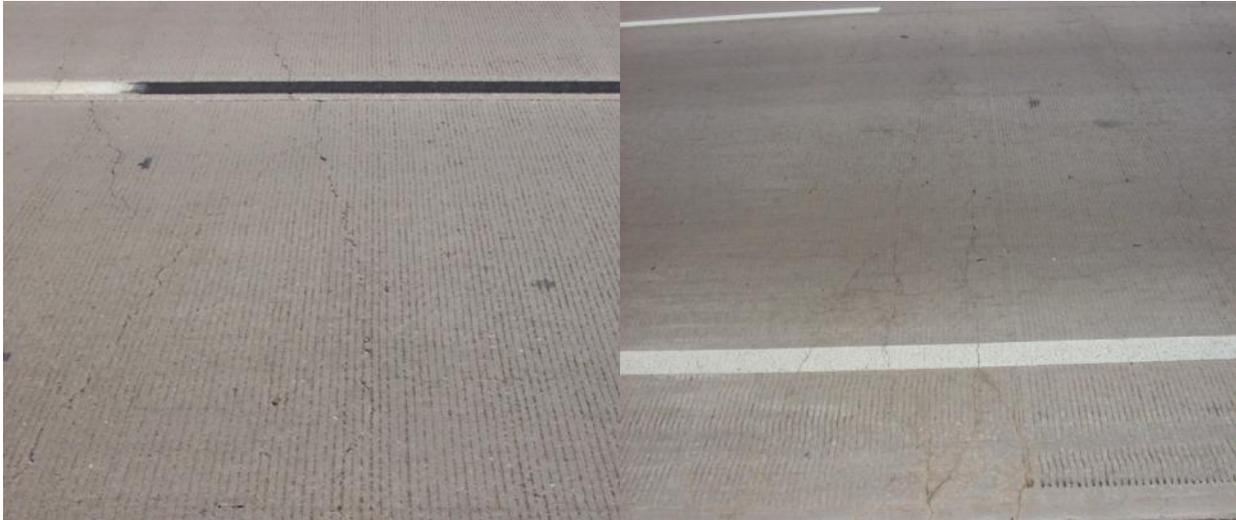
The south bound inspection began at a bridge approach joint 0.16 miles north of mile post 29. The first 0.64 miles inspected were part of the project IMY-35-1(145)029. This area of pavement displayed a low number of Y-cracks. The south bound lane appeared to be more worn than the north bound lane, and its appearance was not as glossy. The south bound lane of the original project of interest displayed various forms of Y-cracking as seen in figure 3.19. However no patches or punch-outs were documented.

**Figure 3.19** – Two different forms of Y-cracking

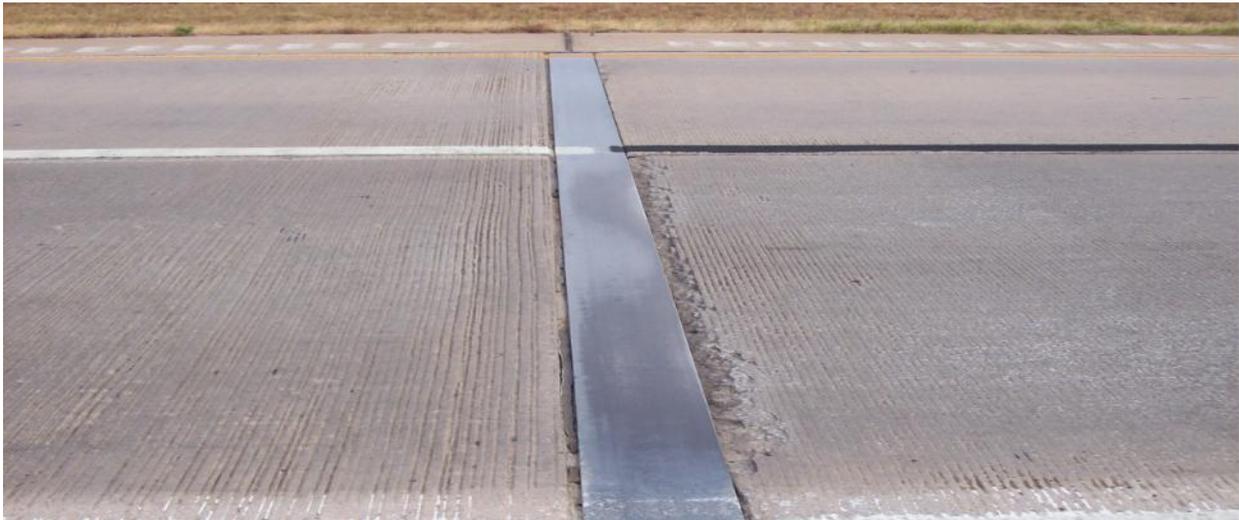
The inspection began in the east bound direction; figure 3.21 shows the terminal joint at the project beginning. The terminal joint has some signs of deterioration. The east bound direction contained several types of Y-cracks (figure 3.22), but seemed to have many places where the transverse cracks were close together. Figure 3.23 shows a place where five transverse cracks all occurred within an eight foot section of pavement. Figure 3.22 right does contain a Y-crack on the far left, but in most cases the closely spaced transverse cracks did not consist of Y-cracks, and in most cases the close transverse cracks did not show signs of punch-out or failure. However, a few did, as shown in figure 3.23.

**Figure 3.21** – Deteriorated terminal joint at project beginning

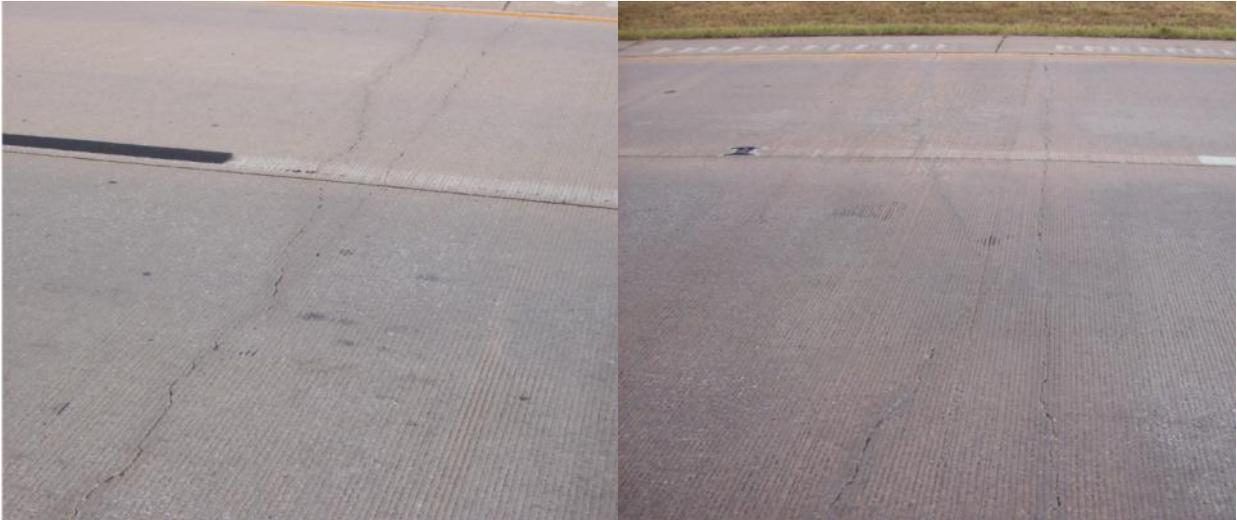
**Figure 3.22** – Two different types of Y-cracks found in the area

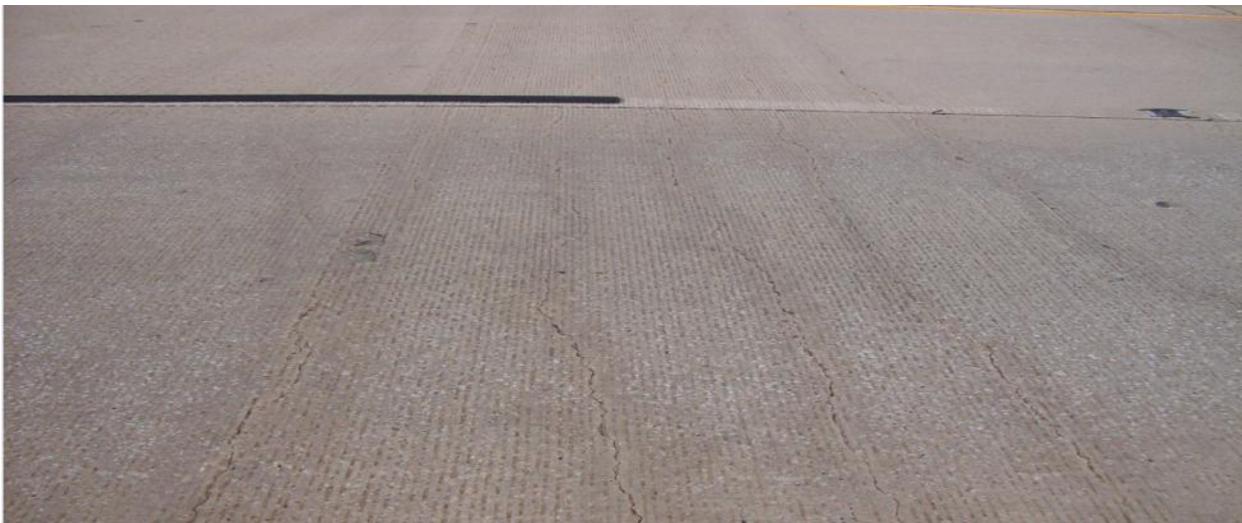
**Figure 3.23** – Closely spaced transverse cracks

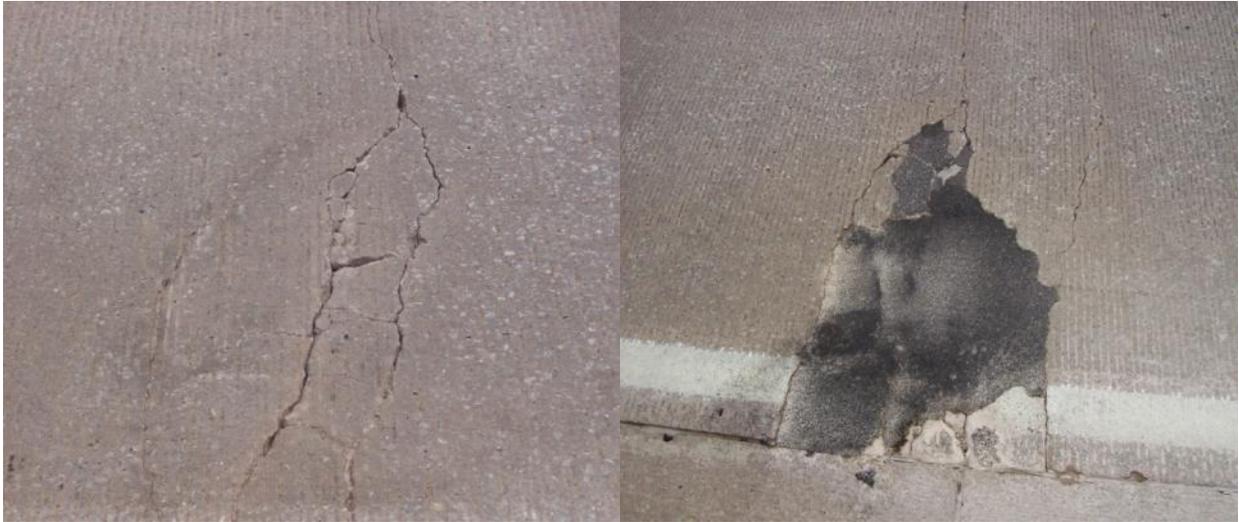
This pavement showed the first signs of a Y-crack leading to a punch-out (see figure 3.24). However, the majority of failures that were not patched seemed to be caused by closely spaced transverse cracks with intersecting longitudinal cracks, as shown in figure 3.25. Overall the east bound lane was in poor shape with thirty-three patches in the outside lane alone over the length of the project.

**Figure 3.24** – Two instances where a Y-crack seemed to be developing into a punch-out

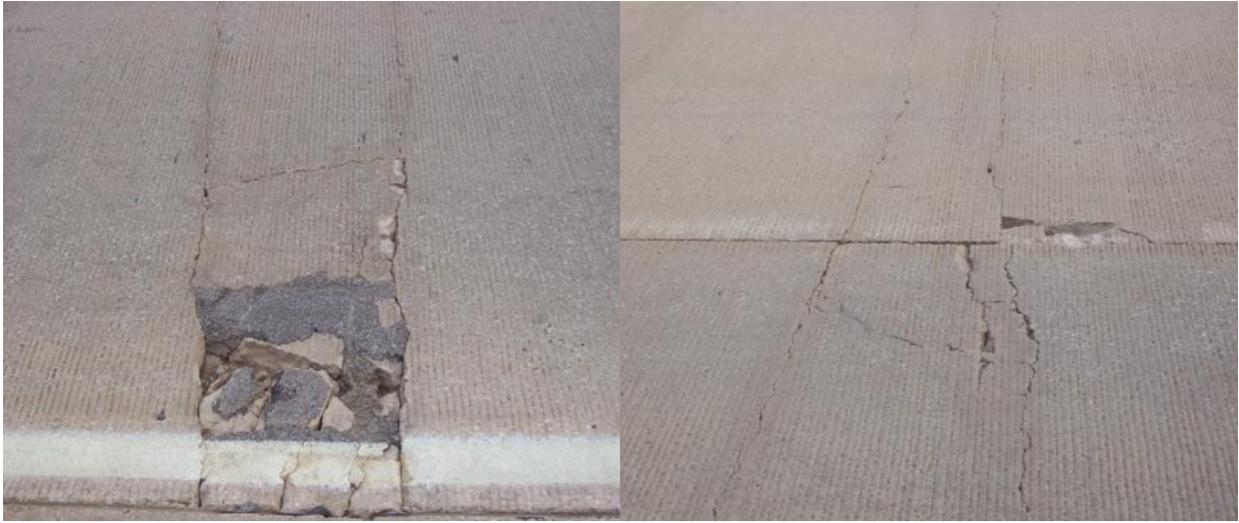
**Figure 3.25** – Punch-outs forming between closely spaced transverse cracks

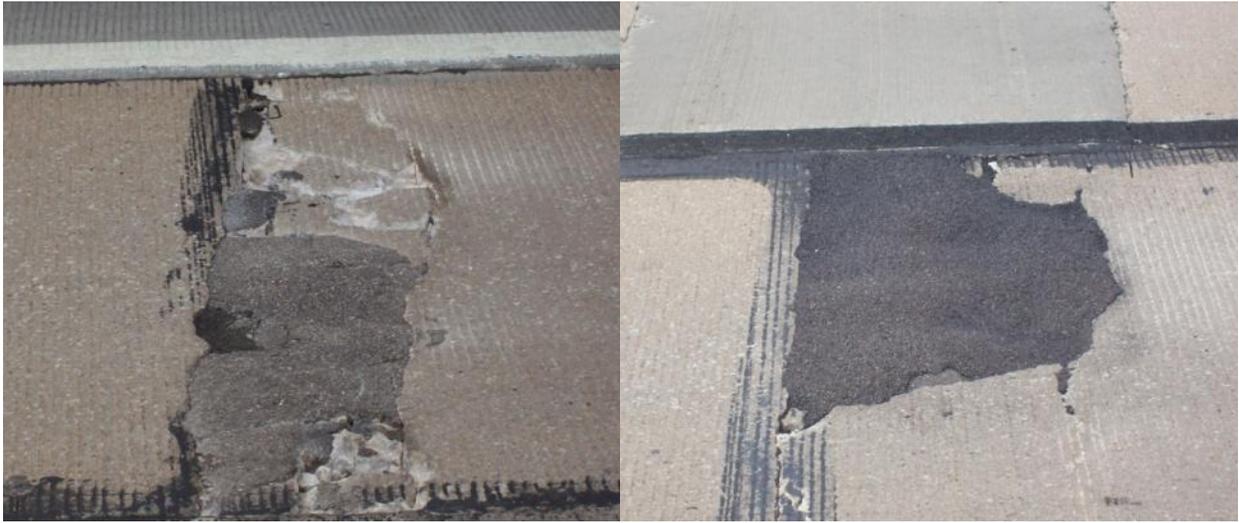
**Figure 3.28** – Patches caused by closely spaced transverse cracks

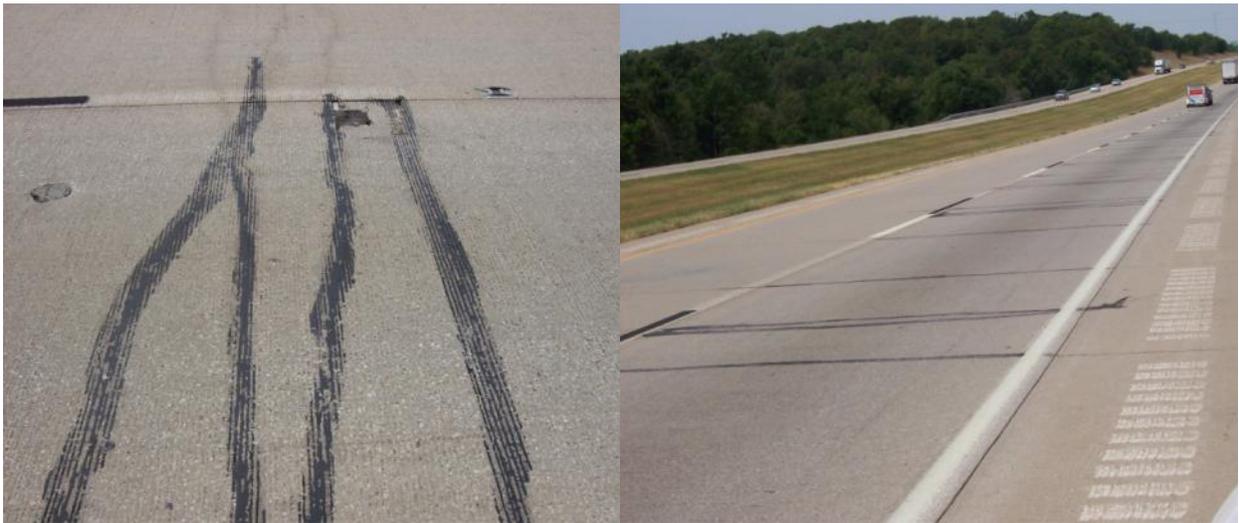
figure 3.28. By observing the west bound lane it was clear that along with the numerous patches, asphalt joint sealant had been applied to many of the transverse cracks along the roadway, see figure 3.29.

**Figure 3.29** – Transverse cracks sealed with an asphalt joint sealant

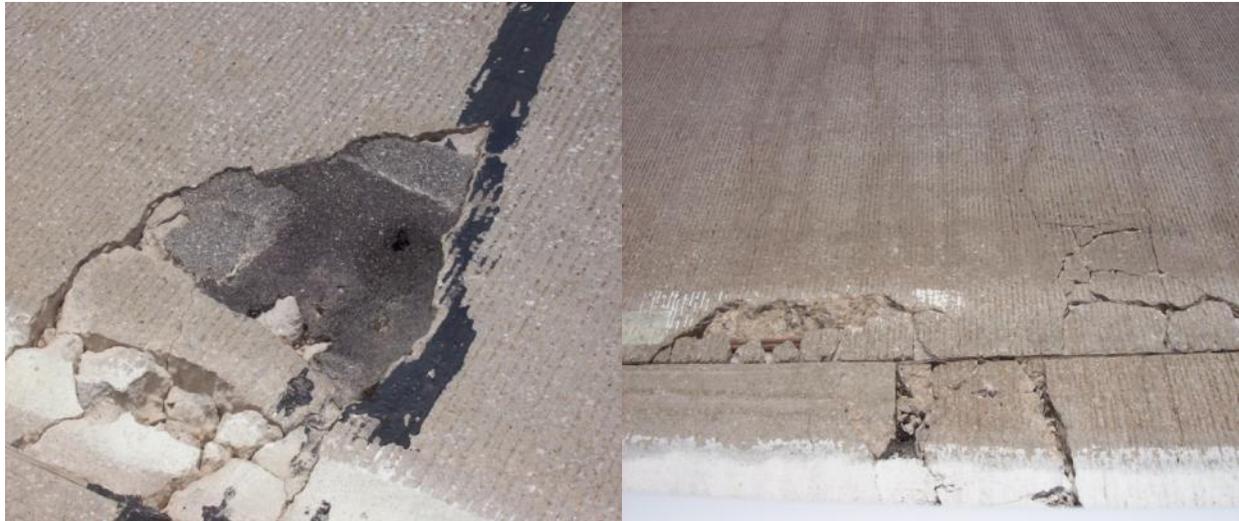
was also noted that the image in figure 3.30 (right) showed a longitudinal steel splice. The steel appeared to be approximately two inches from the concrete surface.

**Figure 3.30** – (left) Y-crack breaking up, (right) distress caused by close transverse cracking

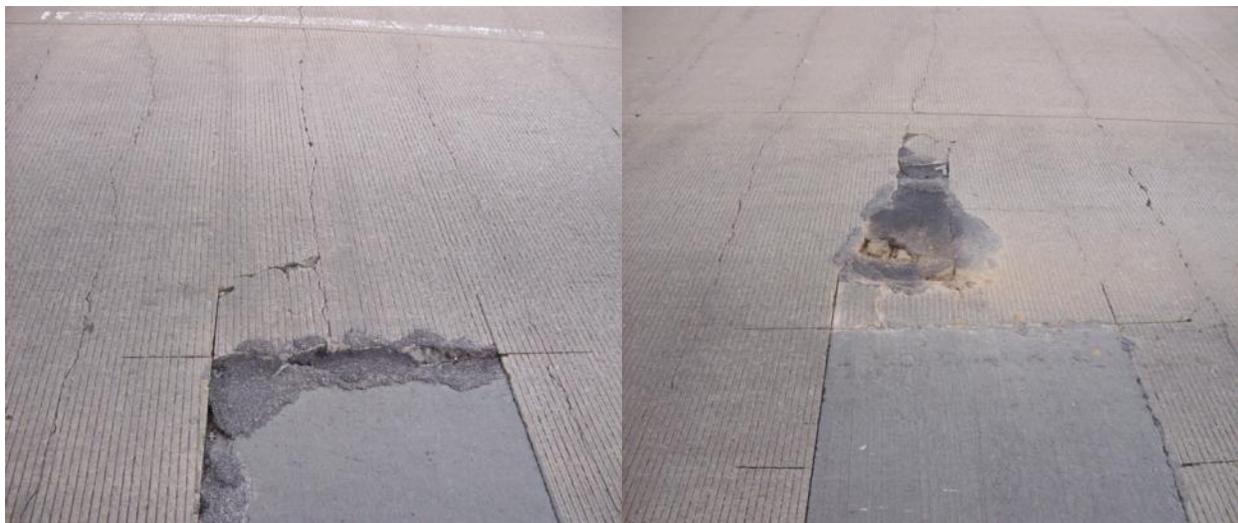
**Figure 3.32** – Small patch with distress developing close by

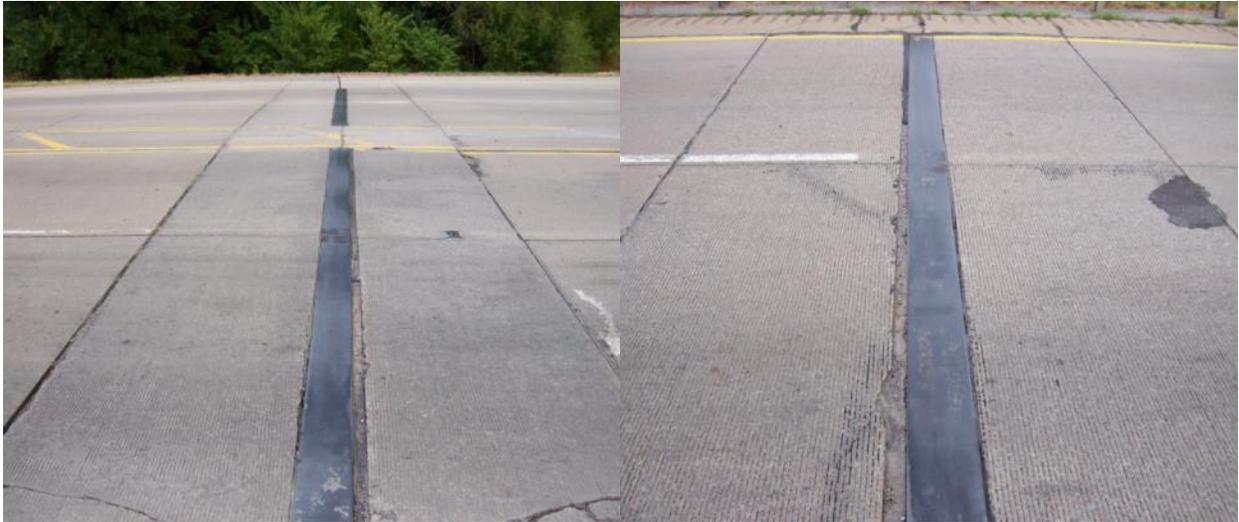
**Figure 3.33** – Terminal joints showing signs of spalling

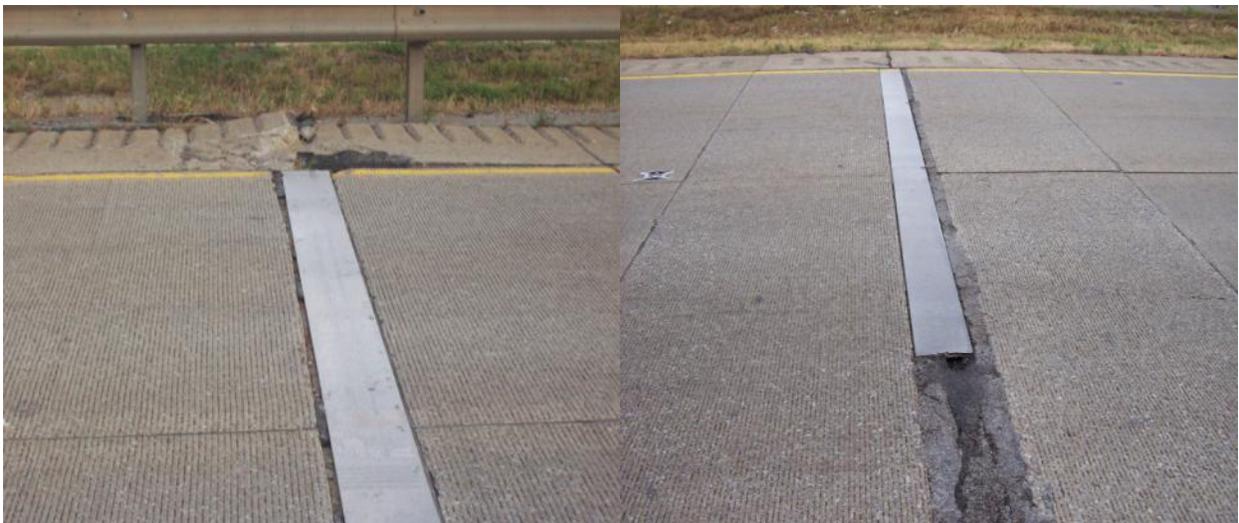
**Figure 3.34** – Terminal Joints with different kinds of distress

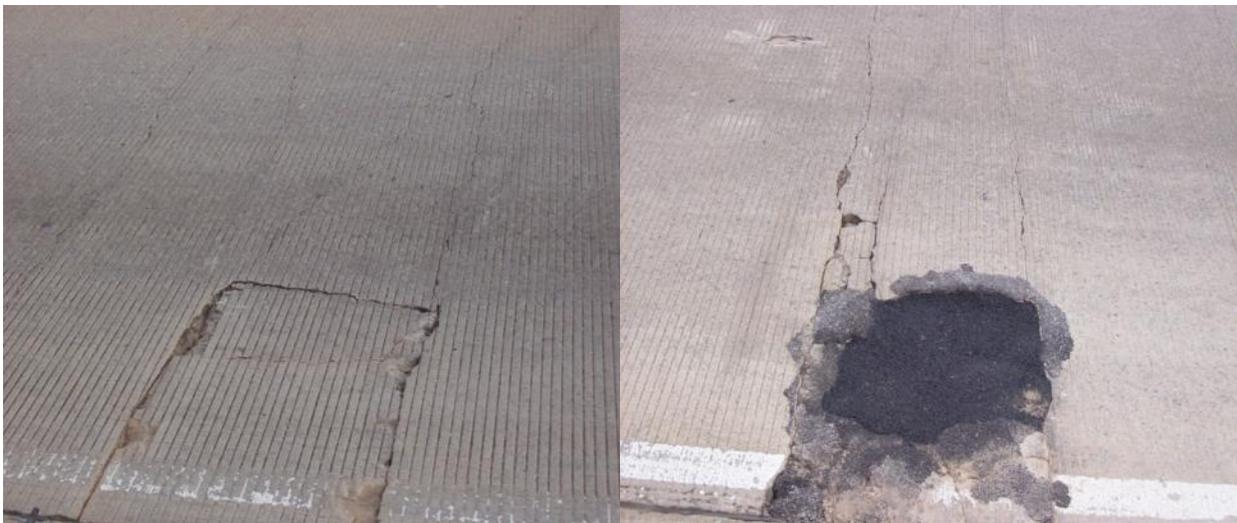
**Figure 3.36** – Y-cracks leading to punch-out and eventually failure

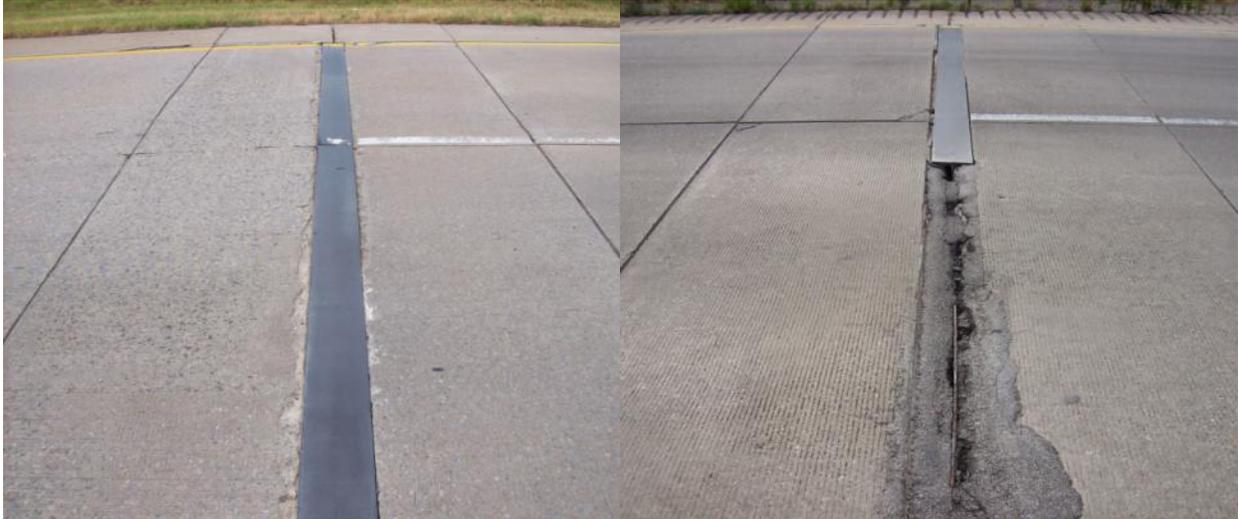
**Figure 3.37** – Terminal joints showing distress

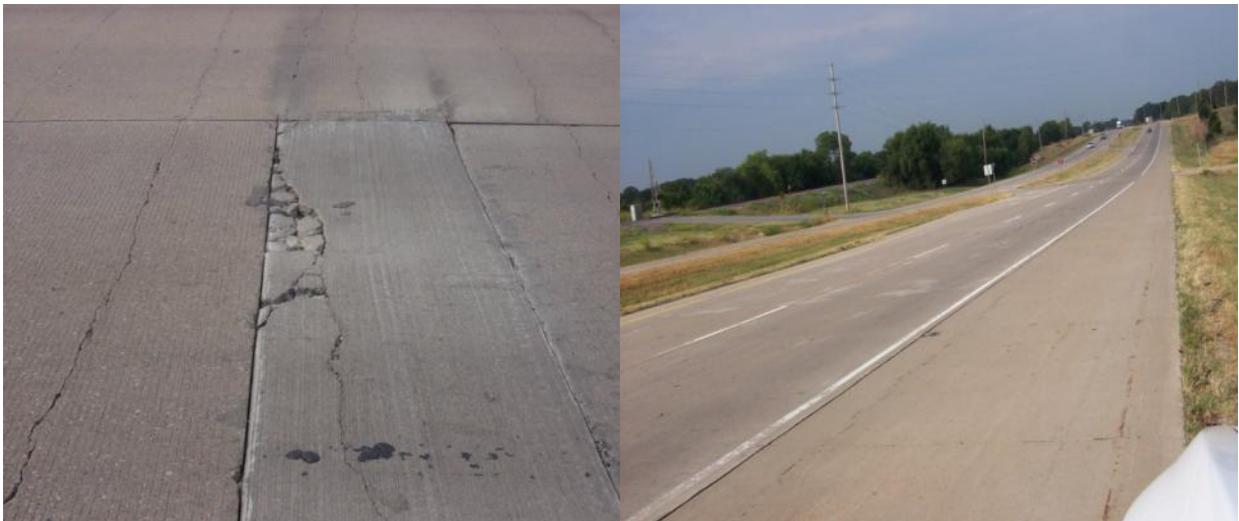
**Figure 3.38** – (left) patch showing signs of distress (right) area of road where crack survey was taken

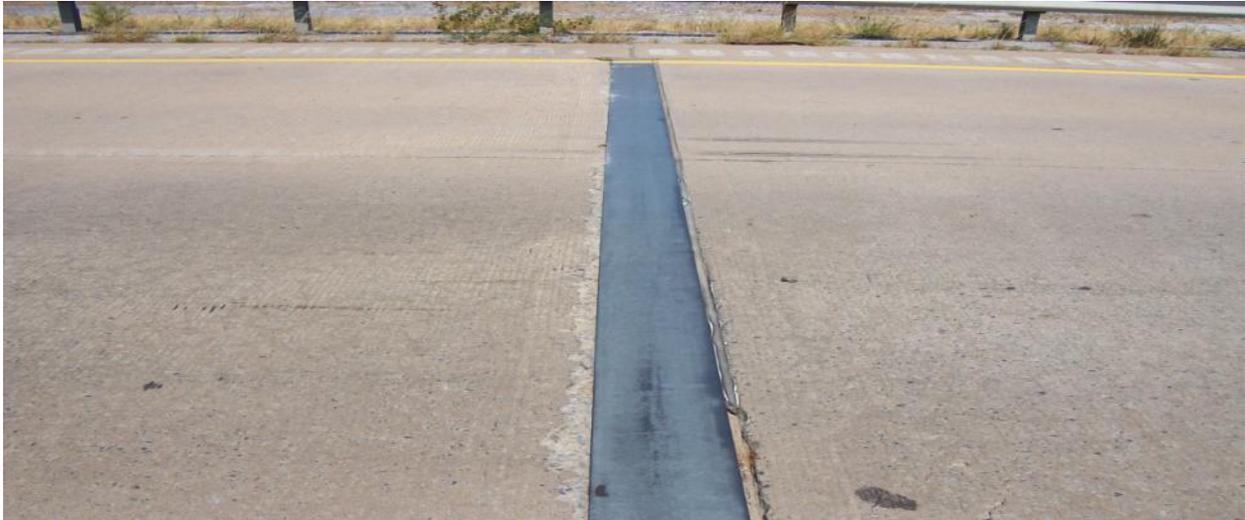
**Figure 3.39** – Spalled terminal joint with worn roadway surface

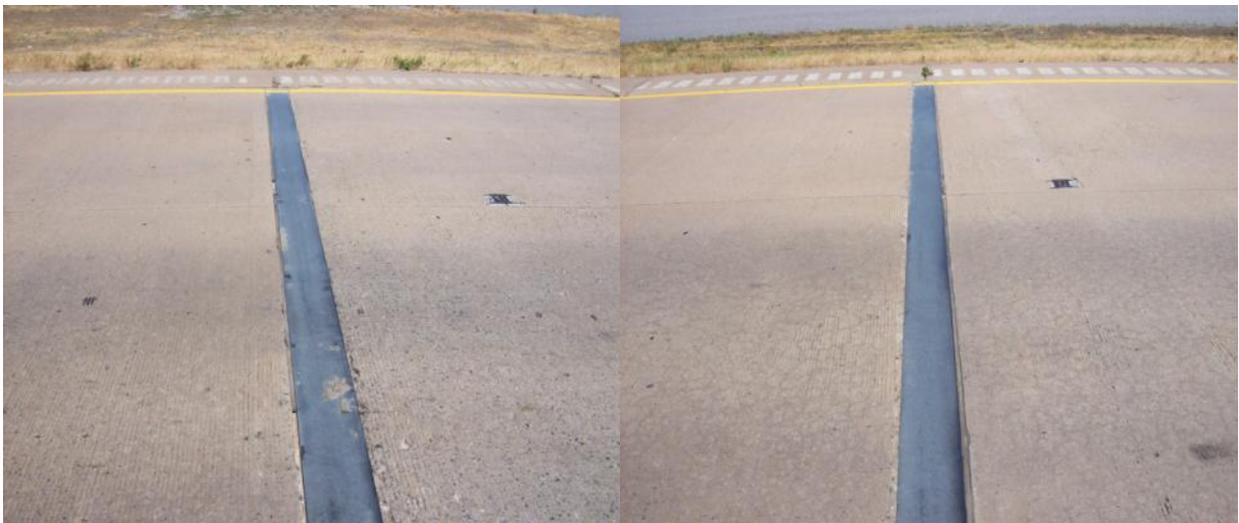
**Figure 3.40** – Spalled terminal joints, with the (right) displaying map-cracking

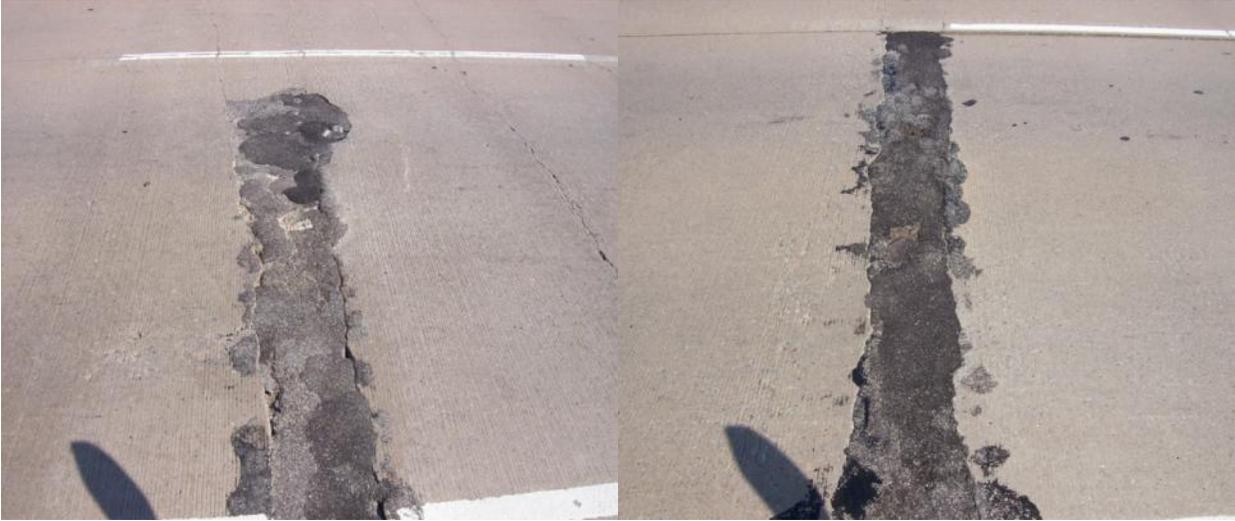
**Figure 3.41** – Patches caused by closely spaced transverse cracks
