# Effect of Y-cracking on CRCP Performance

## **ANNUAL REPORT FOR FY 2011**

ODOT SPR ITEM NUMBER 2230

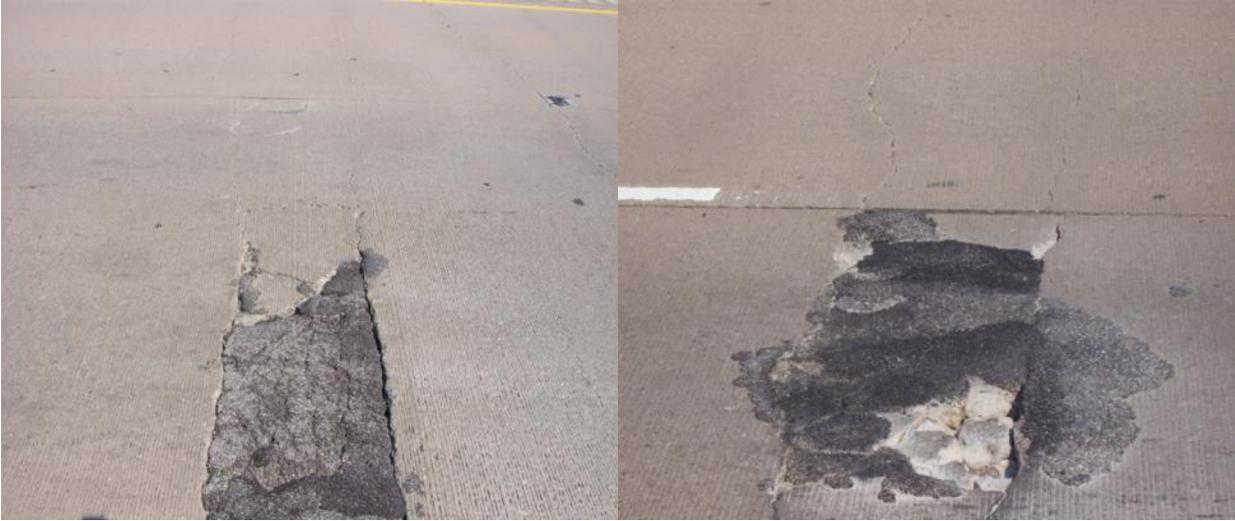
**Figure 3.42** – More patches cause by closely spaced transverse cracks

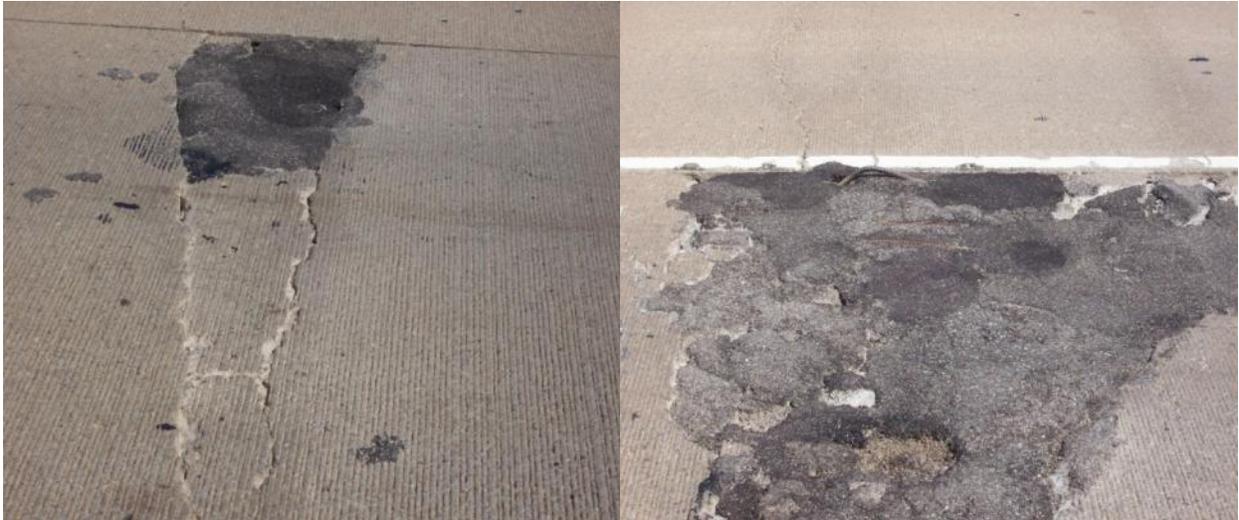
**Figure 3.43** – (left) Patch caused by a Y-crack (right) patch with steel protruding through

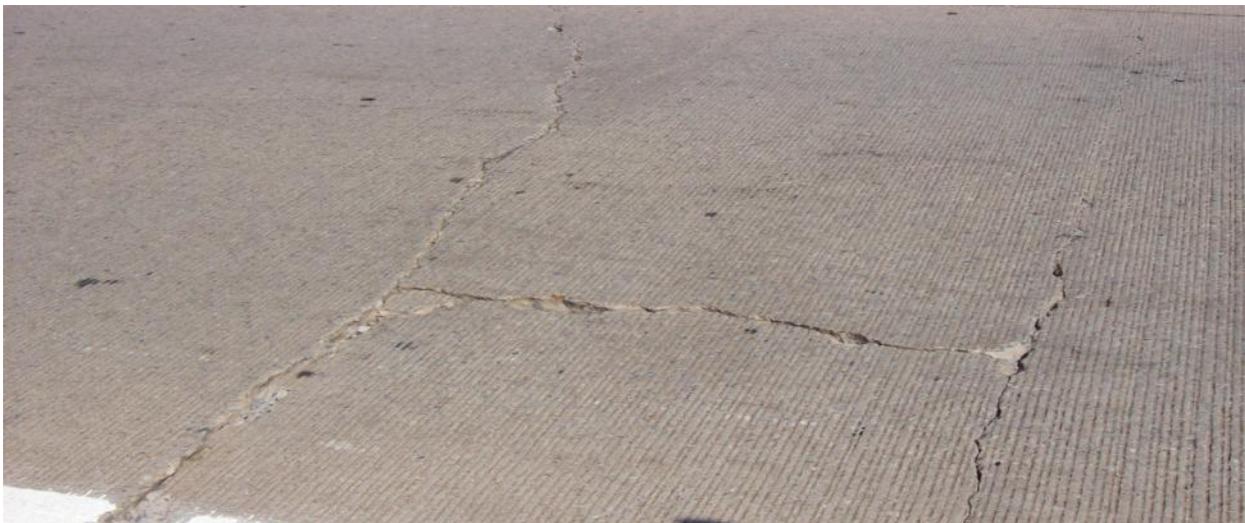
**Figure 3.44** – Two transverse cracks intersected by a longitudinal crack

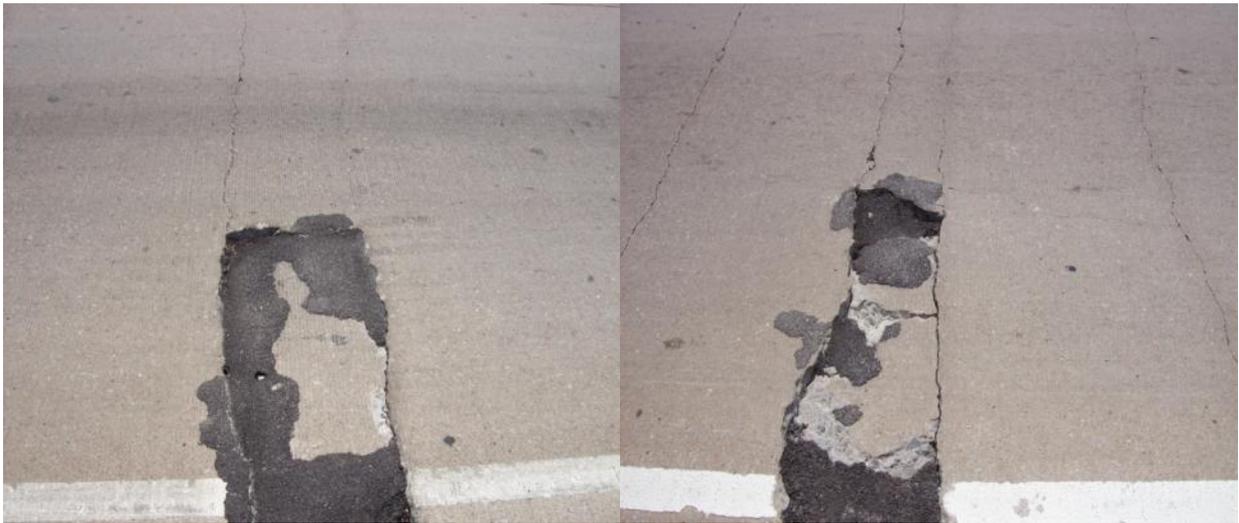
**Figure 3.45** – Transverse cracks intersected by longitudinal cracks

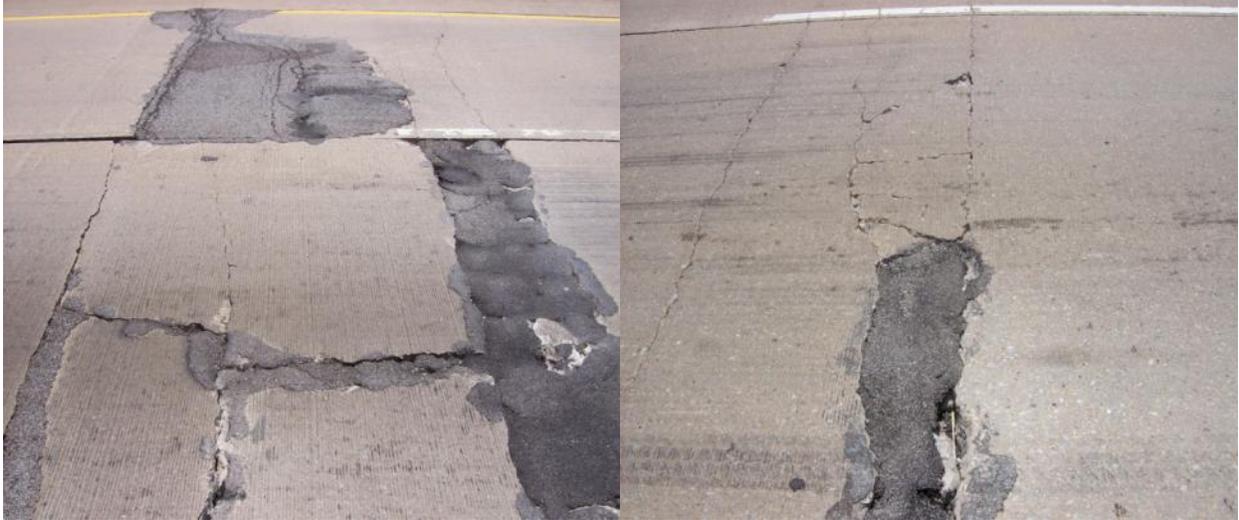
**Figure 3.46** – Transverse cracks intersected by longitudinal cracks

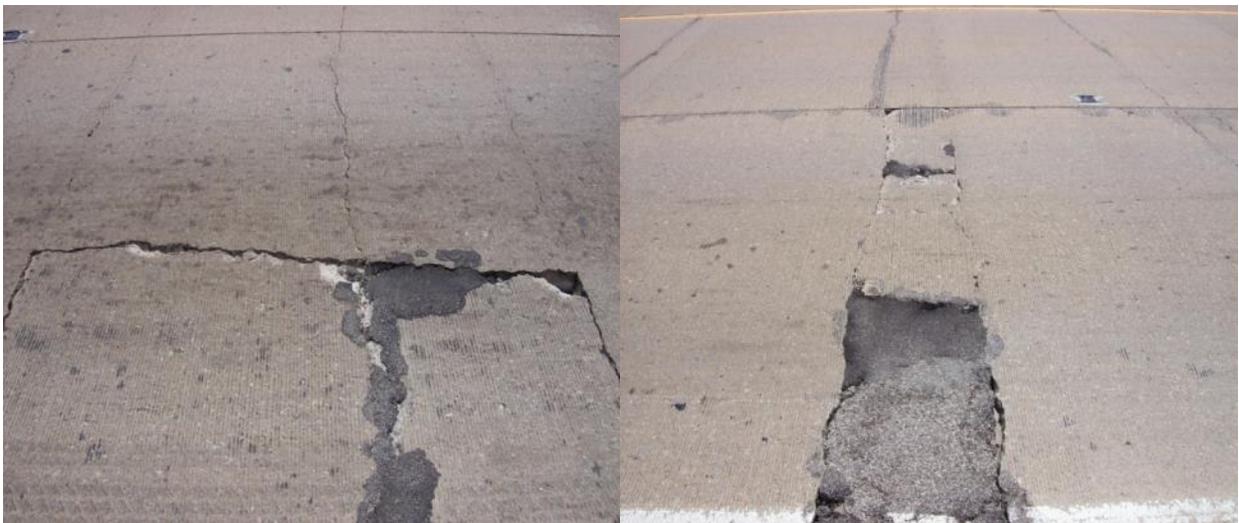
**Figure 3.47** – Transverse cracks intersected by longitudinal cracks

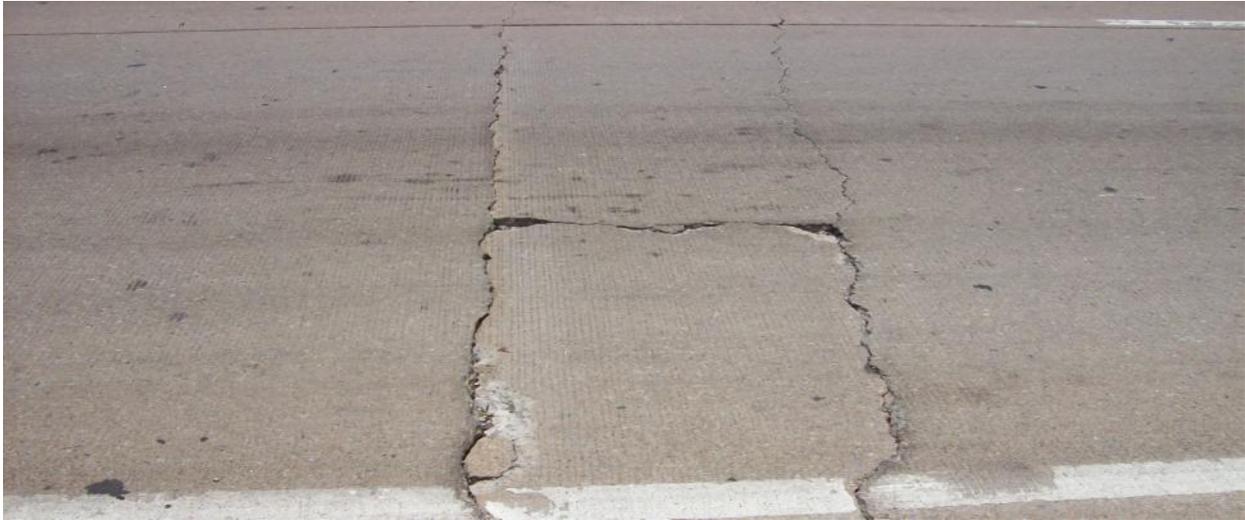
**Figure 3.48** – Two transverse cracks intersected by a longitudinal crack

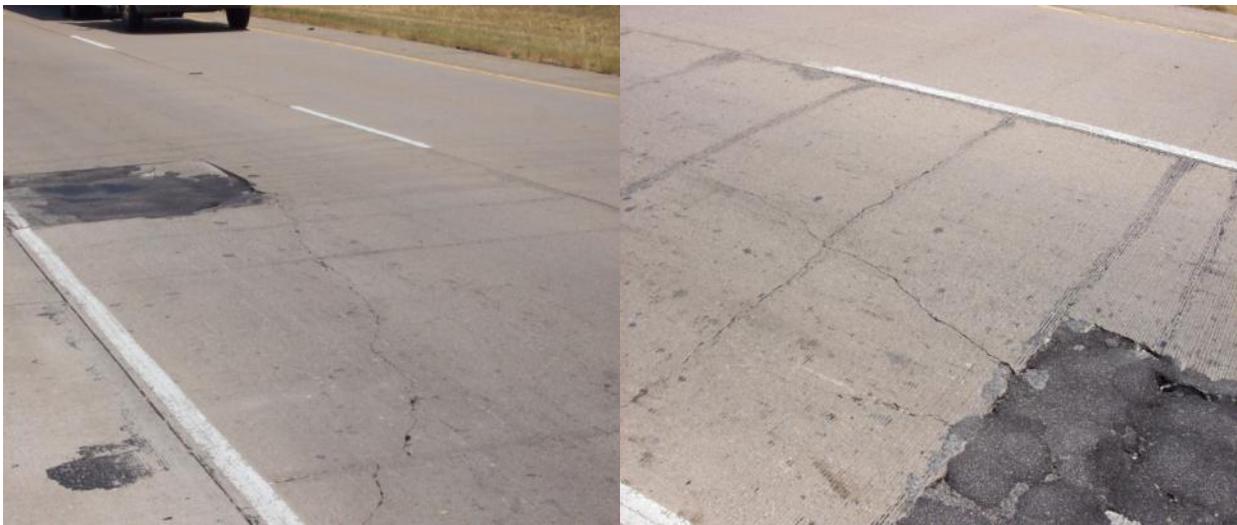
**Figure 3.49** – Multiple transverse cracks intersected by a longitudinal crack

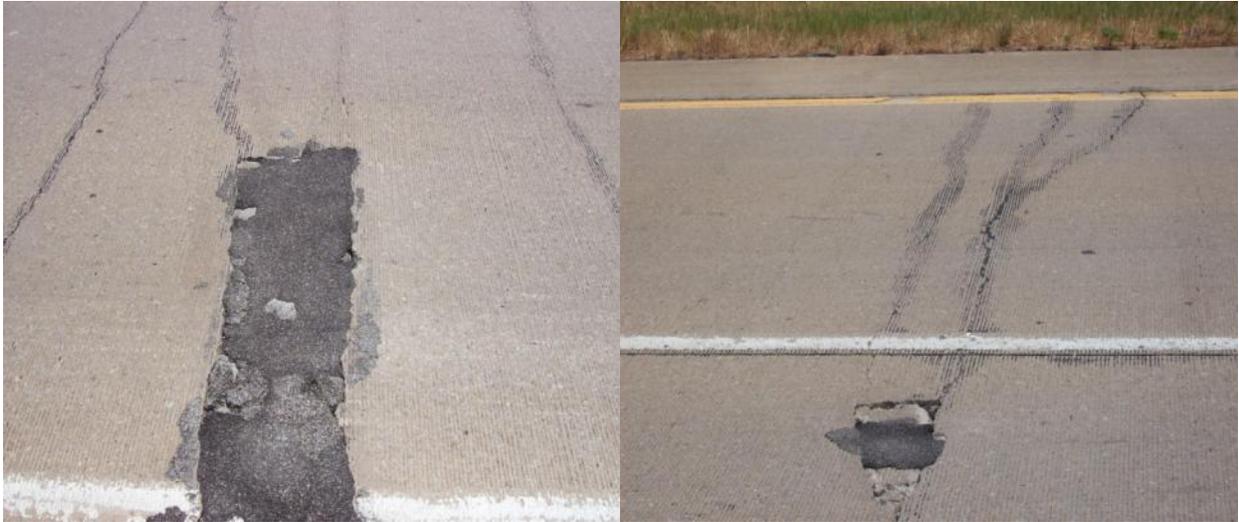
**Figure 3.50** – Patches that appear to be the result of a failed Y-crack

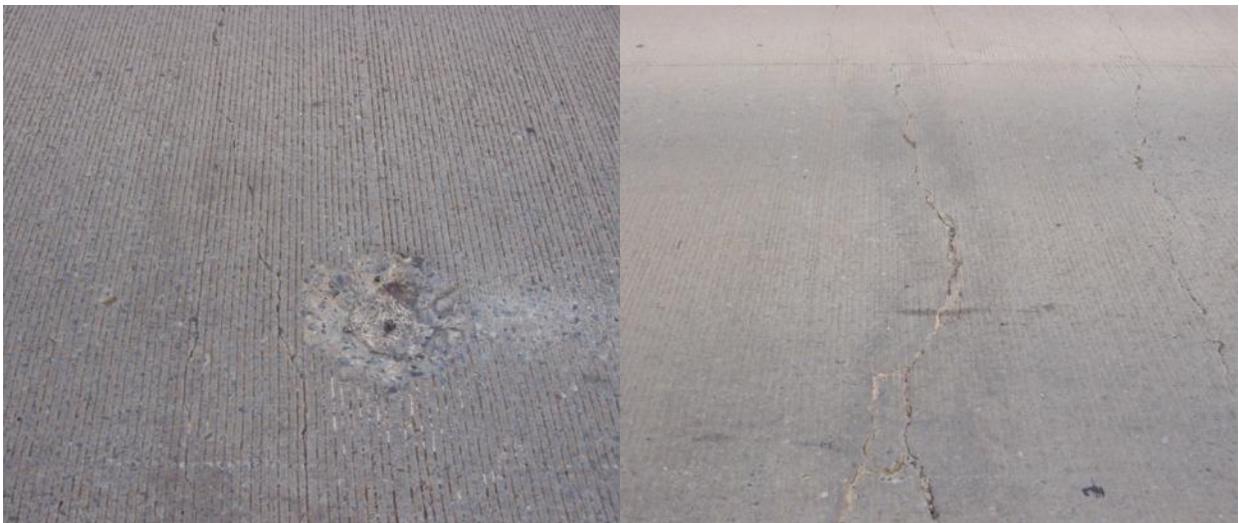
**Figure 3.53** – (Left) Large circular distress, (right) Spalled Y-crack beginning to break up

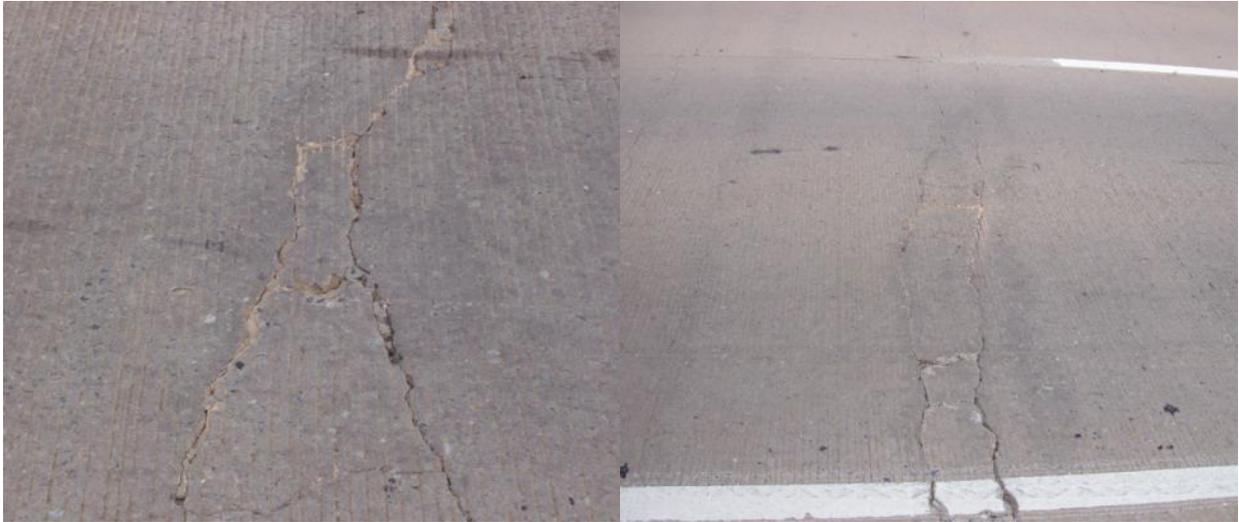
**Figure 3.54** – Two developing punch-outs

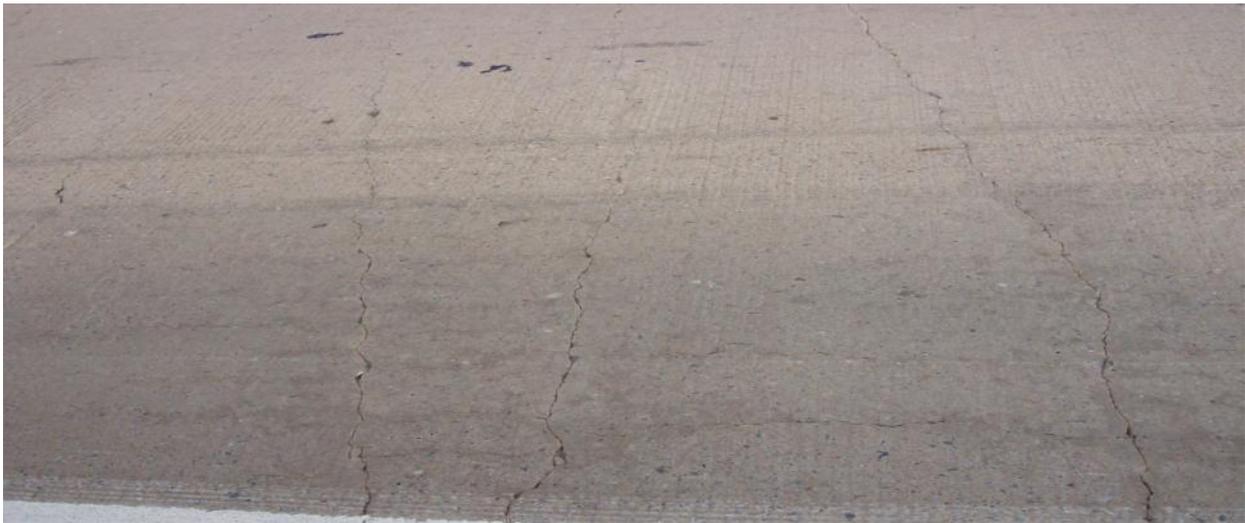
**Figure 3.55** – Stretch of pavement showing signs of map-cracking

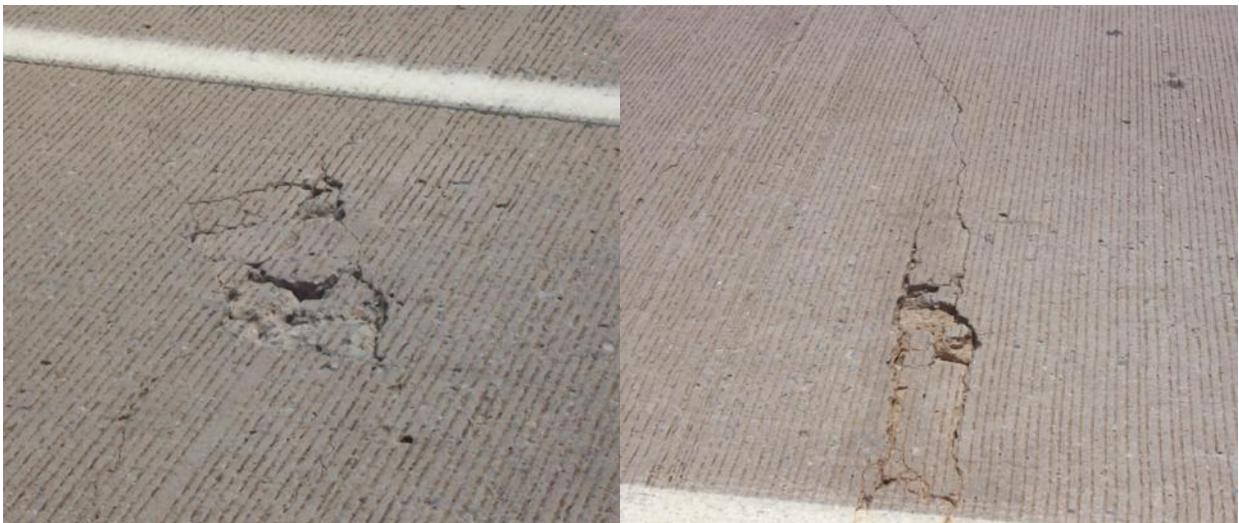
**Figure 3.60** – (left) Two closely spaced transverse cracks, (right) Y-crack developing into a punch-out

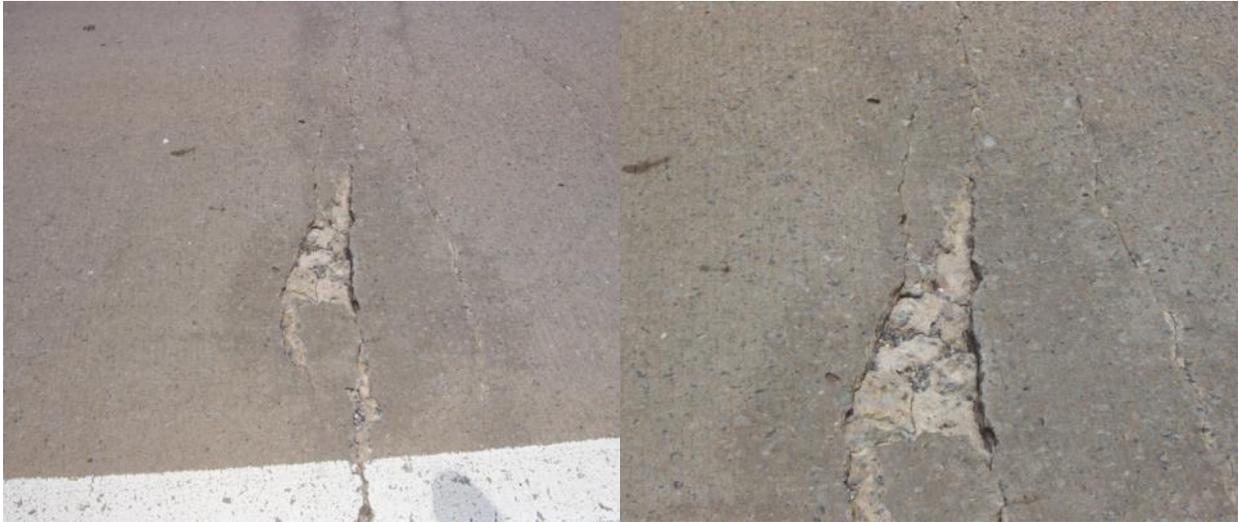
**Figure 3.62** – Y-crack developing into a punch-out

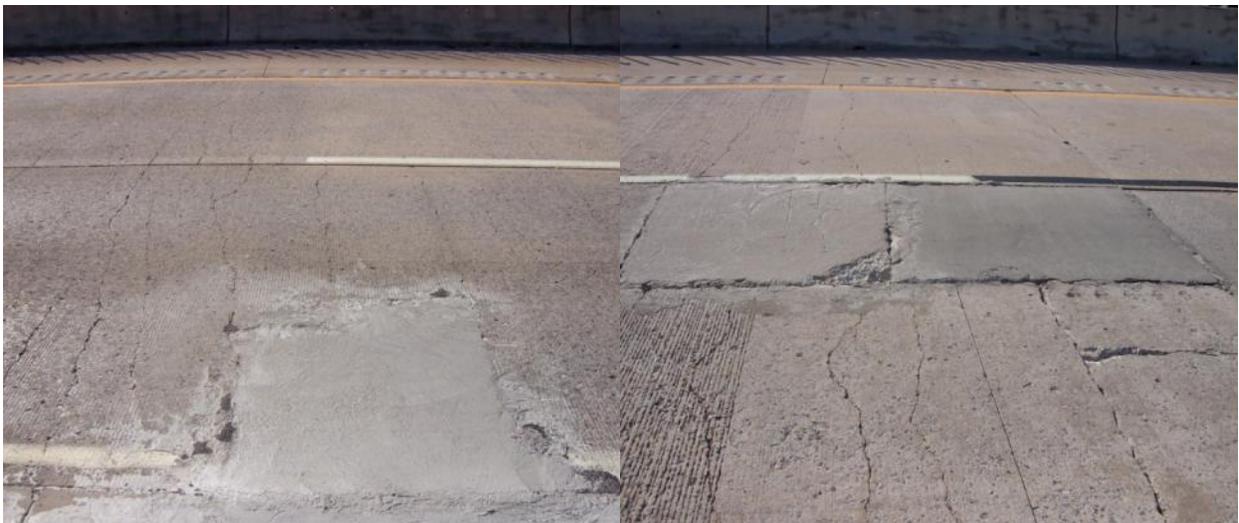
**Figure 3.64** – Patches formed near closely spaced transverse cracks

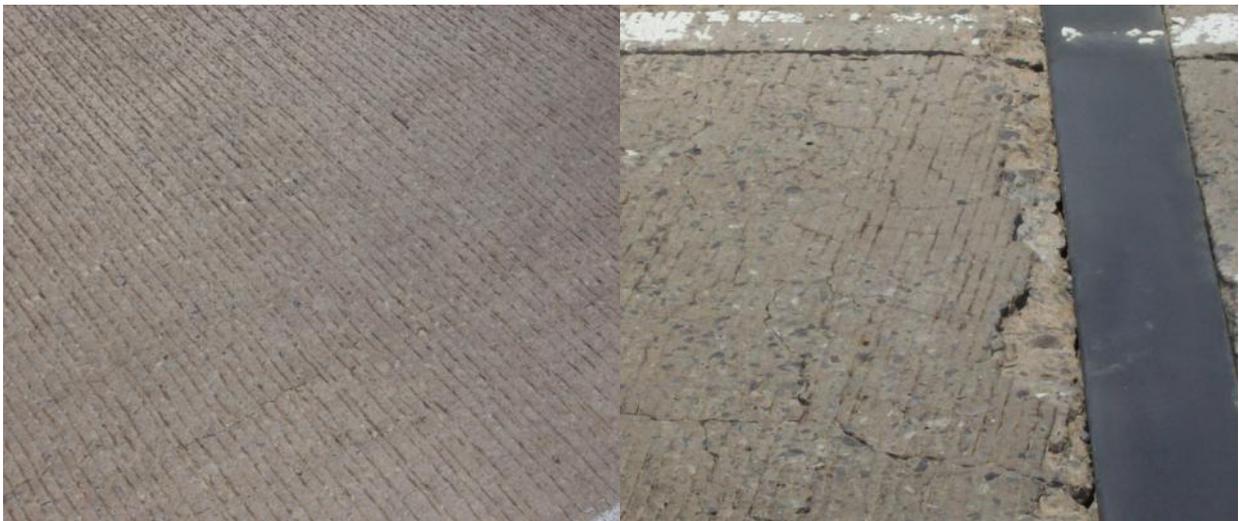
**Figure 3.65** – Close ups showing map-cracking

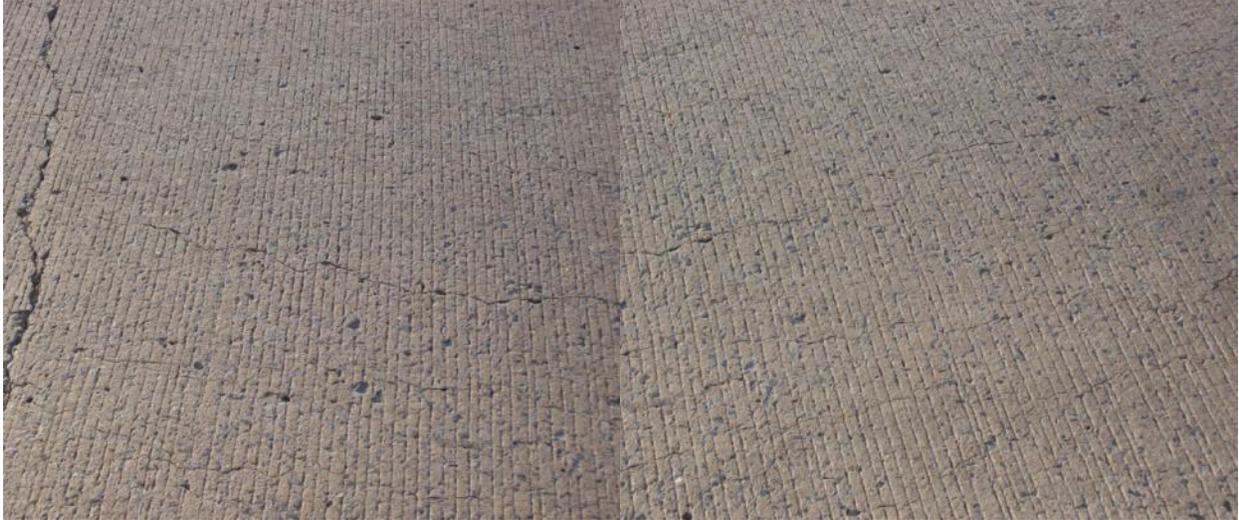
**Figure 3.67** – Map cracking in the south bound lane
