ALTERNATIVE AGGREGATES AND MATERIALS FOR HIGH FRICTION SURFACE TREATMENTS

Final Report Project BDR74-977-05

Performed in cooperation with the Florida Department of Transportation and the Federal Highway Administration

Published May 2016

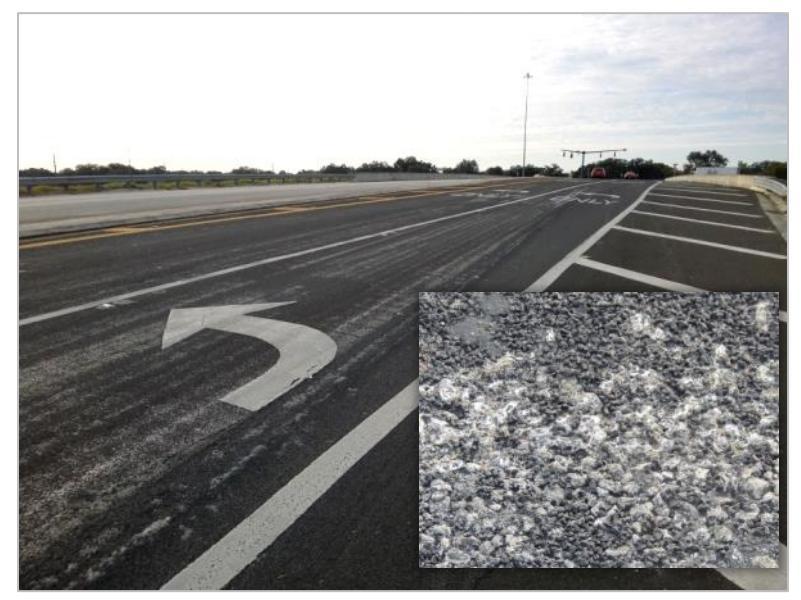
- 1. Insufficient aggregate embedment in the resin binder. OR
- 2. A weak bond between the aggregate and resin binder.

Figure 2.6 – Aggregate loss over uneven texture (Memorial Blvd to I-4)

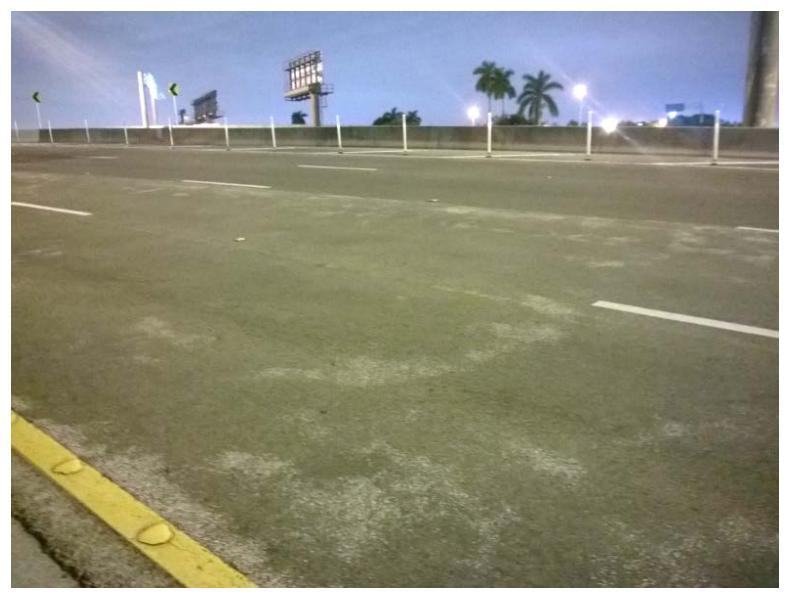
Figure 2.8 – Aggregate loss over OGFC (FLL Airport)

To avoid this problem, surface preparation practices described in the *Best Practices* section should be followed. If applying over an OGFC, the superelevated curves should be completely treated to prevent water from infiltrating beneath the HFST.

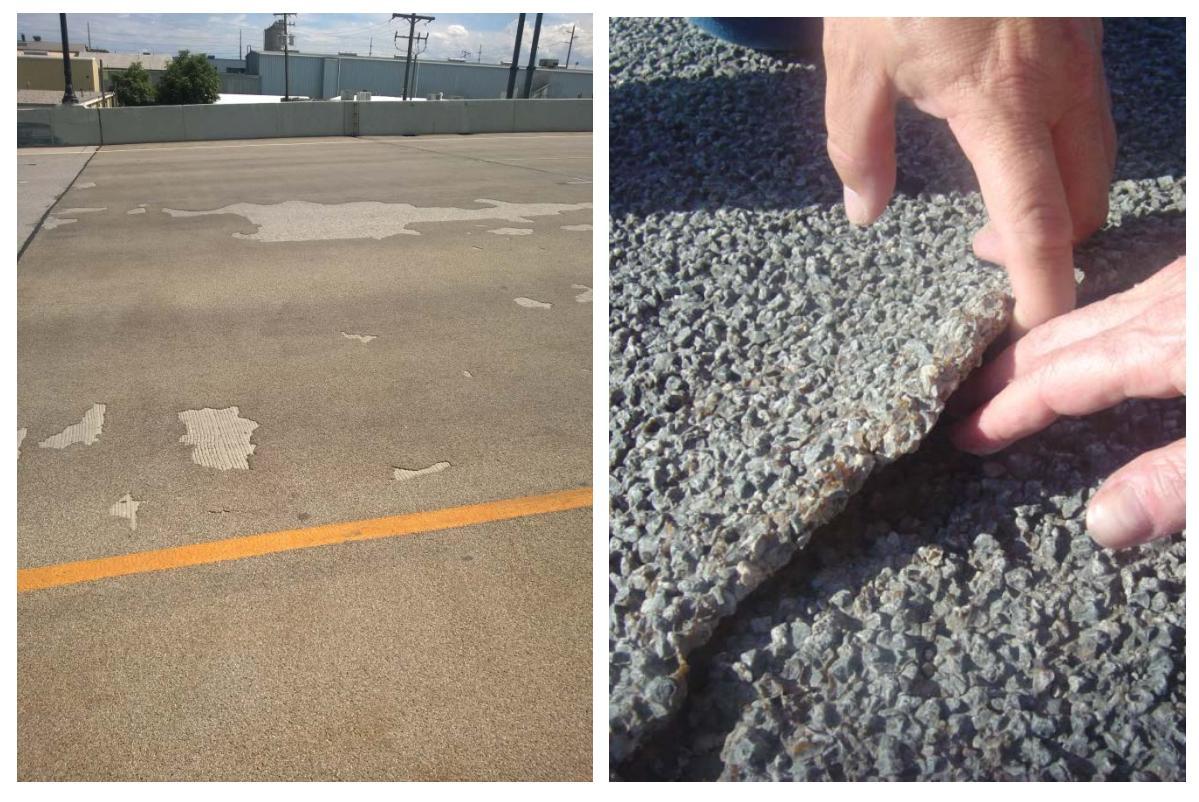
Figure 2.9 – Delamination: Bridge deck and a double layer HFST

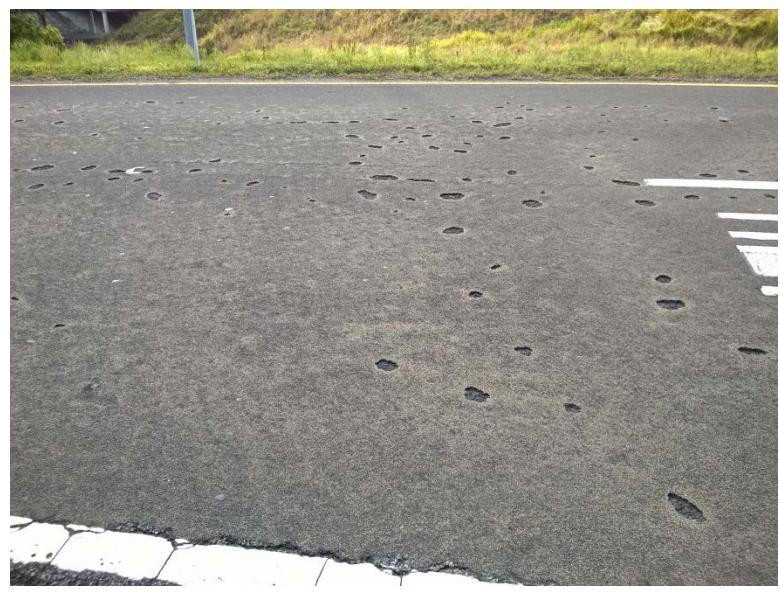
If the binder itself is incorrectly formulated or proportioned, the problem will be wide-spread. If it is a mixing problem, the problem will be manifest as splotchy localized failures.
In the case of two Florida sections (Tampa-I-275 to US 60 and Brandon-US-60 to NB I-75), an inexperienced contractor rented an epoxy mixing truck from the HFST vendor. The equipment malfunctioned and could not completely mix the two epoxy components. After 3 years, the project is covered by localized failures (Figure 2.10). On both projects, the HFST was applied over OGFC. As the aggregate and binder delaminated, moisture collected in the OGFC, stripped the aggregate, and created potholes under traffic. Other examples of uncured binder failure are shown in Figure 2.11 and Figure 2.12.

Figure 2.10 – Widespread localized failures due to poor binder mixing (US 90 – I-75 NB)

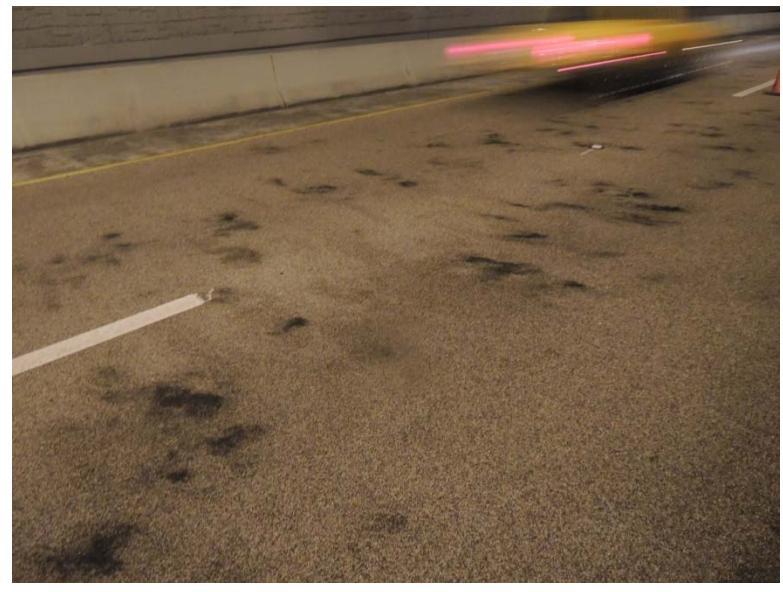
Figure 2.11 – Soft splotchy areas shortly after construction (I-95 ramp)

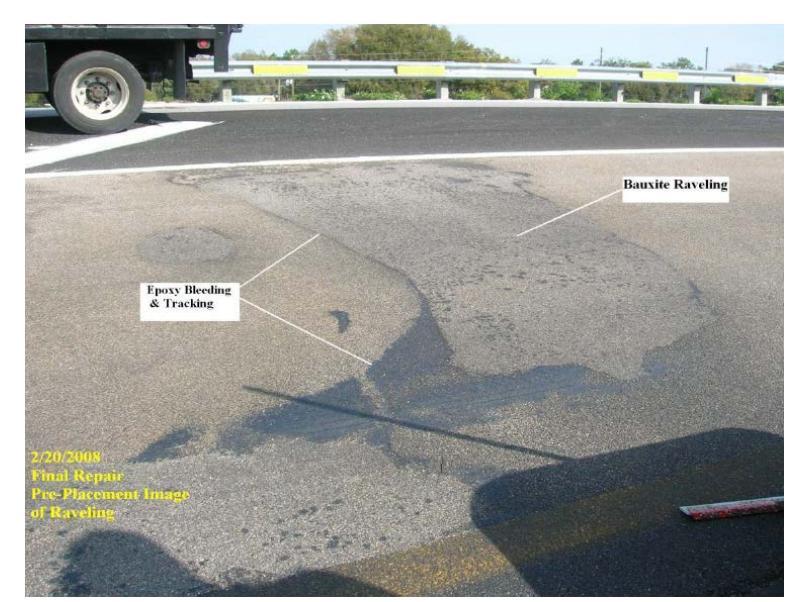
Figure 2.12 – Result of incorrect proportioning: aggregate loss, epoxy bleeding, and epoxy tracking (Polk Co. Parkway to I-4)

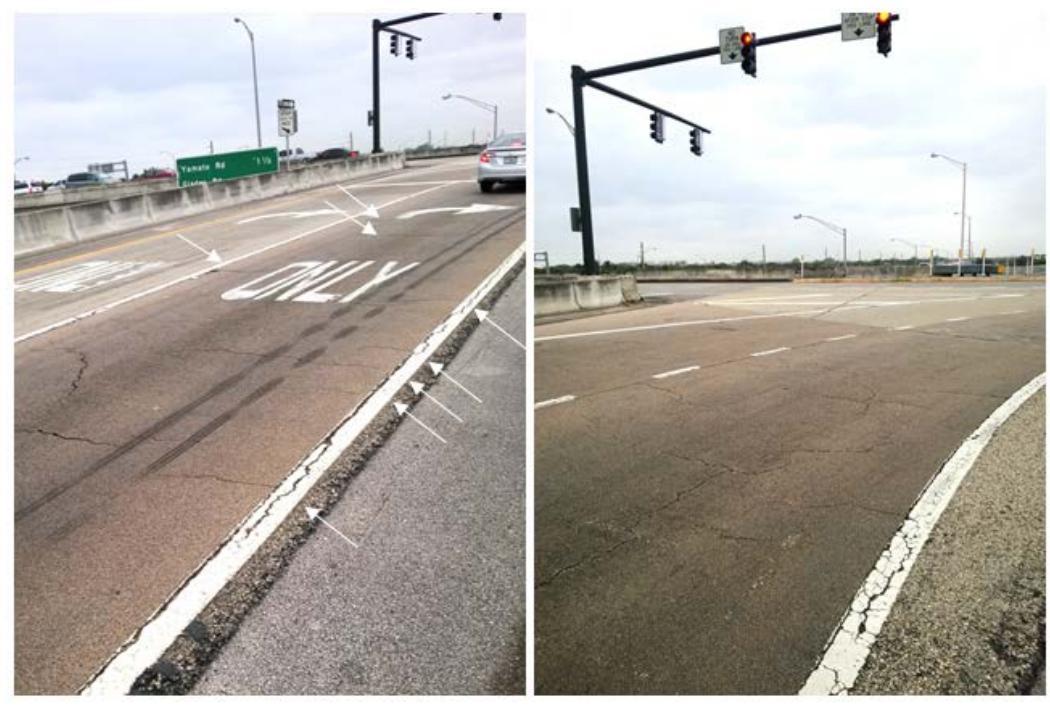
The exact mechanism is not proven but theorized in Figure 2.14. As a vehicle turns, brakes, and accelerates, the tires generate shear forces on the pavement surface. There is also a small amount of slipping that occurs, especially when turning. On an aggressive high-friction surface, the amount of slipping is reduced, and as a consequence, the shear stress between the tire and surface increases. These higher shear stresses can accelerate the deterioration of weak substrates.

Figure 2.13 – Substrate tearing at an approach (transverse) and around curve (random) (Boca Raton-I-95 to Congress)

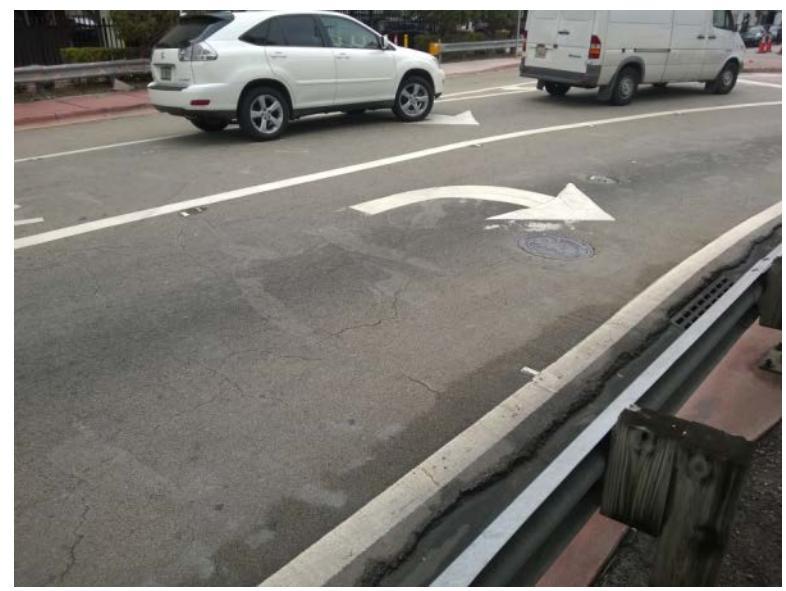
The last substrate-failure mechanism is thermal incompatibility. This type of failure is observed as surface cracking in roughly circular patterns. If the cracked area is removed, the failure in the substrate is in the shape of an inverted cone. (29) This is caused by (1) a difference in thermal coefficients, (2) a difference in layer stiffness (resistance to bending) and (3) low tensile strength of the substrate. The thermal coefficient for typical epoxy is 25 to 36 E^{-6} inch/(inch*°F). (30). This property for asphalt is unknown, but will be measured in later laboratory testing. With temperature changes, the epoxy layer and asphalt layer expand and contract at different rates, generating thermal stress. If this stress exceeds the substrate strength, then the substrate will fail. One particular epoxy was more susceptible to this problem than other epoxies because it was stiffer and would not flex under these stresses. The project in Figure 2.16 used this epoxy. This product is not in general use anymore.

Figure 2.16 – Random cracking likely from thermal incompatibility (Miami Beach-SR A1A)

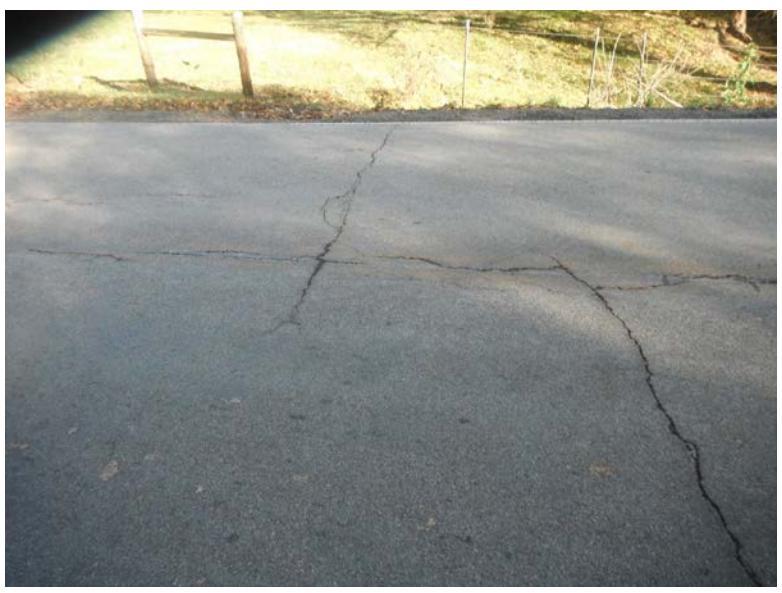
Epoxy has some flexibility and generally resists brittle cracking under traffic. Most observed cracking, if not associated with substrate failure, is reflective cracking. Existing cracks will propagate into the HFST under traffic loads or thermal cycling. (Figure 2.17) Two such examples are projects in North Carolina and Colorado. Reflective cracking here was combined with stripping.

Figure 2.17 – Reflective cracking

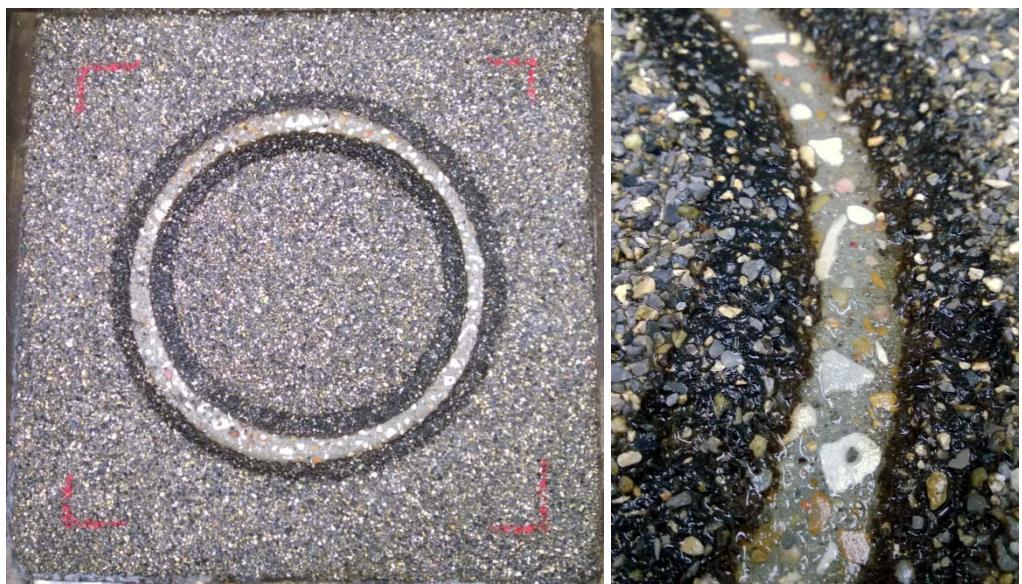
Figure 5.16 – Failure of Binder C sample at 140°F

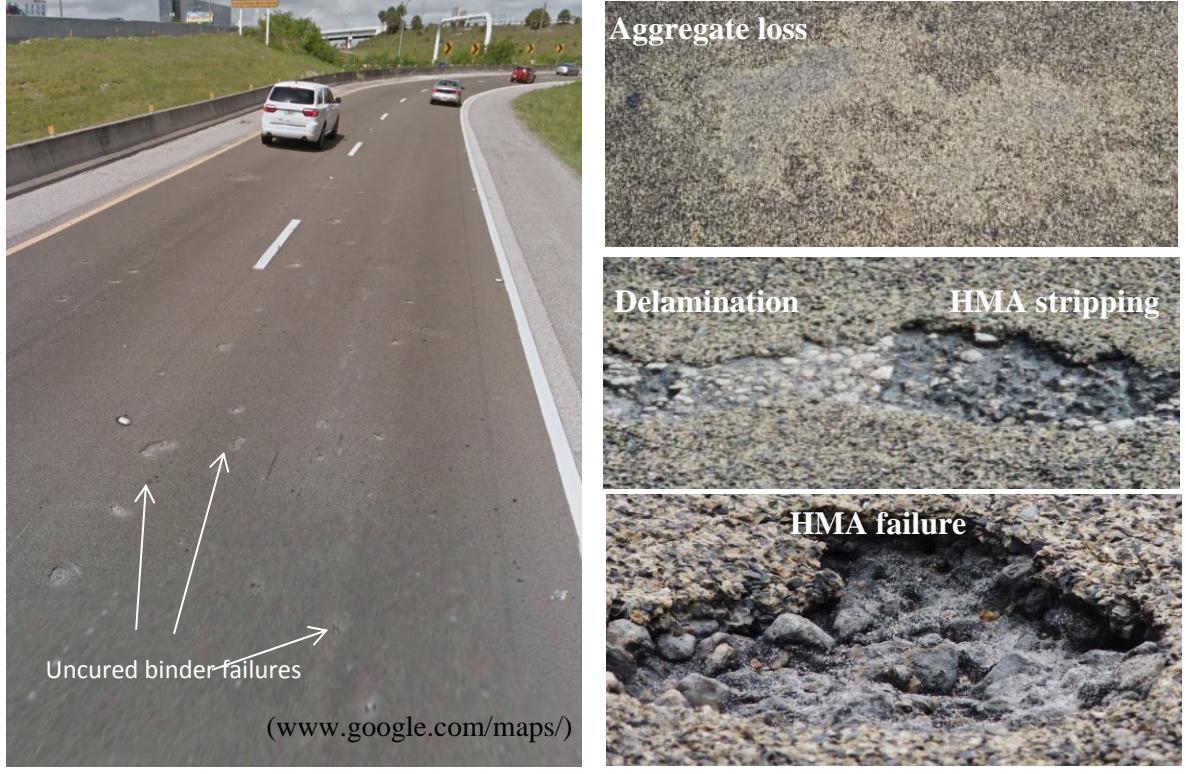
Figure C.3 – Failed locations on HFST (2014)

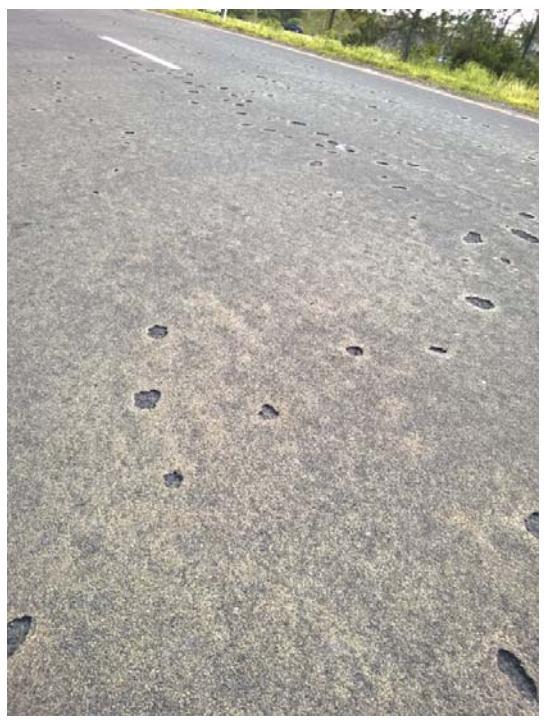
Figure C.6 – Uncured binder failure and potholing.

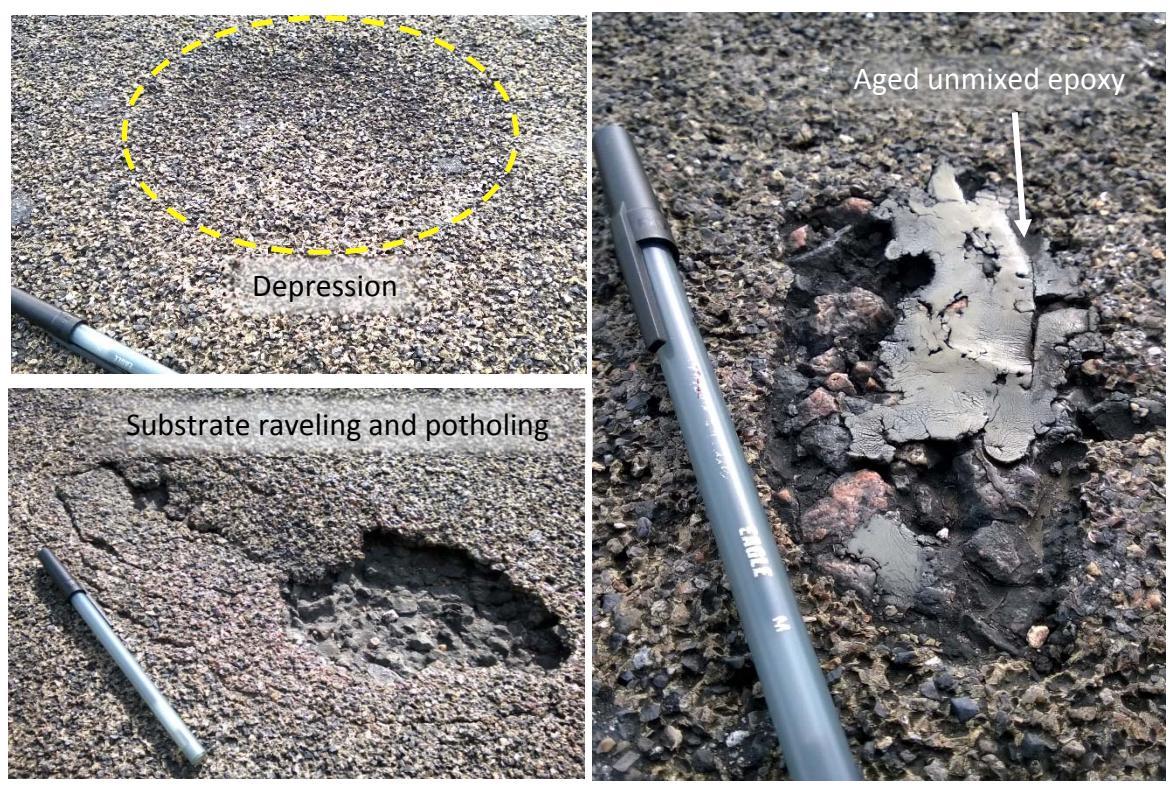
Figure C.7 – Stages of HFST failure.

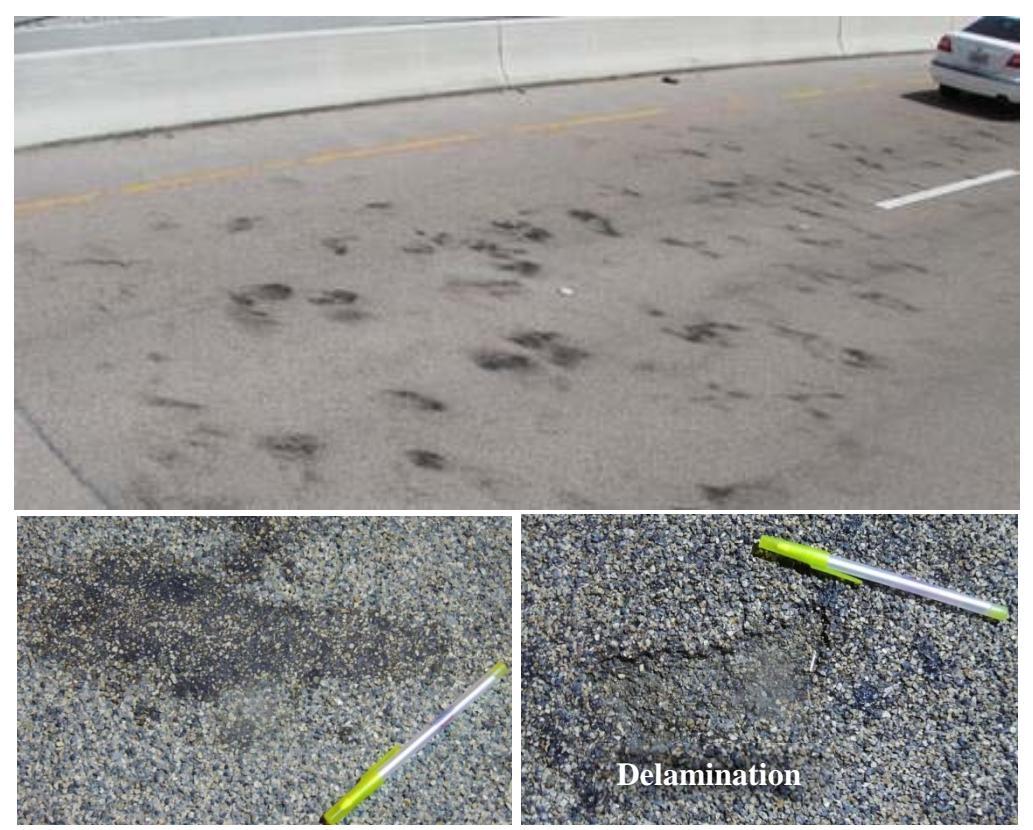
Figure C.16 – Splotchy areas on southbound exit ramp.

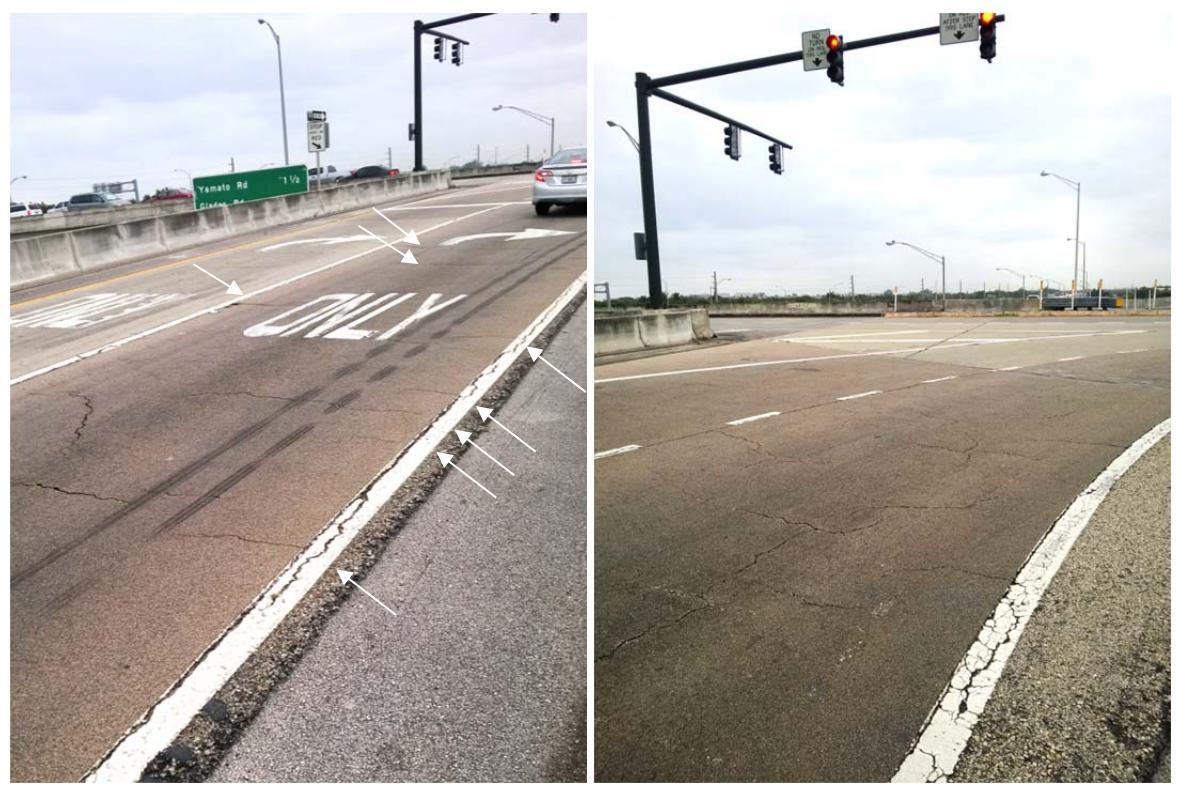
Figure C.21 – Distress near stop bar over OGFC: a) transverse and b) random cracking.

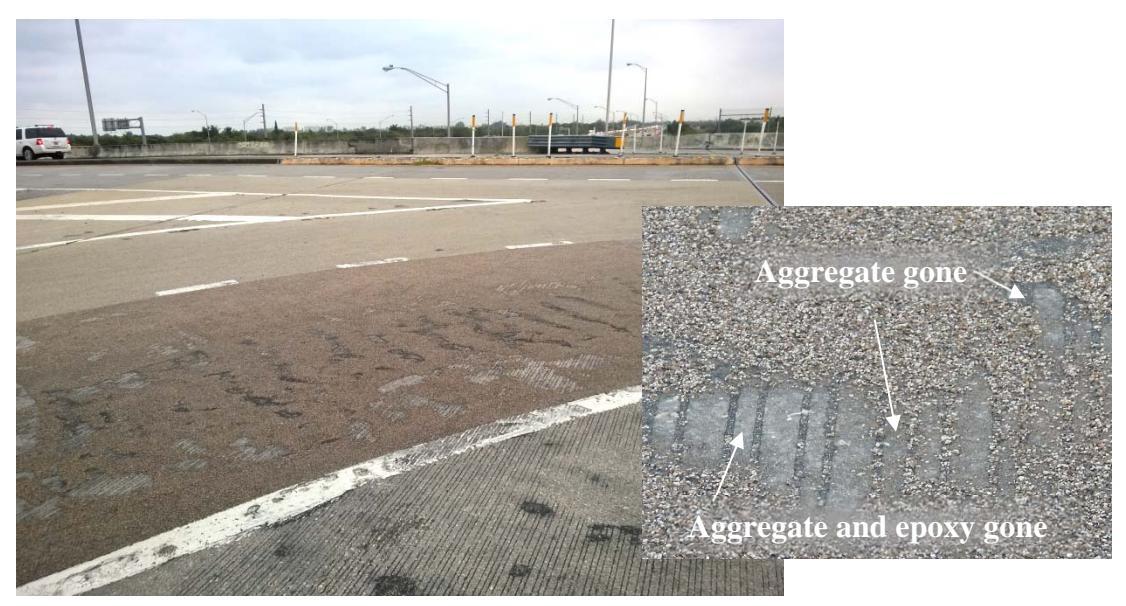
Figure C.22 – Wearing away of HFST around the curve over concrete.

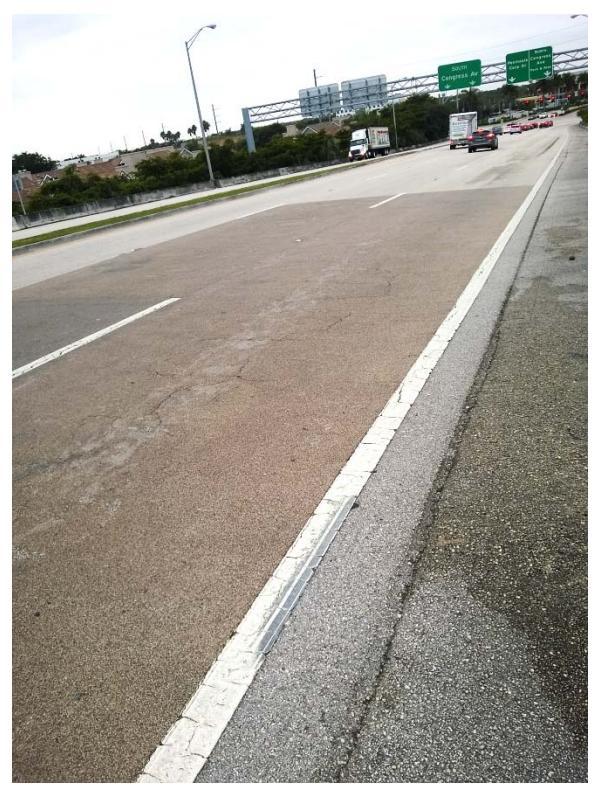
Figure C.23 – Random cracking of HFST after the curve and over HMA.

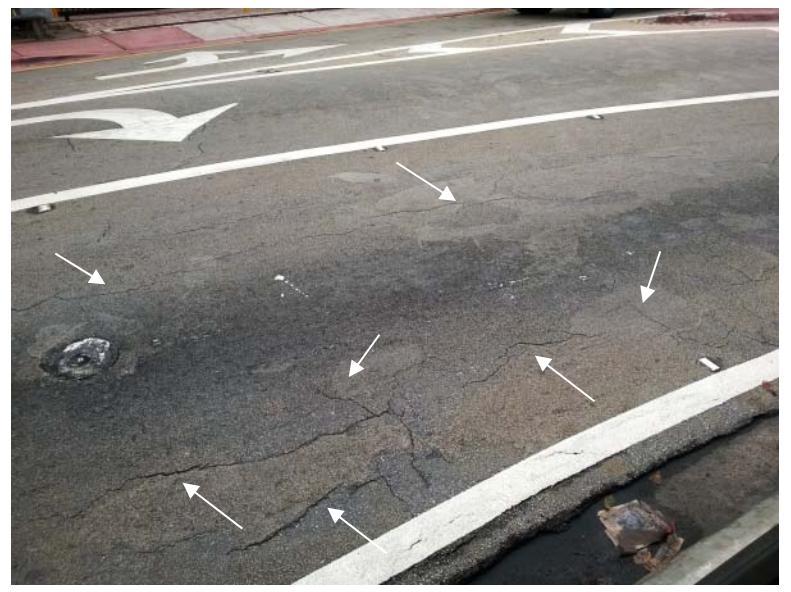
Figure C.27 – Random cracking (likely thermal incompatibility).

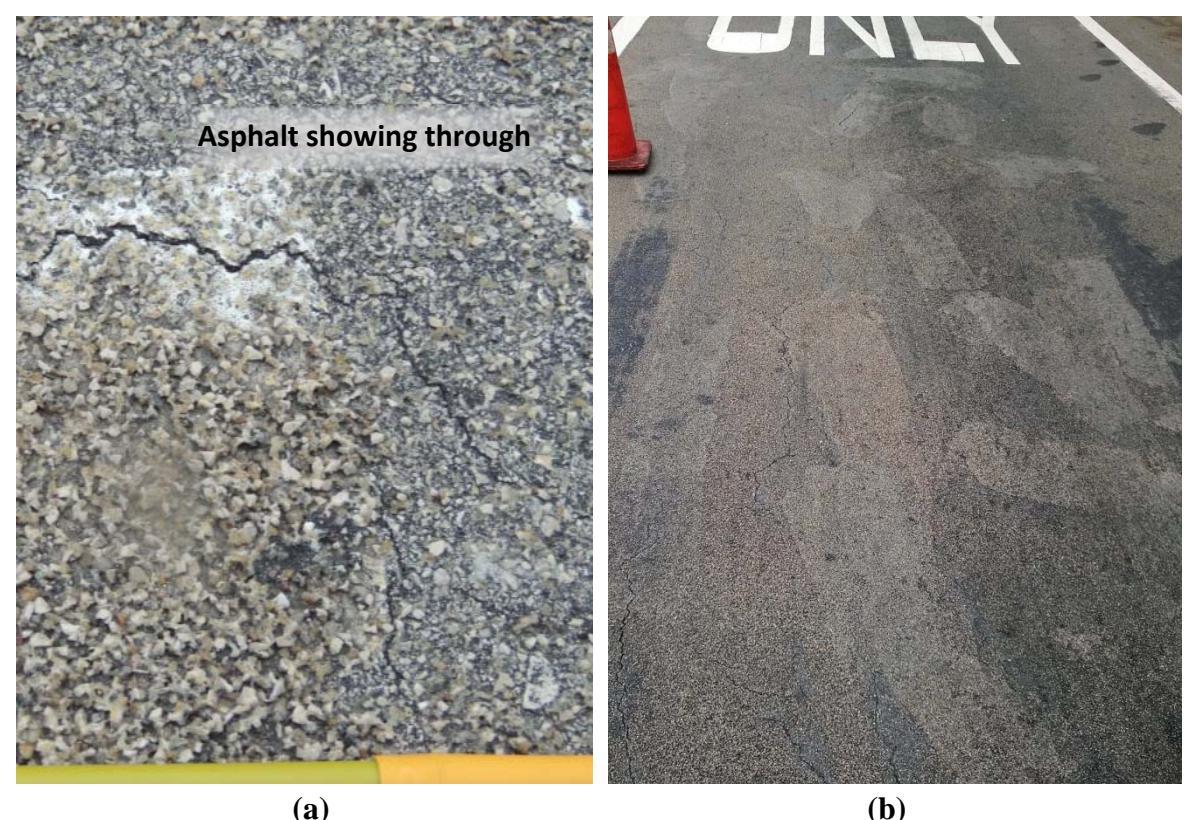
Figure C.28 – Other distress: a) raveling and b) subsequent HFST patching.

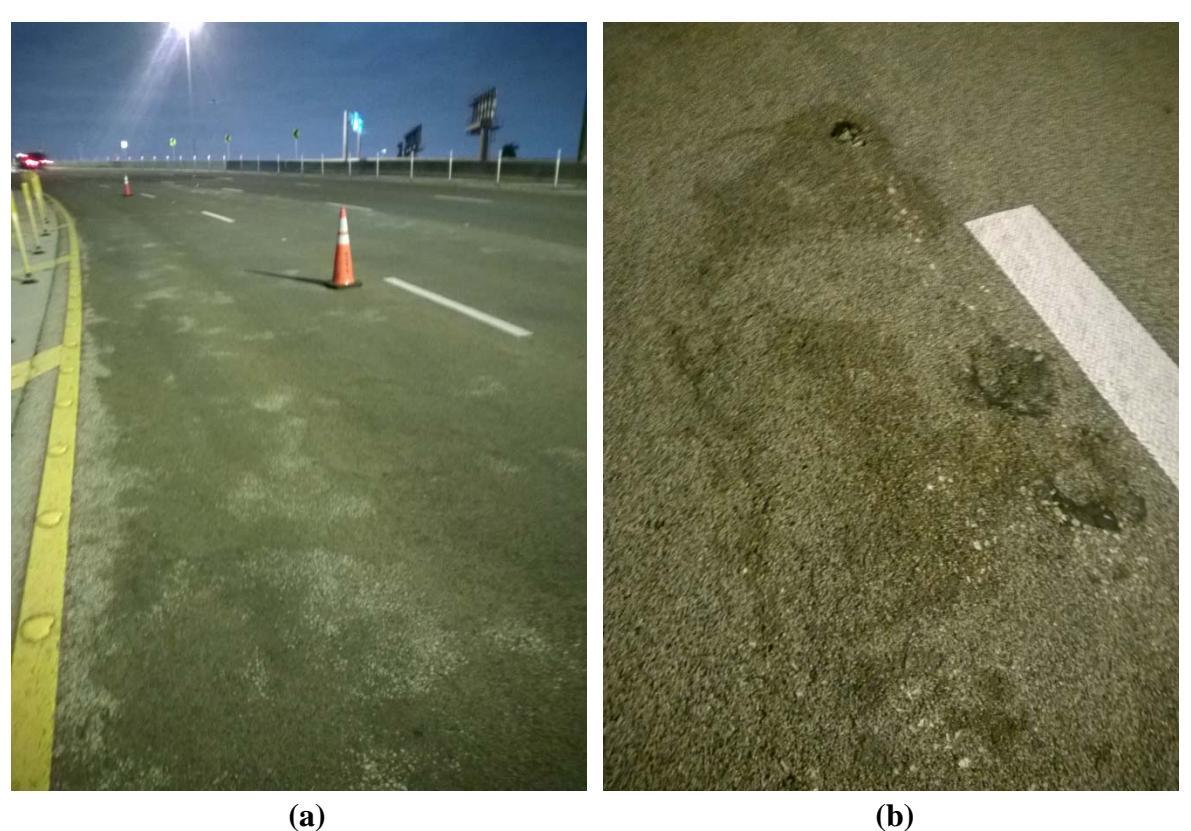
Figure C.32 – Surface distress: a) Aggregate loss and b) irregular depressions.
