# Field Performance Monitoring and Modeling of Instrumented Pavement on I-35 in McClain County

## ANNUAL REPORT FOR FY 2011

ODOT SPR ITEM NUMBER 2200

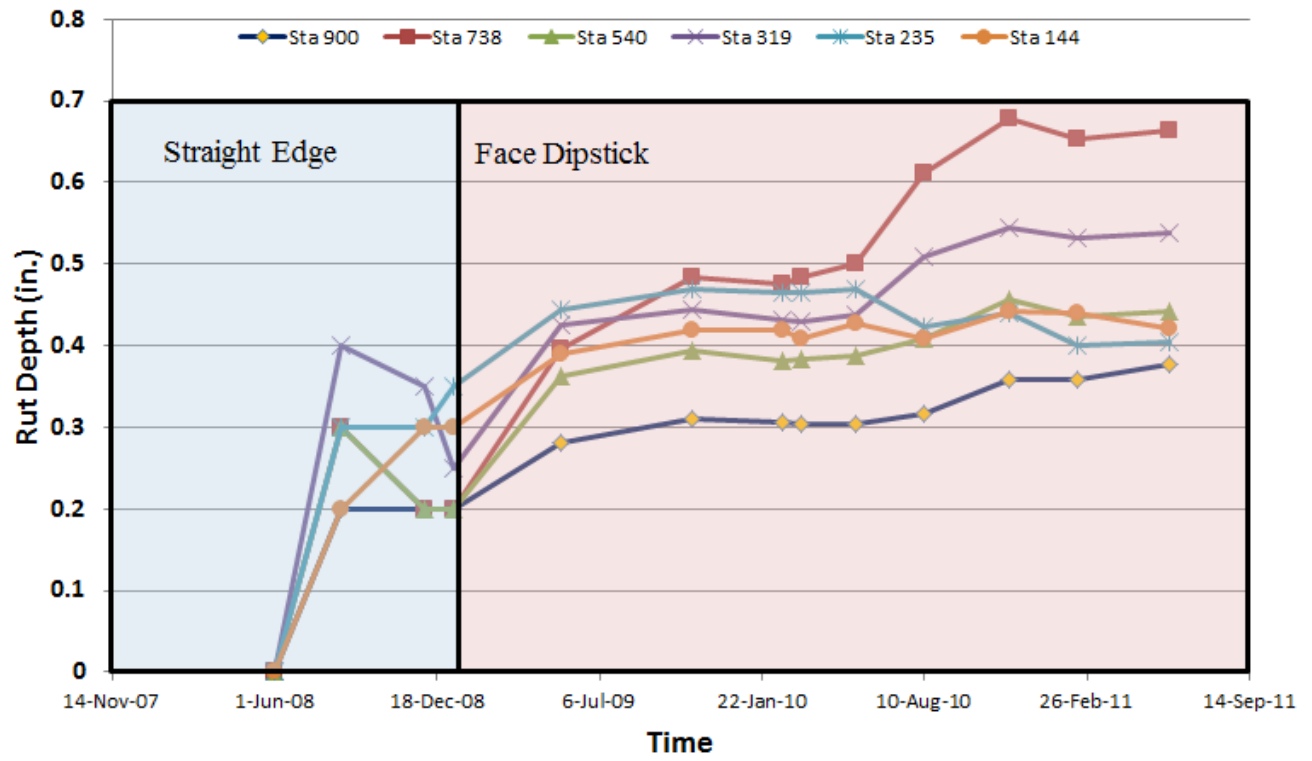
progression curves, each curve representing the rutting progression at a specific station. The first three points of each curve (pertaining to August 21, 2008, December 3, 2008 and January 8, 2009) present the highest rut depth measured with the straight edge/rut gauge combination method. The last nine points of each curve (from May 19, 2009 to June 07, 2011) present the highest rut values of the two wheelpaths measured with the Face Dipstick<sup>®</sup> using 6-in. moon-foot spacing. From **Table 1**, it can be seen that rut depths data, collected during the reporting period (FY 2011), has increased on all stations, except on Station No. 235. The rut increase varied between stations; on Station No. 144, 319 and 540 the increase was between 0.012-in. and 0.032-in., and on Station No. 738 and 900, rut increased more significantly, between 0.051-in. and 0.060-in. The highest recorded rut value is 0.678-in. (17.22 millimeter), recorded on November 22, 2010, and corresponding to Station No. 738. The highest recorded rut value corresponding to the last field trip conducted on June 07, 2011 is 0.663-in. (16.84 millimeter) and was recorded on Station No. 738. From these observations, in general, it can be concluded that the rut depths increased between August 10, 2010 and June 07, 2011, especially during warmer months. Similar type of rut behavior was observed in the AASHO road test (Finn. et al., 1977) and NCAT test track (Selvaraj, 2007). Finn et al. (1977) and Selvaraj (2007) reported visible increase in rut depth values during summer and fall months, but not in winter months. Thus, the observations from the present study are in agreement with those from the AASHO road test and the NCAT studies. Further discussions of field rut test results are presented in Hossain (2010).

Figure 1: Rut Progression on the Test Section

Three field trips and distress surveys were conducted during the reporting period (FY2011): November 22, 2010, February 14, 2011, and June 07, 2011 to address pavement distresses namely, rutting and fatigue cracking. During each survey, field testing was conducted at six stations, namely, Station No. 144, 235, 319, 540, 738 and 900, located at approximately 100-ft. intervals along the outer wheelpath. Rut data was collected across the wheel paths at each station using a Face Dipstick<sup>®</sup> using 6-in. moon-foot spacing. The rutting progressions in all the test sections are presented in **Figure 1**, where there are six rutting

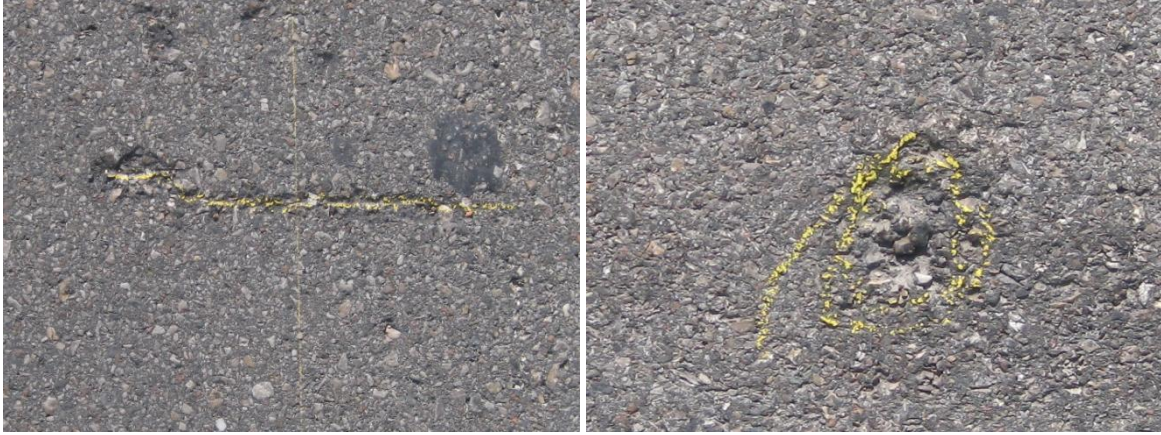
Crack mapping was also performed during the distress survey for the entire test section. For the Station No. 144, 319, 540, 738 and 900, crack mapping was performed at 50-ft. both way of each station. To eliminate overlapping of mapping area, crack mapping was performed at 41-ft. north and 34-ft. south of Station No. 235. No crack is observed, so far, at any station, except along the construction joint and localized pot holes near the LPS sensors. Also, loss of aggregates (or raveling) was noticed on the pavement surface, as shown in Figures 3 (a) and (b). Further, Figures 4 (a) and (b) show a comparison of pavement surface condition at Station No. 144 in the form of photograph taken on June 05, 2009 and February 14, 2011, respectively. It is clear from Figures 4 (a) and (b) that the pavement has undergone noticeable deterioration along the edges (between driving lane and shoulder). Additional freeze-thaw cycles and precipitation are likely to cause formation of potholes, if cracks are not sealed.

**Figure 3: Photographic View of Loss of Aggregates from Pavement at a Distance of (a) 318 ft and (b) 741 ft from North End of the Test Section**

- e) Maintenance of the instrumentation such as temperature probes, axle sensors, and strain gauges, as needed.
- f) Monitoring of pavement distress including formation of pot holes that are likely with additional freeze-thaw cycles in winter 2012, particularly near/along the longitudinal joint between the driving lane and the shoulder.

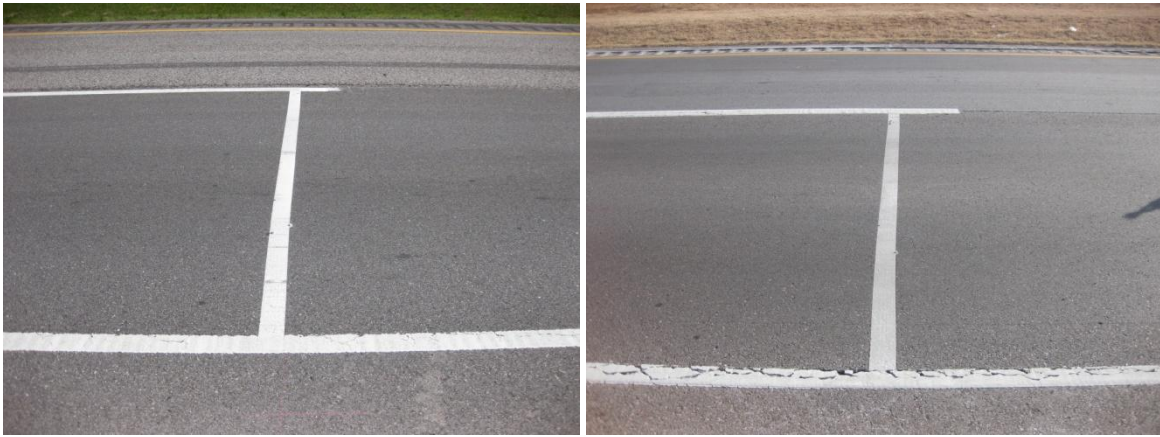
**Figure 4: Photographic View of Pavement Surface at Station No. 144 taken on (a) June 05, 2009, and (b) February 14, 2011**

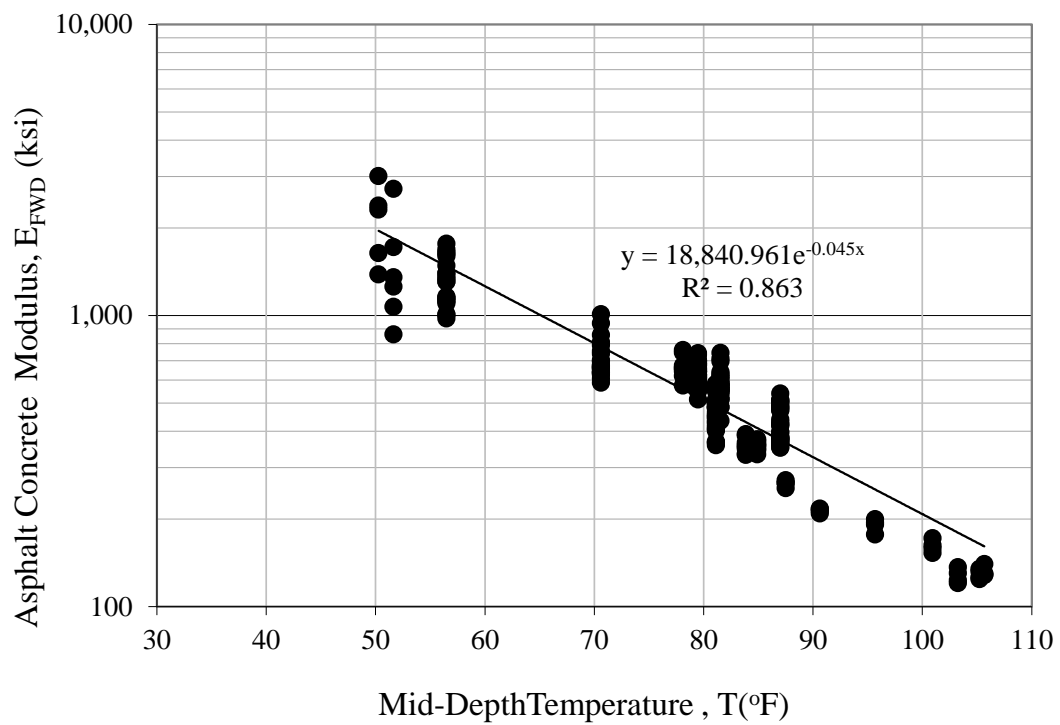
A Dynatest model 8000 series (8002-057) type FWD was used in this study. The testing pattern was designed for a series of six stations located at approximately 100-ft. intervals along the outer wheel path. For conducting tests on the top of asphalt concrete layer, a plate of 11.8-in. diameter was used with seven deflection sensors spaced at 8-, 12-, 24-, 36-, 48-, and 72-in. from the center, as recommended by the ASTM D 4694 test method. The loading pattern included three seating drops plus one load drop from different heights in progressive order. The FWD testing was conducted on the top of asphalt concrete layer by including four different loads (6, 9, 12 and 15 kips). The collected data was analyzed for layer modulus values using MODULUS 6.0 software. The asphalt concrete modulus-temperature correlation obtained by collecting data up to October 28, 2009 is presented in **Figure 5**. The regression analysis on back-calculated data from FWD yielded an exponential best-fit line of the form presented in Equation (1) with  $\alpha_1$  = regression constant (18,841 ksi),  $\alpha_2$  = regression constant (-0.045), and T = mid-depth temperature of asphalt concrete from temperature sensors.

In general, Equation (1) is good predictor ( $R^2 = 0.863$ ) of modulus value of asphalt concrete at different temperatures. At low temperature (50°F) the average back-calculated modulus value is approximately 1,792 ksi with a 40% coefficient of variation. On the other hand, at higher temperature of approximately 105°F the average back-calculated modulus value and coefficient of variation is approximately 131 ksi and 4%, respectively. Additionally, Figure 6 shows variation of asphalt concrete modulus values with temperature for all the FWD data collected until June 07, 2011. It is evident from Figure 6 that the modulus values back-calculated from FWD data collected before opening the lane for traffic is lower than the modulus values at corresponding temperature collected after opening the lane for traffic. For example, the average modulus value collected at a temperature of approximately 95°F is 191 and 412 ksi before opening the lane for traffic (May, 2008) and after opening the lane for traffic on August 11, 2010. Since the test section had relatively high initial air voids (approximately 8% to 10%) in the asphalt concrete layers, it is expected that compaction of asphalt concrete layer took initially by compaction due to traffic and thus increased modulus values.

**Figure 5: Asphalt Concrete Modulus-Temperature Relationship**

Fatigue transfer functions have been development by the OU research team, covering the first three years of the test section damage life (May 2008 to May 2011). First, the strain-temperature relationships used in the fatigue transfer function have been finalized for both steering and tandem axles (Figures 8 and 9). Also used in developing transfer functions, is the asphalt concrete modulus-temperature relationship developed from back-calculated FWD data (Figure 5).

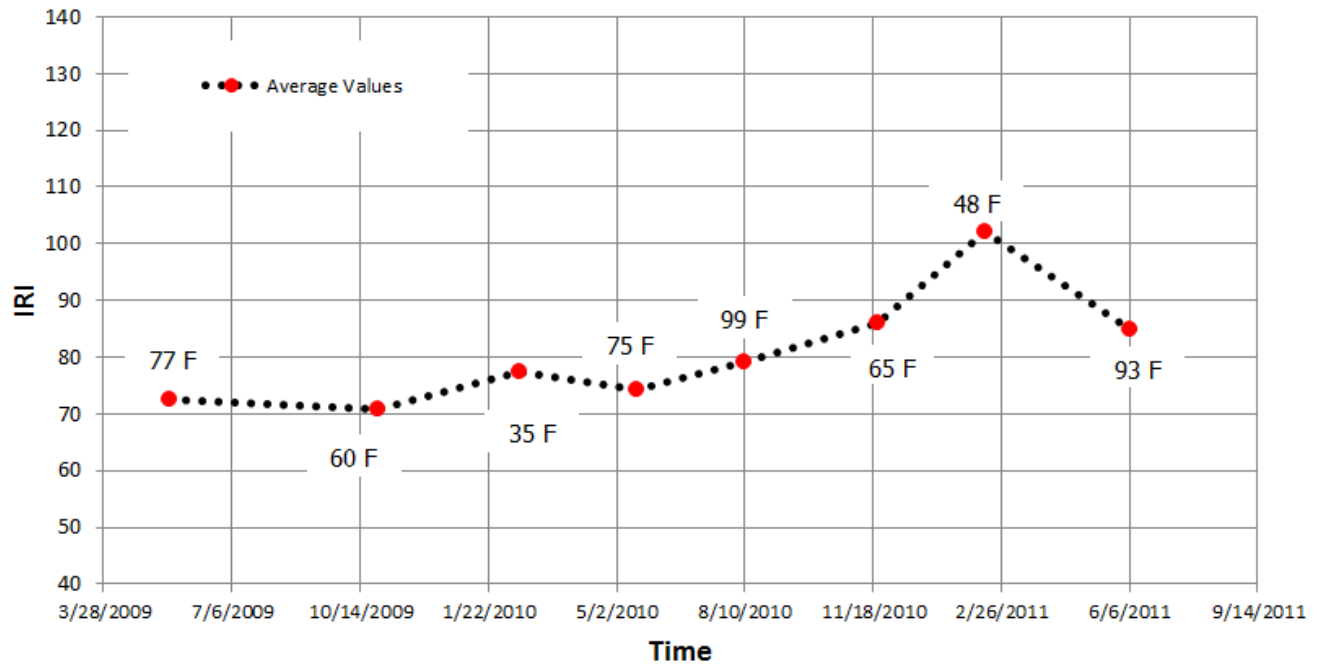
The IRI for the test section was developed using previous and recent collected IRI field data (up to June 7, 2011) using the Face Dipstick. The data are collected from Station No. 319, going 50-ft. north then 50-ft. south at three different locations: inner wheel path, outer wheelpath and mid-lane. The IRI results are presented in graphical and tabular form in Figure 7 and Table 3, respectively. Based on the graph presented in Figure 7, the average IRI value at the section started around 70s and increased until it reached mid-80s. In general, values are increasing with time, which means that the road surface is getting rougher. Based on the Federal Highway Administration (IRI between 60 to 94), the pavement at the test section is still considered in good conditions.

Figure 7: Average IRI Values for the Test Section

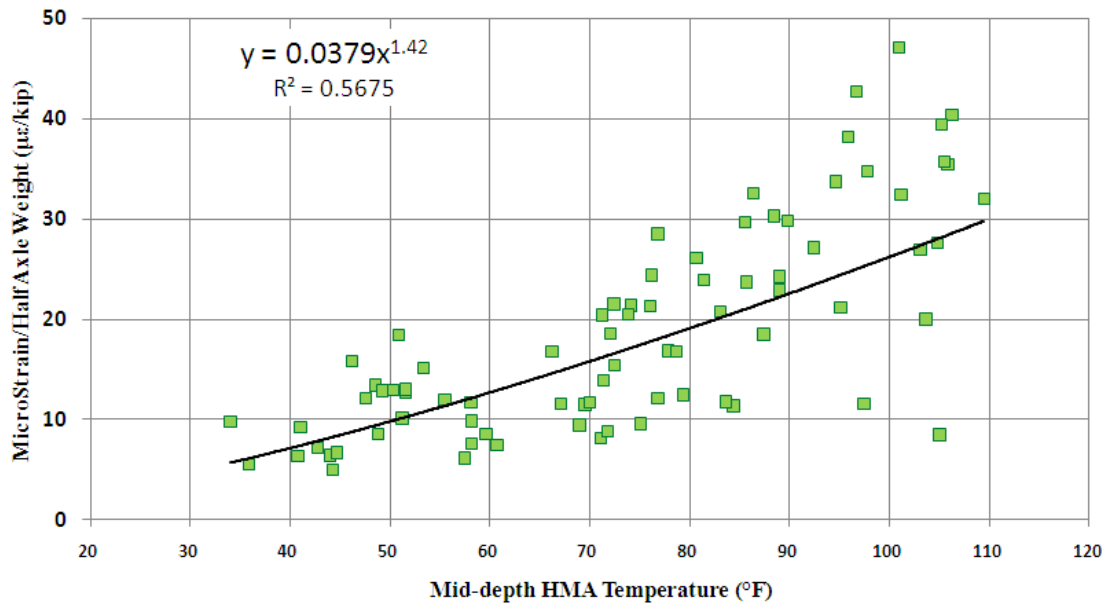
**Figure 9: Strain-temperature Correlation for Dual Tires (May 30, 2008 to May 27, 2011)**
