# **Overturning Forces at Bridge Abutments and the Interaction of Horizontal Forces from Adjacent Roadways**

## **ANNUAL REPORT FOR FY 2011**

ODOT SPR ITEM NUMBER 2228

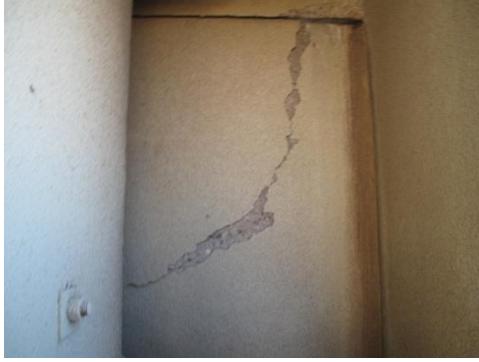
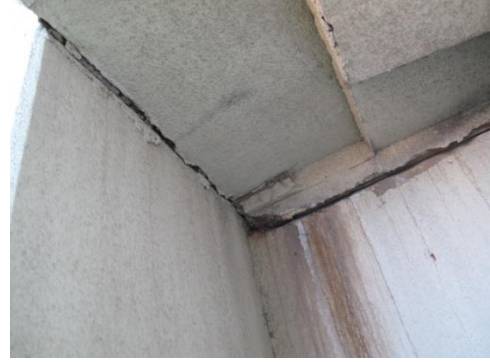
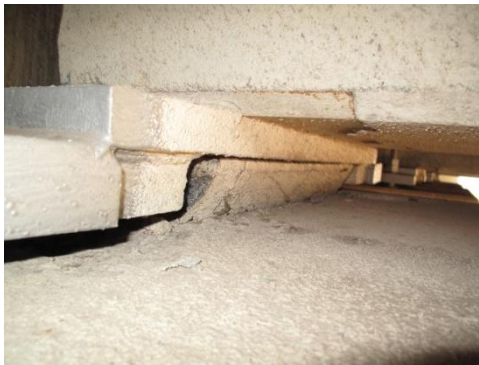
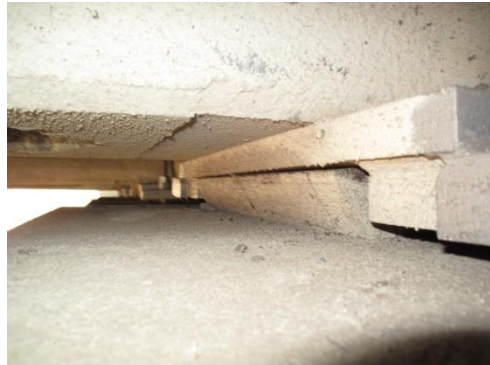
Figure 1. 19th Street Bridge (I-35 under) in Moore, OK. (a) Distresses on bridge abutment  
(b) Shearing of elastomeric bearings

Based on the field reconnaissance visits and discussions with the ODOT Bridge and Planning & Research Division personnel, bridges NBI No. 18141 (US 64 Westbound over Shell Creek) and NBI No. 25440 (19<sup>th</sup> St. Moore - I-35 Under) were selected for detailed instrumentation. In addition, widths of expansion joints in several I-244 bridges and the bridge NBI No. 12643 (SH 76 Over Rush Creek - Garvin County) will be monitored on a periodic basis. Some of the distresses observed on the 19<sup>th</sup> Street Bridge in Moore are shown in Figure 1. The northern most rocker bearing and the girder on the west abutment of US 64 Westbound over Shell Creek as seen on May 6, 2011 and May 26, 2011 are shown in Figure 2. The May 6, 2011 photo was provided to the OU research team by Mr. Walt Peters of the ODOT Bridge Division. Sometime after May 6, the rocker bearing shown on Figure 2 was straightened by ODOT personnel. The girder shown in Figure 2 is touching the abutment backwall.

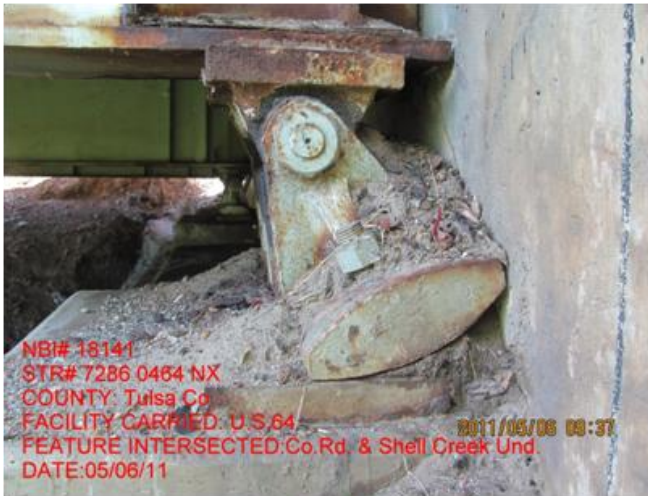
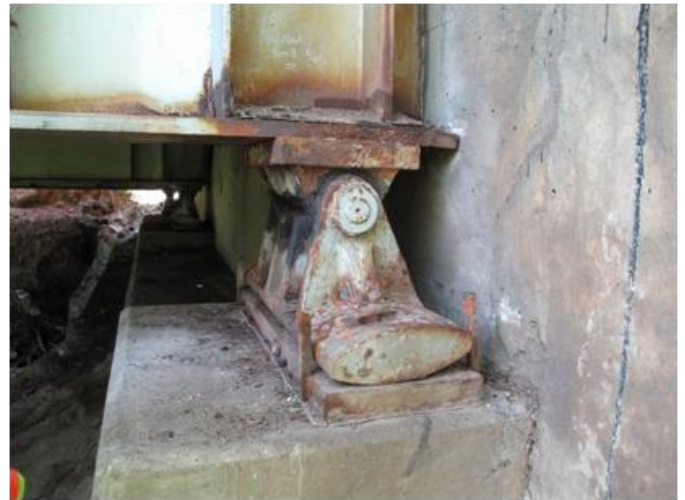
(a) On May 6, 2011

(b) On May 26, 2011

Figure 2. Northern most rocker bearing and girder on the west abutment of the US 64 Westbound bridge over Shell Creek before and after repairs

The instrumentation manufactured by Geokon, Inc. will be utilized in this project. For the 19th St. Moore Bridge, both the east and west abutments will be instrumented. For the US 64 Westbound bridge over Shell Creek, only the west abutment will be instrumented. As shown in Figure 2, distress was more severe on the west abutment of this bridge. A meeting with the ODOT personal was held on August 26, 2011 to finalize the instrumentation plan. The following instruments have been ordered and received from Geokon.
