US-259 TRAFFIC STUDY

McCURTAIN COUNTY, OK

**FINAL REPORT
August 2018**

US-259 Traffic Study McCurtain County, Oklahoma

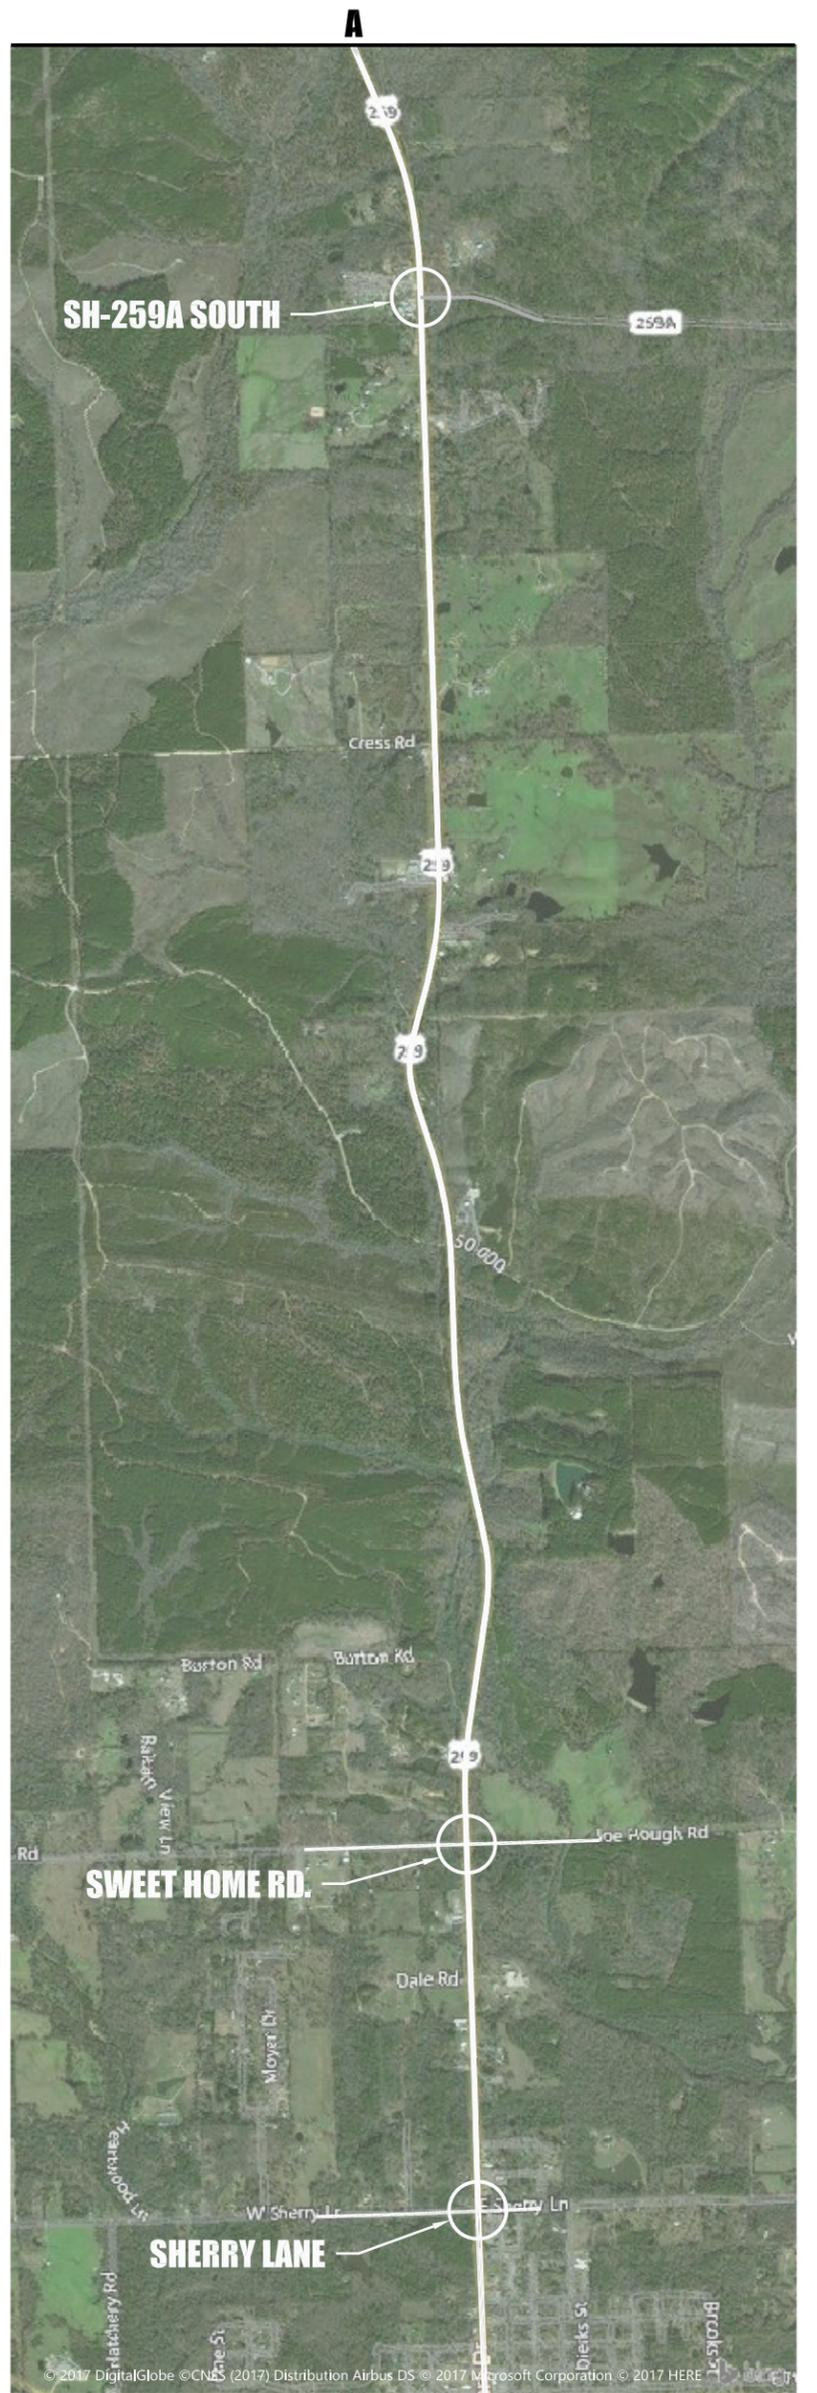
FIGURE 1

**STUDY LIMITS OF
 US-259 CORRIDOR**

U.S. Route 259 (US-259) is a highway that runs in the north-south direction for approximately 250 miles in Texas and Oklahoma. The southern terminus is near Nacogdoches, Texas and its northern terminus is approximately 15 miles south of Heavener, Oklahoma. US-259 winds through the Ouachita Mountains and on the west side of Broken Bow Lake near Broken Bow, Oklahoma. The focus of this traffic study is the US-259 corridor that begins $\frac{1}{8}$ mile south of Sherry Lane in Broken Bow and extends north for approximately 13.5 miles to just north of Cedar Creek Trail (51810). **Figure 1** shows the study limits of the US-259 corridor.

Twelve (12) intersections and four (4) roadway segments throughout the US-259 study corridor were evaluated for operational analysis. These locations were previously depicted in Figure 1 and were analyzed to determine their current and predicted operational capacity and levels of service. In addition, warrants for a traffic signal and left- and/or right-turn auxiliary lanes at intersections were evaluated. Other analysis includes sight distance measurements at intersections and driveways, access management opportunities and passing zones evaluation. Recommendations to improve safety and operations along the corridor are summarized at the end of this report.

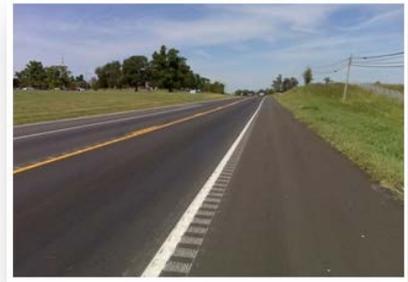
Centerline and edge line rumble strips

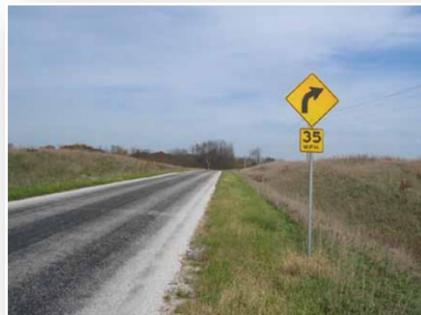
Curve warning sign

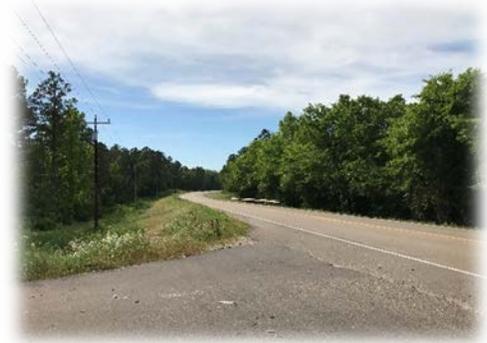
Looking north from Lukfata Trl/US-259 intersection

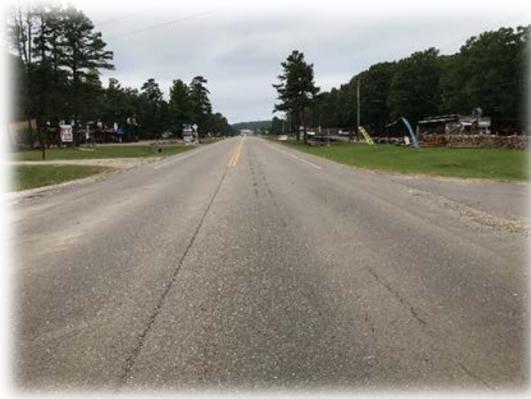
Looking north from Old Hochatown Road (Pinyon Rd)/US-259 intersection

- Sherry Lane – Tree limbs on both the west and east sides of US-259 may partially obstruct sight distance and should be trimmed.
- Old Hochatown Road (Pinyon Road) – Trees on the east side of US-259 partially obscure sight distance and should be trimmed or removed.
- Carson Creek Road (Juniper) – A sign on the east side of US-259 and trees on both the west and east sides partially obstruct sight distance. The trees should be trimmed or removed.

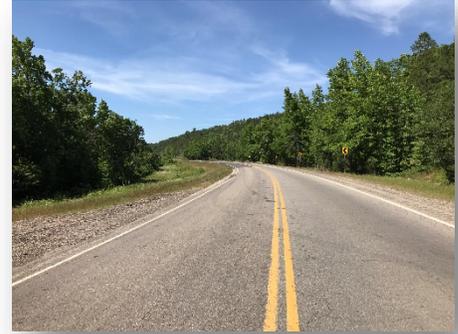
No Passing Zone pavement marking on US-259 north of Stevens Rd

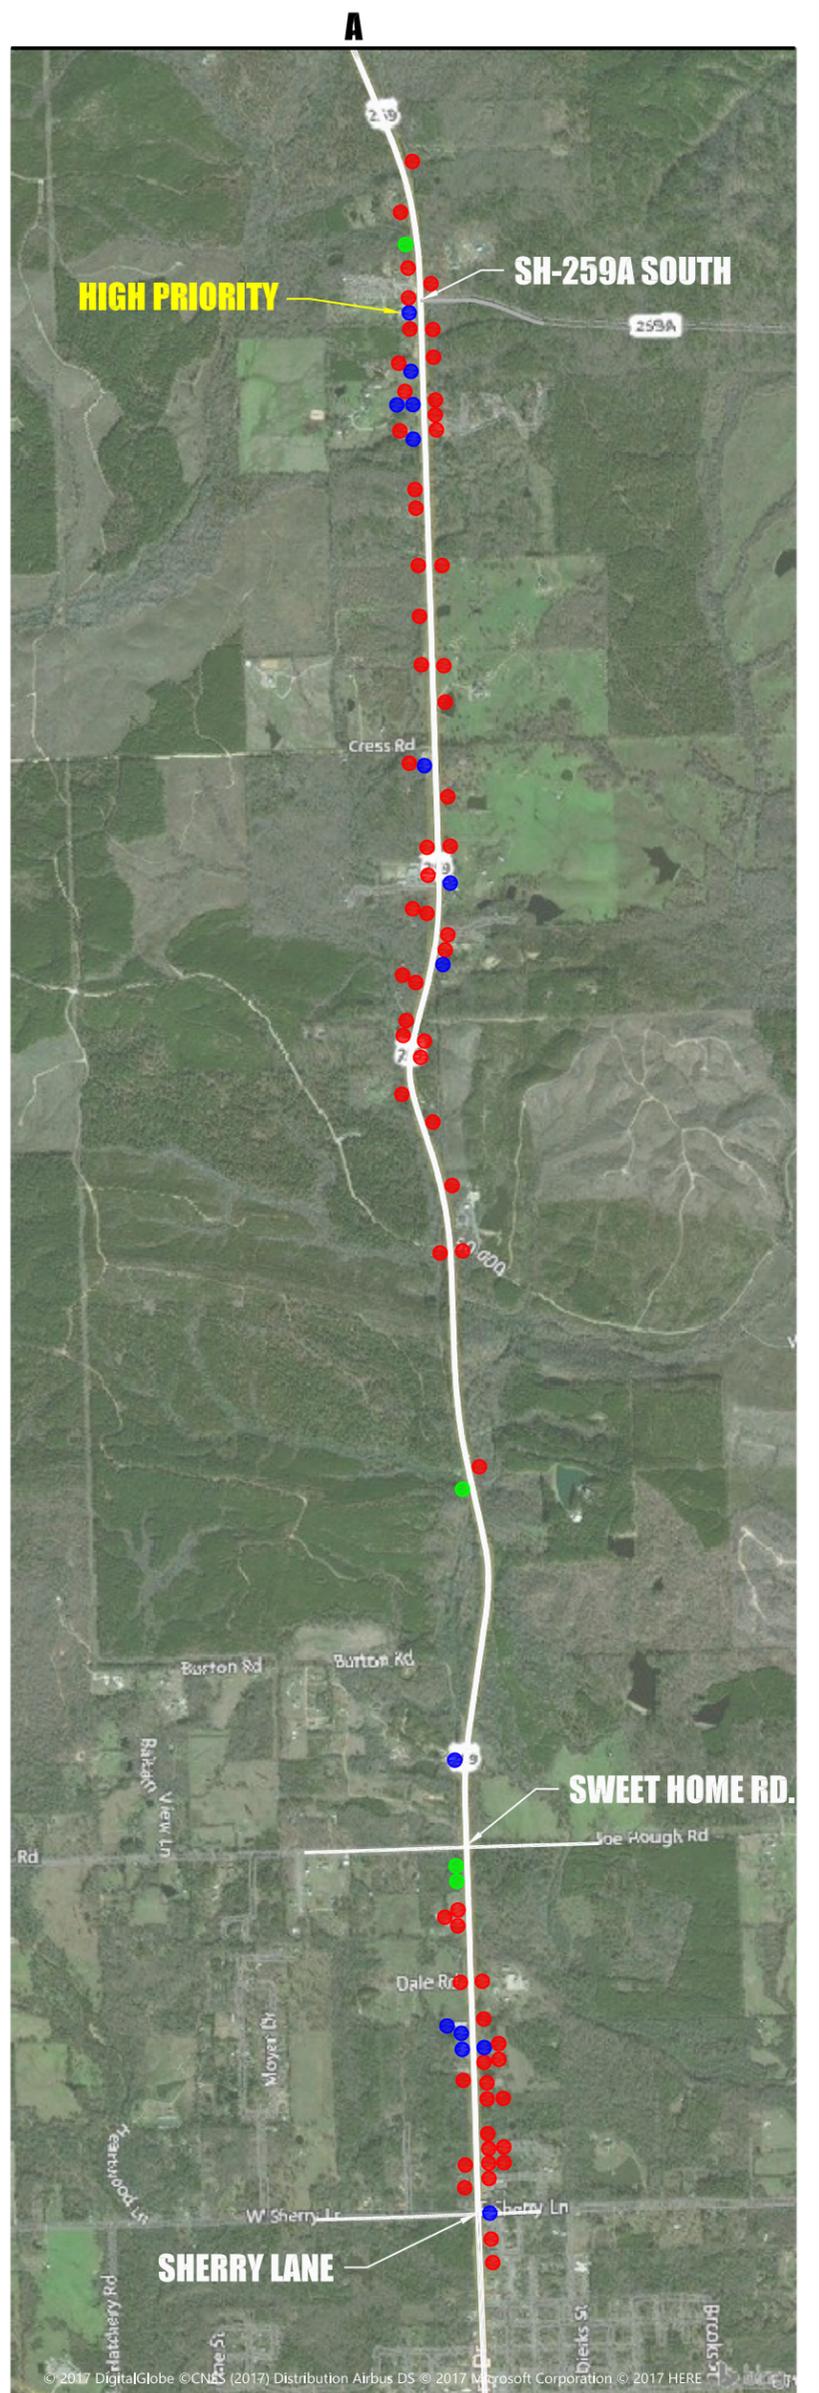
FIGURE 16

ACCESS MANAGEMENT RESULTS

Figure 16 depicts the location of all existing access points and identifies those that are recommended for removal or modification. The recommendations listed above that are noted as High or Medium Priority are also exhibited in further detail in **Figures 17 through 19**. It is recommended that new and modified driveways be designed to accommodate large turning radii of oversized vehicles such as recreational vehicles, trucks with trailers and boats, and commercial trucks. All recommended access management improvements are within ODOT’s existing right-of-way.

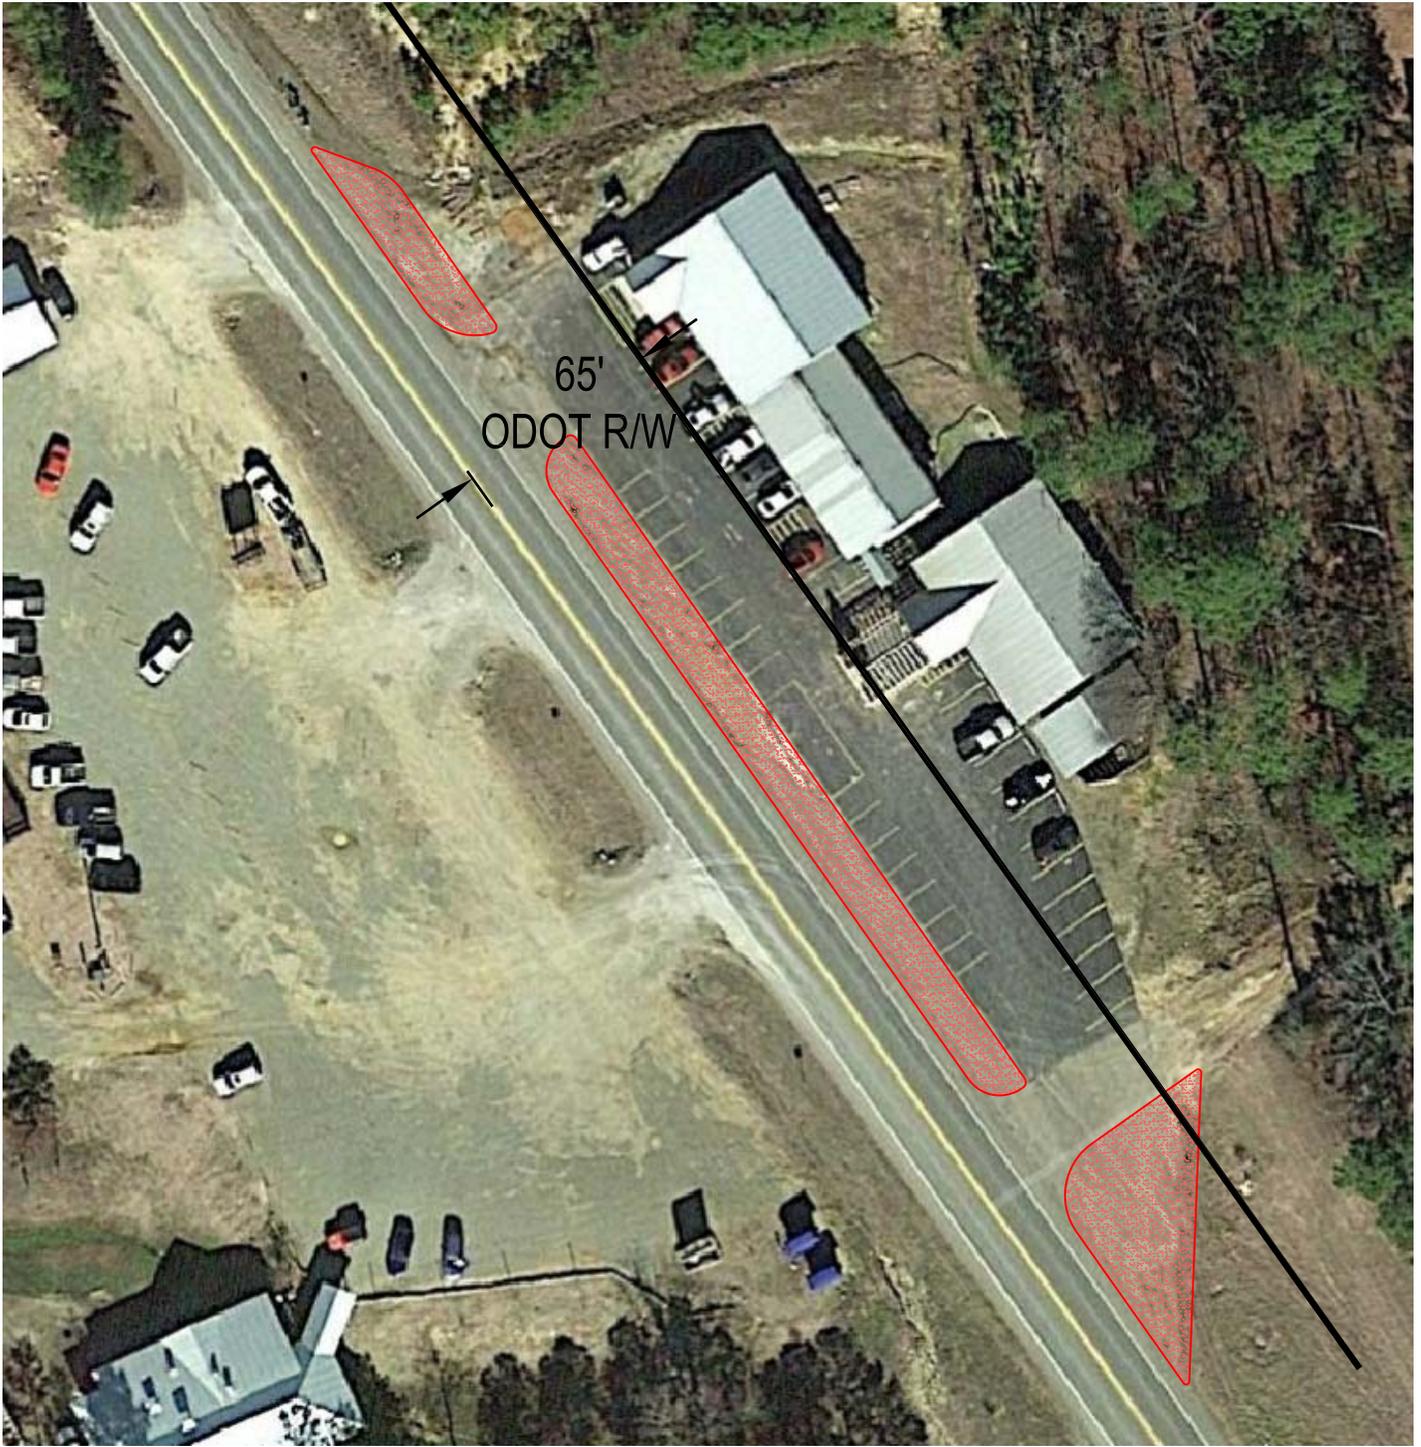
FIGURE 19

ACCESS MODIFICATION FOR
GIRLS GONE WINE
(E64 AND E65)

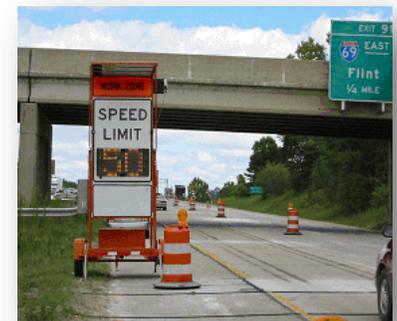
VSL in a work zone

The segment of US-259 through Hochatown is a suitable location for a VSL pilot project. It is recommended that the limits of the project begin at Old Hochatown Road (Pinyon Road) and extend 1.5 miles north towards Carson Creek Road (Juniper). In this segment, the posted speed limit would vary depending on the traffic volume or 85th percentile speeds. As a default, the posted speed limit would be 55 mph, consistent with the current posted speed limit. As detected traffic volumes increase and/or the 85th percentile speeds decrease, the posted speed limit would decrease to 45 mph. This type of VSL system would require electronic detection of traffic volumes and vehicle speeds that would transmit this information to an operator, who would confirm the data and adjust the posted speed limit signs in VSL mode.

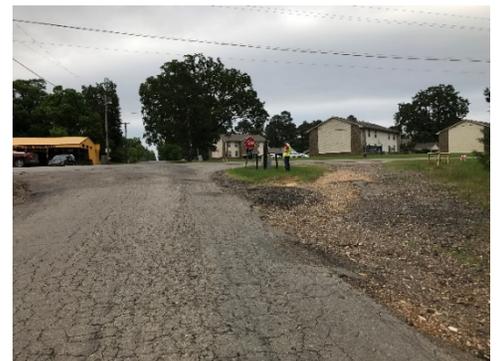
- At the eastbound approach on Sherry Lane at US-259, 90% of the right-turning traffic cut through the gravel on the southwest corner and used this as a continuous right turn lane. This approach should be modified to restrict vehicles from cutting through this lot. It is recommended that the eastbound approach be widened to include either a dedicated left-turn lane or right-turn lane.
- There were many heavy trucks observed making a southbound right-turn (traveling westbound) from US-259 onto Sherry Lane which provides a direct connection to SH-3.
- Trucks with trailers were observed making wide turns across both lanes at the Stevens Gap Road and US-259 intersection.
- Heavy southbound right turns and northbound left turns were observed at Lukfata Trail.
- Stevens Road, Penner Road, and Last Resort Drive have steep grades approaching US-259.

Eastbound right-turn “cut through” at Sherry Lane/US-259 intersection

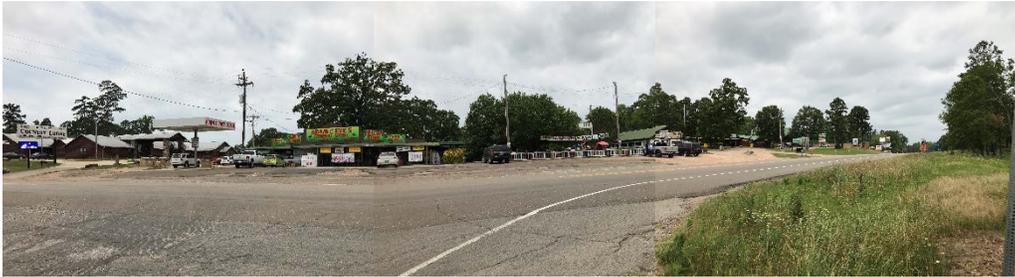
Wide, open driveways across from SH-259A (S)/US-259 intersection
