# Effect of Y-cracking on CRCP Performance

## **ANNUAL REPORT FOR FY 2011**

ODOT SPR ITEM NUMBER 2230

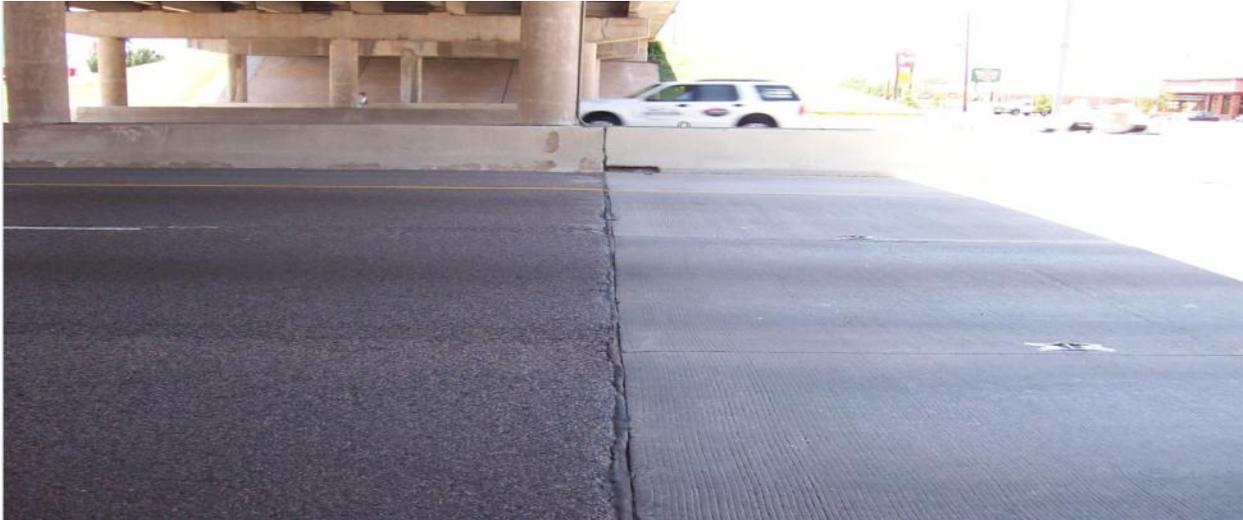
The north bound lane of the project was more accessible which allowed the full length of the pavement to be viewed. The inspection began at the joint on the southern end of the project (figure 3.13). It was noted that the pavement had no cracks for the first forty-two feet, and then displayed a long crack spacing of approximately fifteen feet. Then cracks slowly became closer, reaching a spacing of three to four feet. Overall, the north bound lane, like the south bound lane, was in good shape with no patches or punch-outs recorded.

**Figure 3.13** – Joint at the Southern end of North bound lane

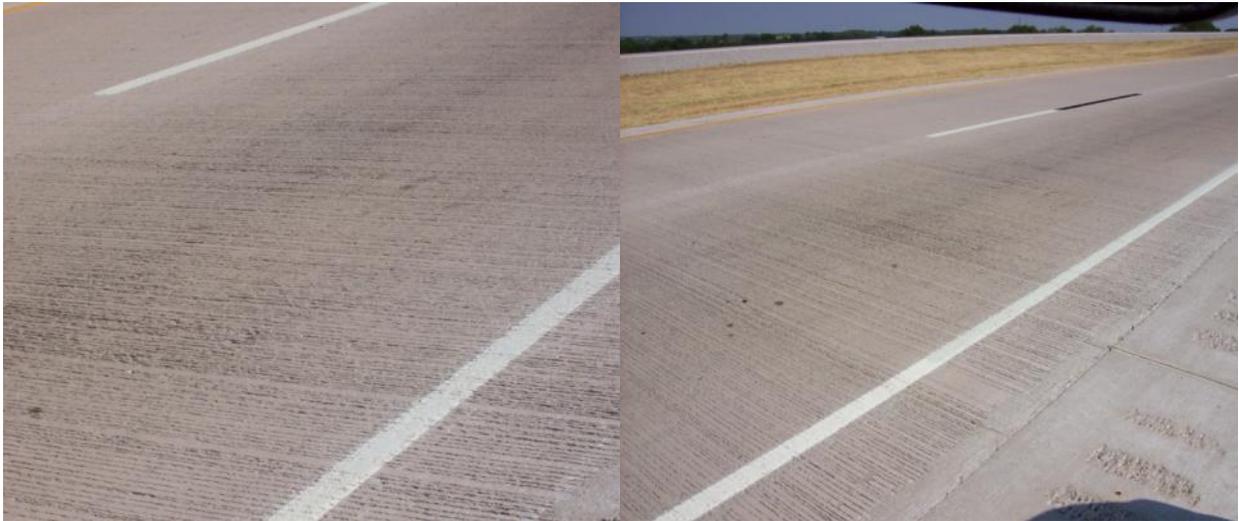
Due to curiosity, approximately ½ mile of this project was inspected in both the north and south bound directions. Figure 3.18 shows images of the pavement. The roadway displays a grey/silver color, possibly due to curing compound, while the surface appears to be in good shape with virtually no wear.

**Figure 3.18** – Two images showing the glossy pavement surface with little wear

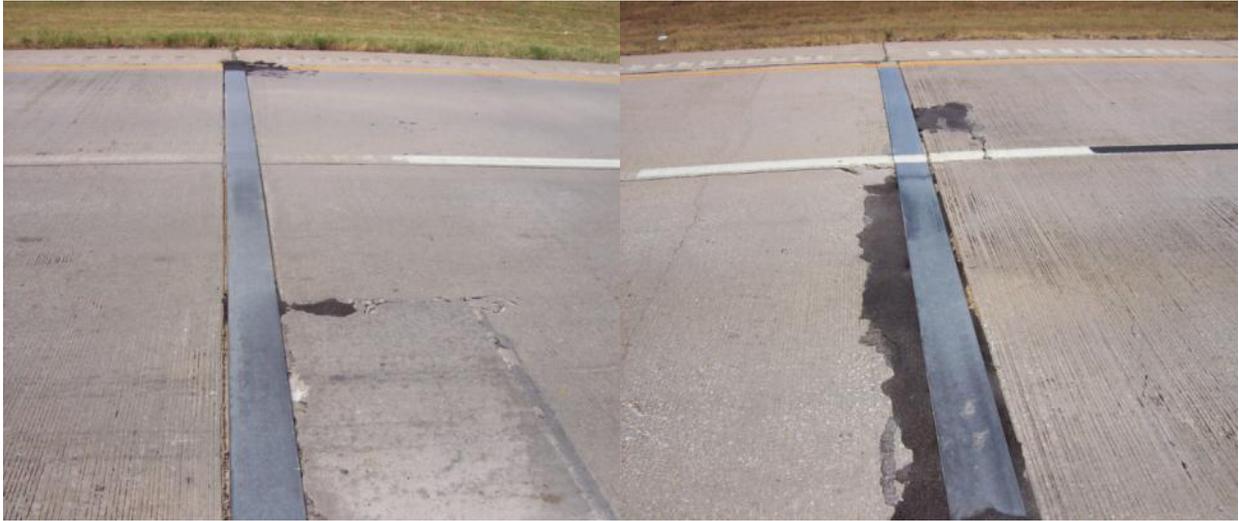
Figure 3.26 shows the terminal joint at the beginning (left) and the end (right) of the west bound inspection. The joints appeared to be in poor shape with several patches. The west bound lane had many patches of both asphalt and Portland cement. Some of the patches filled with asphalt left an outline that seemed to look like a Y-crack, see figure 3.27, while many of the patches seemed to be caused by closely spaced transverse cracks with longitudinal connecting cracks, see

**Figure 3.26** – (left) Terminal joint at west bound beginning, (right) terminal joint at west bound end

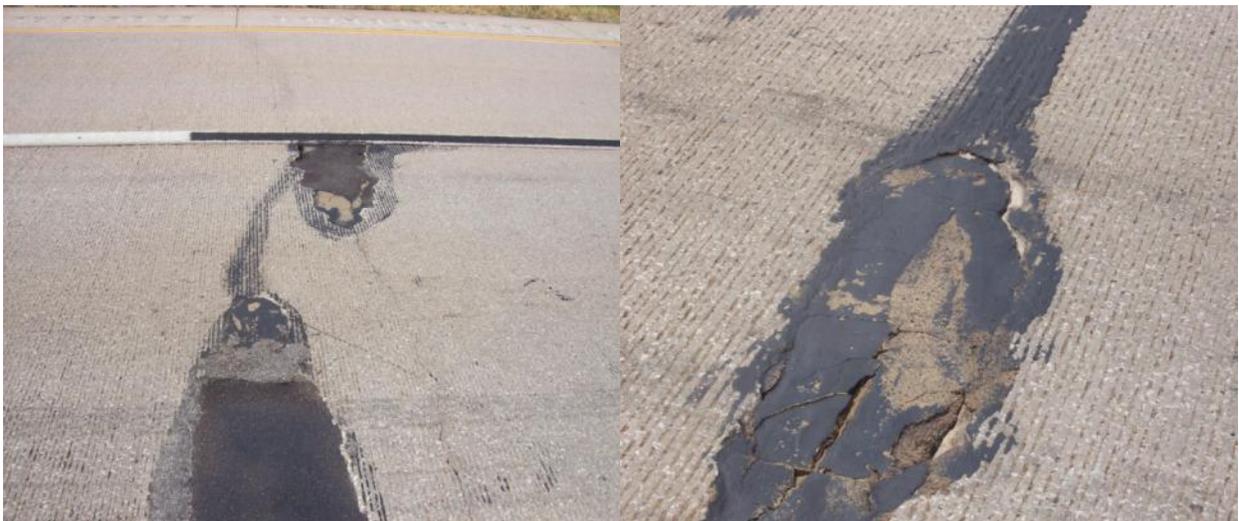
**Figure 3.27** – Y-shaped patches

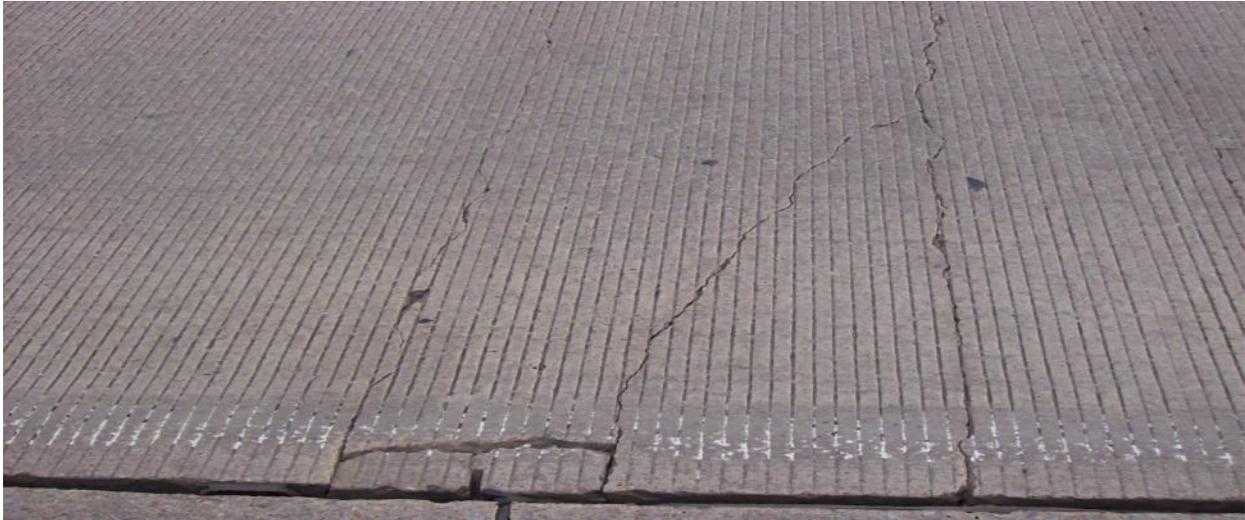
The pavement did exhibit Y-cracks; however, the first Y-crack in the north bound lane did not occur until 0.13 miles into the project. Figure 3.35 shows a typical Y-crack for the area. It was noted that a few of the Y-cracks appeared to be leading to punch-outs, mainly because of longitudinal cracks connecting the two legs of the “Y”, see figure 3.36.

**Figure 3.35** – Typical Y-crack for the area

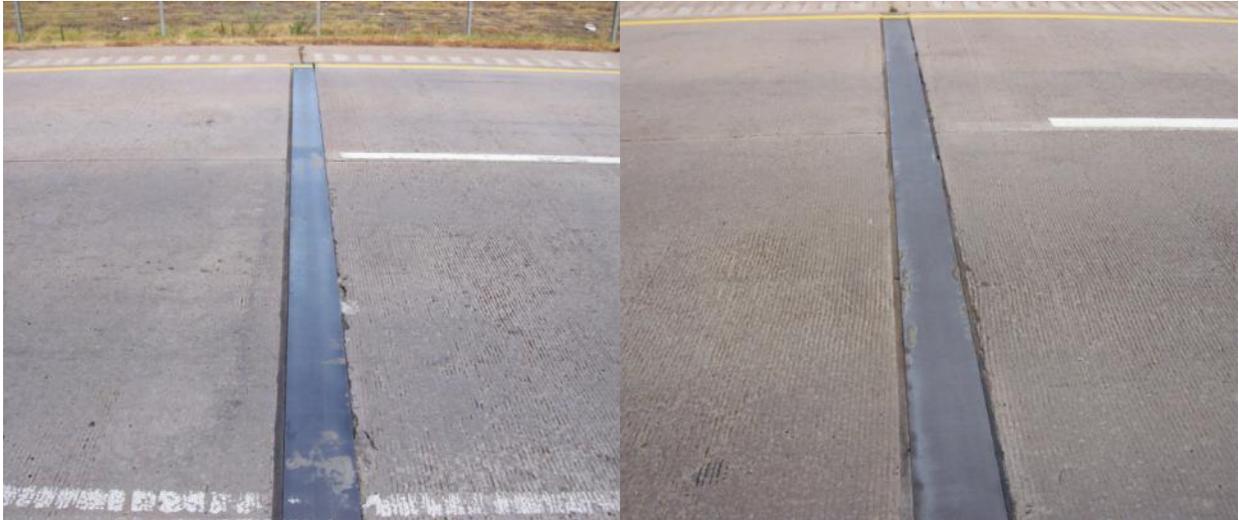
Overall Pittsburg 1 north bound was in good shape, but it showed signs of future deterioration. The terminal joints at the project were in good shape overall, displaying only a small amount of spalling, see figure 3.52. The pavement contained a few distresses (figure 3.53 (left)) that seemed to be random and unrelated to any cracking. It was also noted that many cracks, both Y-cracks and transverse cracks had spalling, see figure 3.53 (right). There were also a few Y-cracks showing signs of beginning to develop into punch-outs, see figure 3.53 (right). There were several other places along the pavement where closely spaced transverse cracks were being intersected by longitudinal cracks and beginning to form punch-outs, see figure 3.54. The North bound lane also contained a few patches of map-cracking, see figure 3.55. Despite all of this the north bound lane only contained two patches over its four mile length, see figure 3.56.

**Figure 3.52** – Terminal joints at north bound beginning and end

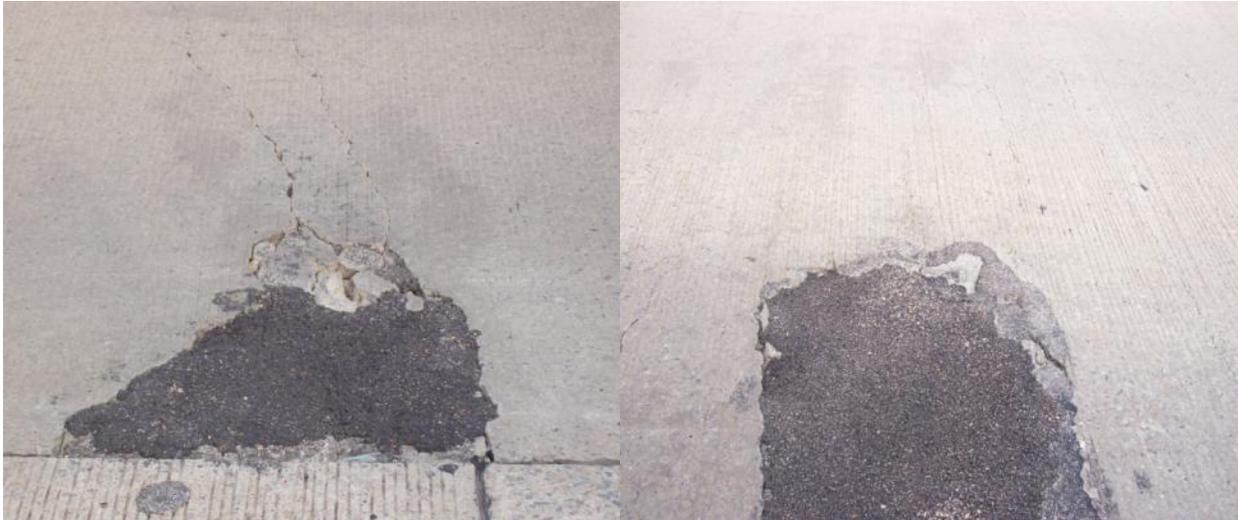
**Figure 3.56** – The two patches in the north bound lane

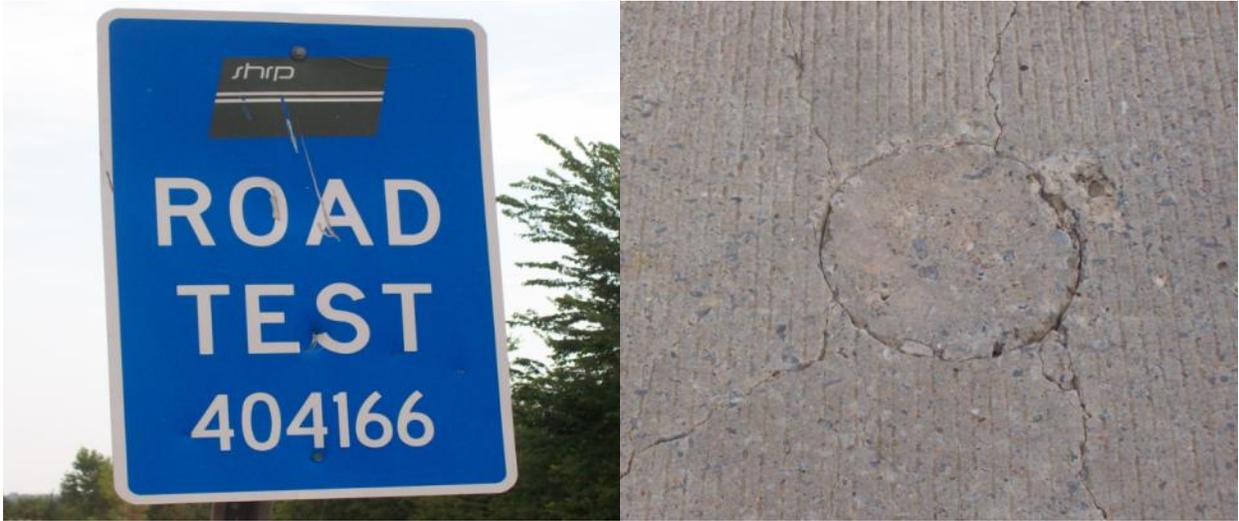
The north bound lane also contained several places where past testing had been done, see figure 3.57. These testing sites consisted of several cores. Some of the cores had been taken from along the outside edge of the pavement and even in the shoulder. A few cores were also taken out of the roadway, and showed signs of sensors of some type being implemented, see figure 3.58.

**Figure 3.57** – (right) road test sign found beside roadway, (left) one of several large cores taken

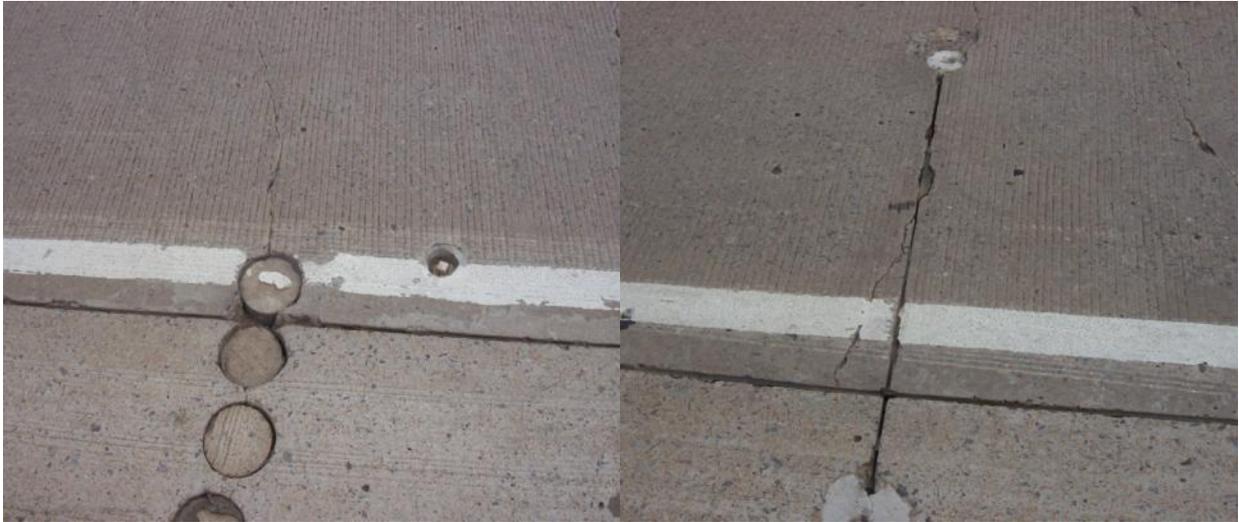
**Figure 3.58** – (left) cores taken from shoulder, (right) core with sensor wire extending to shoulder

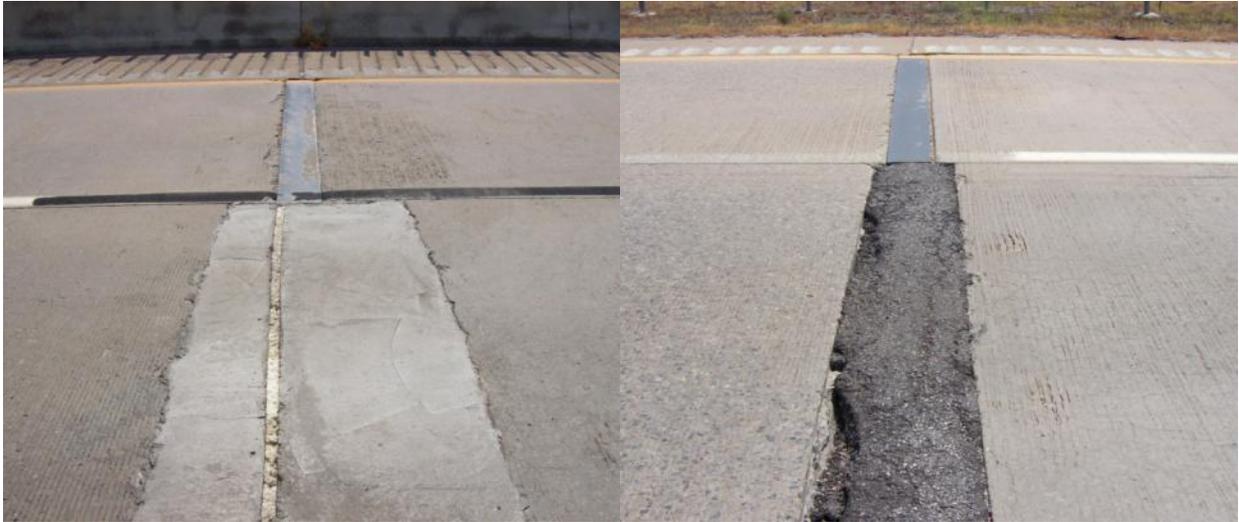
The south bound lane was in a similar condition to the north bound lane. The south bound lane did show more deterioration at the terminal joints, figure 3.59. Like the north bound lane, the south bound lane seemed to have several instances where closely spaced transverse cracks led to distress, see figure 3.60 (left). The south bound lane also contained a Y-crack beginning to develop into a punch-out, but this was a rare case when compared to the closely spaced transverse cracks leading to distresses, see figure 3.60 (right).

**Figure 3.59** – Terminal joints at the beginning and end of the project

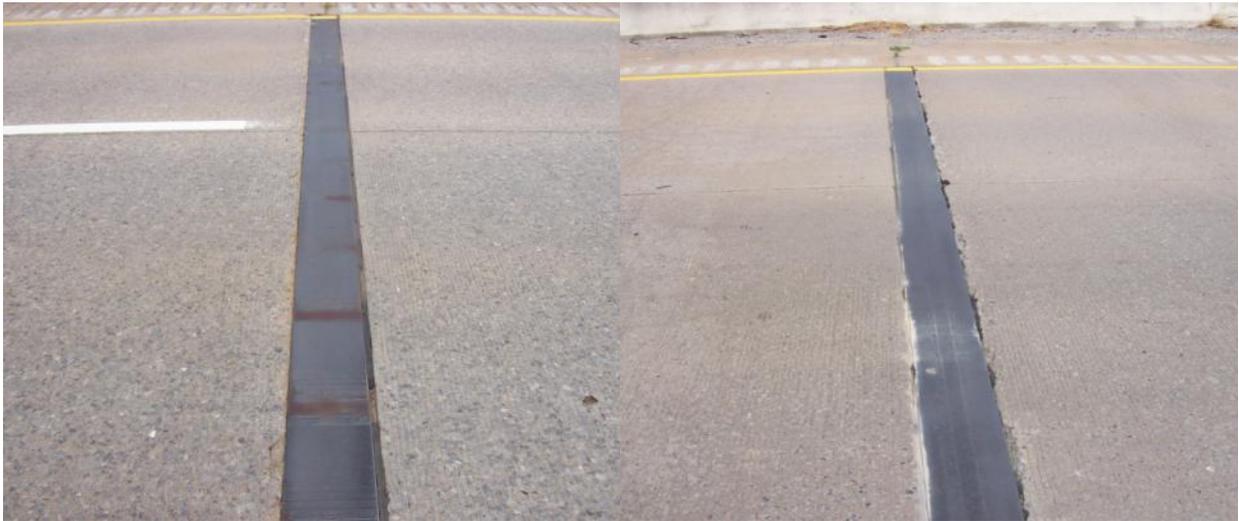
The northbound lane of Pittsburg 2 was in overall good shape. Figure 3.61 shows the terminal joints on each end of the project; both appear to be in good shape, displaying only a minor amount of spalling. The pavement recorded just two patches over its six mile length, despite the occurrence of Y-cracking. The patches did not leave any evidence of what may have caused them; however, there was one Y-crack that appeared to be developing into a punch-out, see figure 3.62. Even though one Y-crack seemed to be developing into a punch-out, none of the other Y-cracks showed this.

**Figure 3.61** – Terminal joints on each end of the project

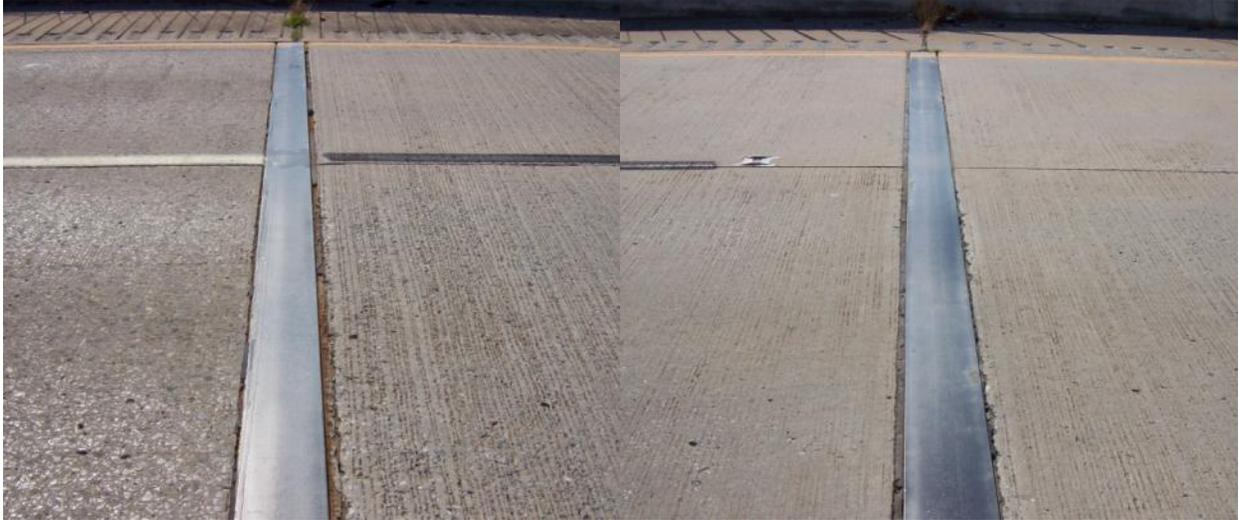
The south bound lane of Pittsburg 2 was in worse condition than the north bound lane. Figure 3.63 shows the terminal joints at the project beginning and end, which like the north bound lanes, were in good condition, displaying only minor signs of spalling. The south bound lane contained eight patches over its six mile length, which is four times more than the north bound lane. All of the patches seemed to be the result of closely spaced transverse cracks, see figures 3.64. It was noted during the inspection that the third mile of the project contained a heavy amount of Y-cracking -- two-hundred and eight cracks within the mile. However, this stretch of pavement only contained one patch. Despite the occurrence of patches and Y-cracks, there was no evidence of a Y-crack leading to a punch-out or patch over the six miles of pavement in the southbound direction.

**Figure 3.63** – Terminal joints at the project beginning and end

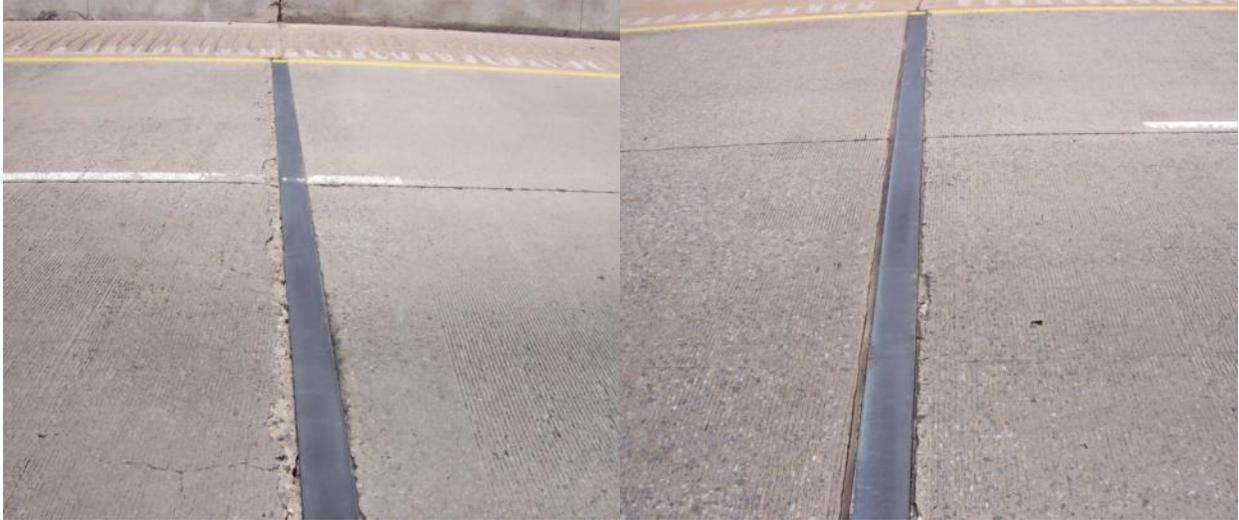
Pittsburg 3 north bound was in good shape as far as patches, recording zero over its 3.66 mile length. However, most of the project contained map-cracking, but no punch-outs or patches had developed as a result of the map-cracking. The sections of roadway that did have map-cracking reported slightly lower numbers of Y-cracks. Figure 3.65 shows the map-cracking. Figure 3.66 shows the w-shaped beams used at the joints; these joints show signs of spalling, which could possibly be enhanced by the map-cracking.

**Figure 3.66** – Terminal joints at project beginning and end

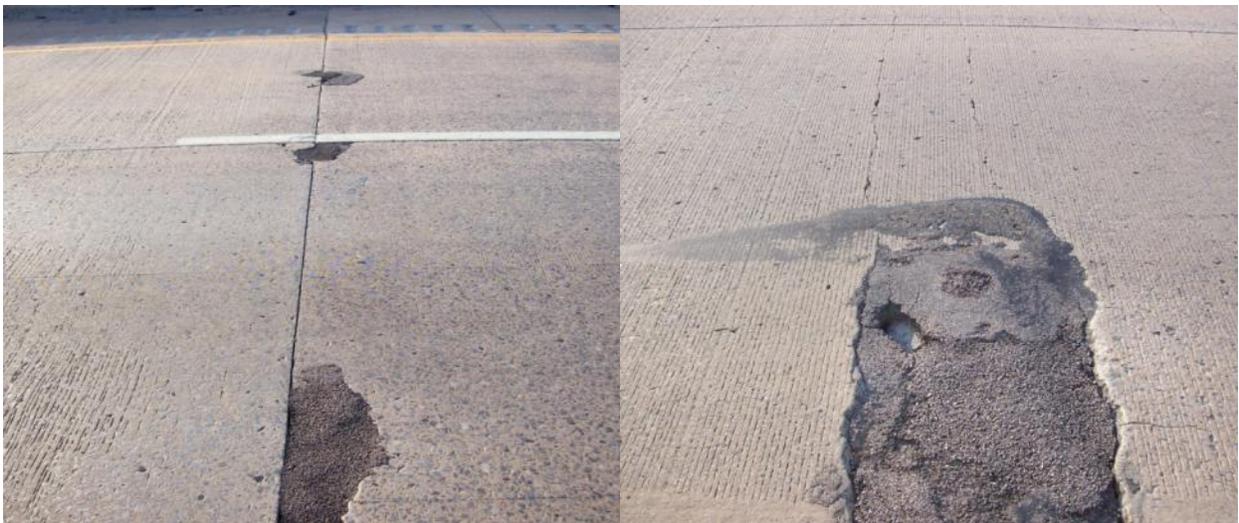
Pittsburg 3 south bound displayed many of the same issues as its northbound counterpart. The south bound lane contained map-cracking throughout its entire length, see figure 3.67. Despite having one of the lowest amounts of Y-cracks per mile, the project did have three patches over its 3.62 mile length. None of the patches seemed to be related to the Y-crack phenomenon, figure 3.68. Figure 3.69 shows the terminal joints at the projects beginning and end, both of which show deterioration.

**Figure 3.68** – Patches in the south bound lane

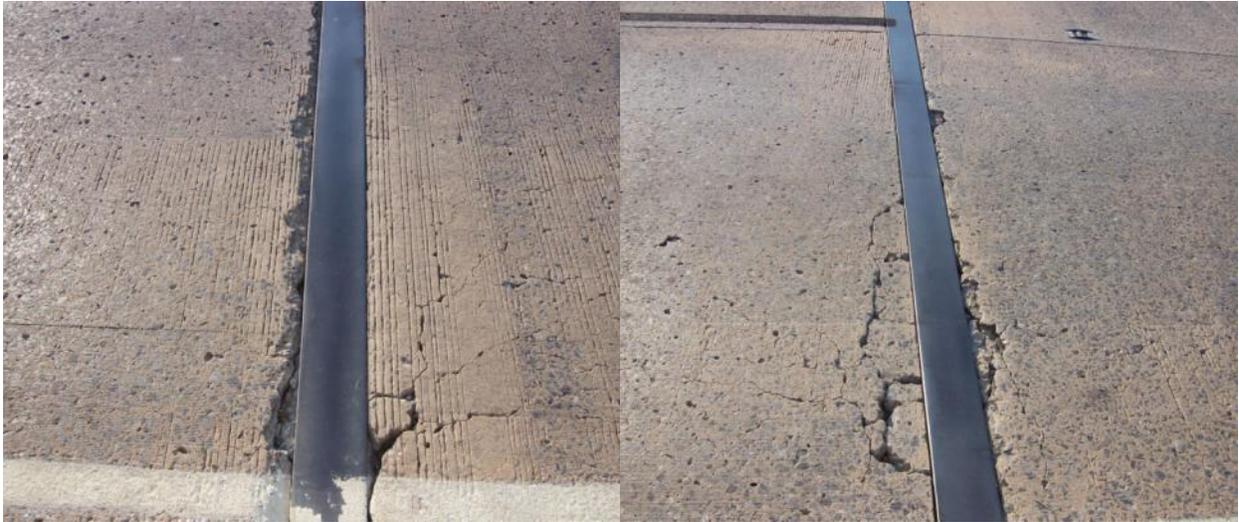
**Figure 3.69** – Terminal joints at the beginning and end of the project
