ALTERNATIVE AGGREGATES AND MATERIALS FOR HIGH FRICTION SURFACE TREATMENTS

Final Report Project BDR74-977-05

Performed in cooperation with the Florida Department of Transportation and the Federal Highway Administration

Published May 2016

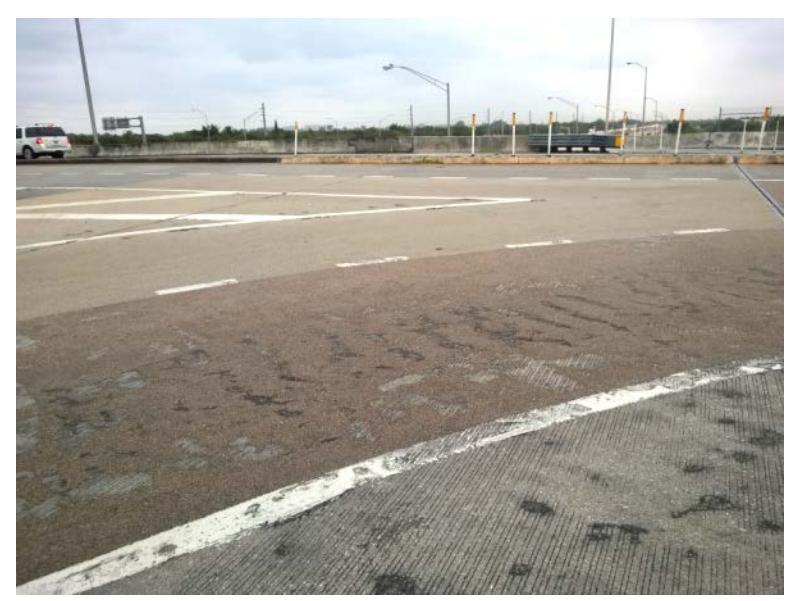
The most common type of failure is aggregate loss, or raveling. Skid resistance can be significantly compromised depending on how much aggregate is lost. This can occur within the wheel path (Figure 2.6) or across the whole application (Figure 2.7). Aggregate dislodgement under traffic is a result of one of two problems:

Figure 2.7 – Aggregate loss over concrete, single HFST application (I-95 to Congress)

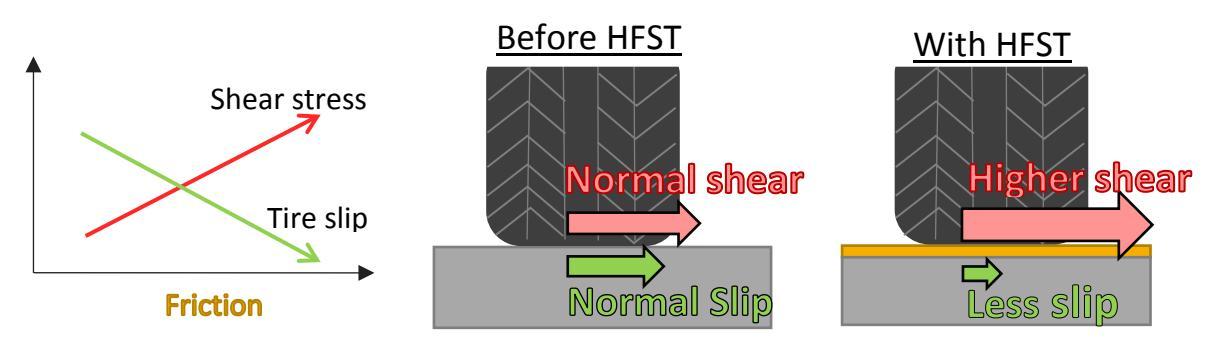
The exact mechanism is not proven but theorized in Figure 2.14. As a vehicle turns, brakes, and accelerates, the tires generate shear forces on the pavement surface. There is also a small amount of slipping that occurs, especially when turning. On an aggressive high-friction surface, the amount of slipping is reduced, and as a consequence, the shear stress between the tire and surface increases. These higher shear stresses can accelerate the deterioration of weak substrates.

Figure 2.14 – Theoretical mechanism of substrate tearing

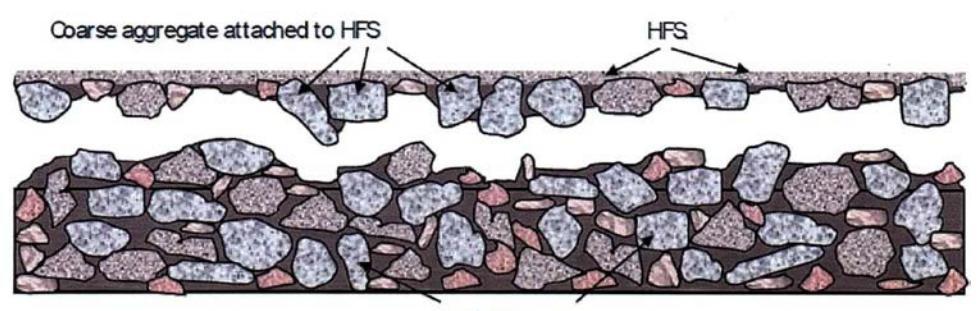
Stripping may first look like a delamination failure, except that the actual location of failure is in the substrate, and not at the HFST bond interface (Figure 2.15). Moisture at the time of construction, or moisture that later infiltrates, becomes trapped beneath the HFST and can strip the asphalt under traffic and high temperatures. Waters (28) investigated HFST failures in New Zealand and found that most cases were a failure within the top 20 mm of the asphalt substrate. This stripping condition is worsened by the previously described mechanism of higher shear stress.

Asphalt Layer Figure 2.15 – Cohesive failure (28)

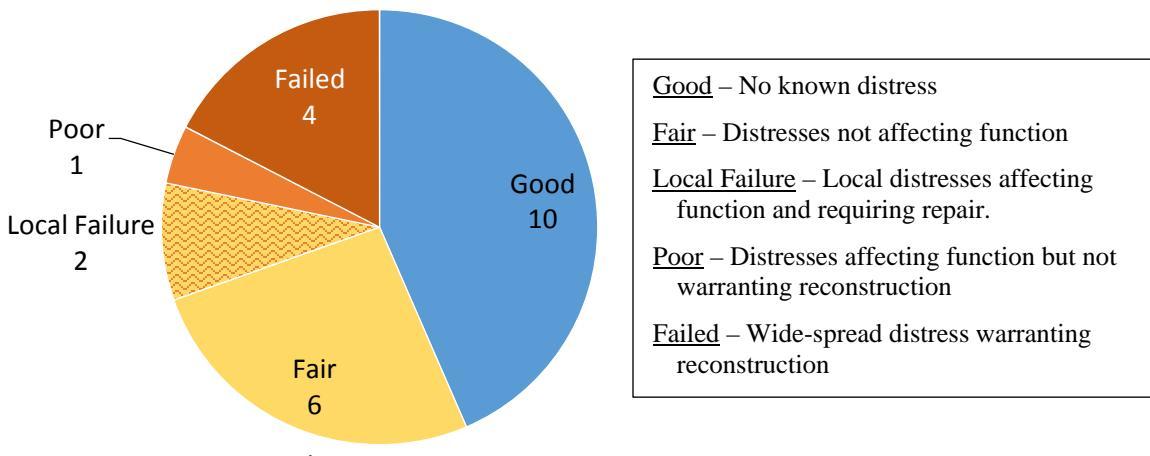
The general distress condition of all projects is summarized in Figure 3.5. Ten out of 23 projects (43 percent) are in good condition and 16 projects (nearly 70 percent) are in fair or better condition. Two projects had localized failures but were otherwise in fair or good condition. One project was in poor condition and four projects had severe wide-spread distress. The poor and failed projects constitute 22 percent of all the HFST projects.

Figure 3.5 – Distress condition of HFST projects (Subjective rating)

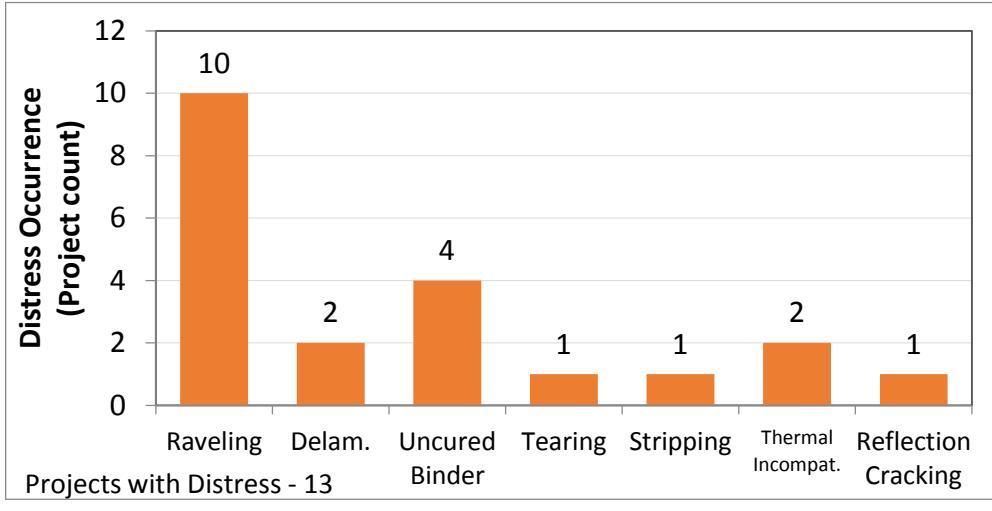
The frequency of specific distresses types is summarized in Figure 3.6. Descriptions and examples of each distress described in the Chapter 2 under HFST Failure Mechanisms. Raveling

was the most frequent problem, occurring on 10 projects, and is usually caused by inadequate binder film thickness. The next most frequent problem (four projects) was uncured binder failure, which happens if the binder is improperly mixed, proportioned, or has an incorrect formulation. Delamination occurred on three projects and a potential thermal incompatibility issue on two projects. Substrate tearing, substrate stripping, and reflection cracking occurred on one project each.

Figure 3.6 – Occurrences of HFST distress

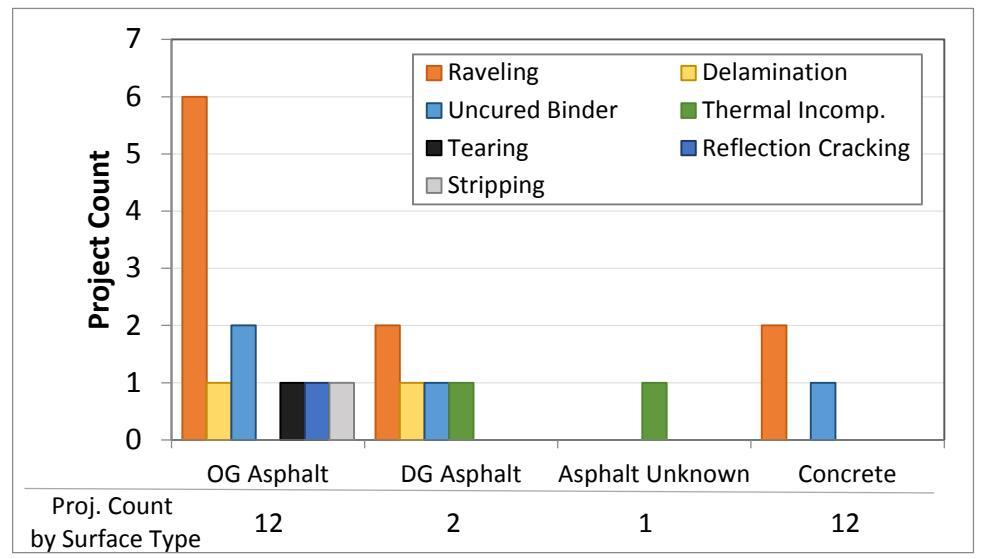
Figure 3.7 shows the distribution of these distresses by surface type. Of the 12 projects with open-graded surfaces, six (or 50 percent) of these had raveling. Five other distress types were noted over OGFC's. Both of the dense-graded asphalt projects had raveling, and had delamination, uncured binder failure, and thermal incompatibility. Of the 12 concrete sections, two had raveling and one had uncured binder failure.

Figure 3.7 – Distribution of HFST distress by surface type

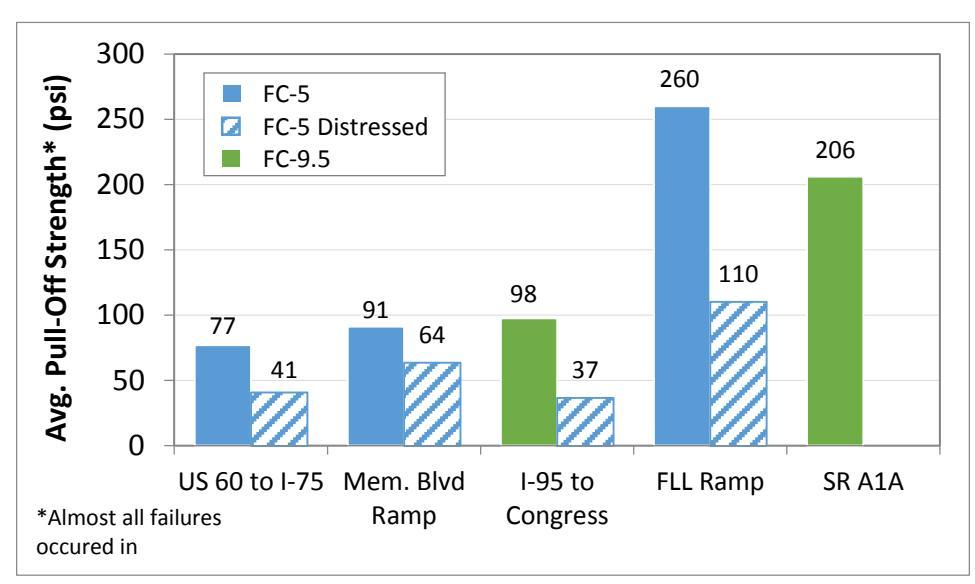
Figure 4.3 is a simplified representation of all the pull-off results. The first bar is the average of "higher strength" and intact HFST locations. The second bar generally represents the average at locations with observed distresses. Most sections were over FC-5 with two FC-9.5 sections. Average values for the good locations ranged from 77 to 260 psi. The distressed sections ranged from 37 to 110 psi, including some cores that failed during sample preparation. Most tests failed within the substrate but a few failed at the HFST bond. These were a heavily distressed sample on I-95 to Congress (just after the stop bar), one reading on SR A1A, and one reading on FLL Ramp in the un-distressed area.

Though the field tests on concrete sections were unsuccessful, the researchers noted that the strength when the test failed was between 100 and 250 psi. They also noted that the bond strength over splotchy areas on the I-95 off-ramp at 6^{th} Ave S was very weak and the material was even removable by hand.

Figure 4.3 – Summary of pull-off test results

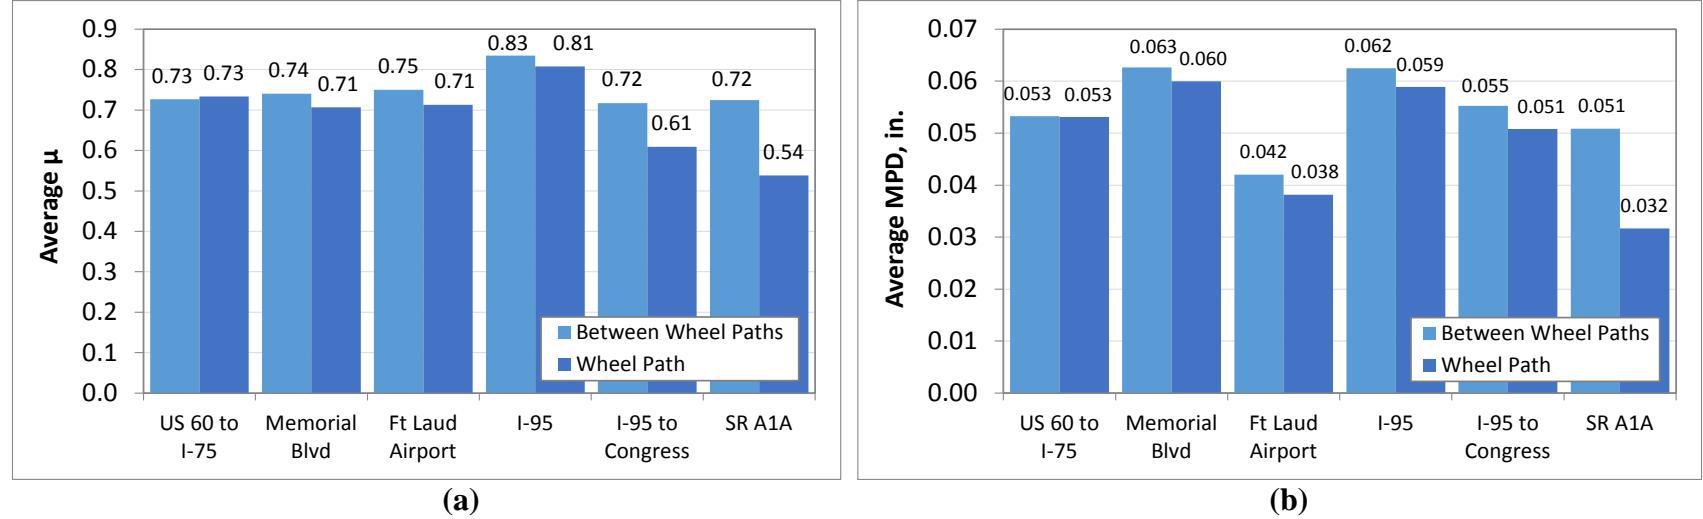
Figure 4.4 – Friction results between and in the wheel paths: (a) DFT and (b) CTM

The friction results for between and inside the wheel paths are shown in Figure 4.4. Friction consistently decreased in the wheel path under traffic for both the DFT and CTM readings. The average friction coefficient, μ , without traffic was 0.75 and dropped to 0.69 (9 percent decrease) with traffic. For the CTM, the average mean profile depth (MPD) changed from 0.054 to 0.049 inches (11 percent decrease). This is after an average of 3 years.

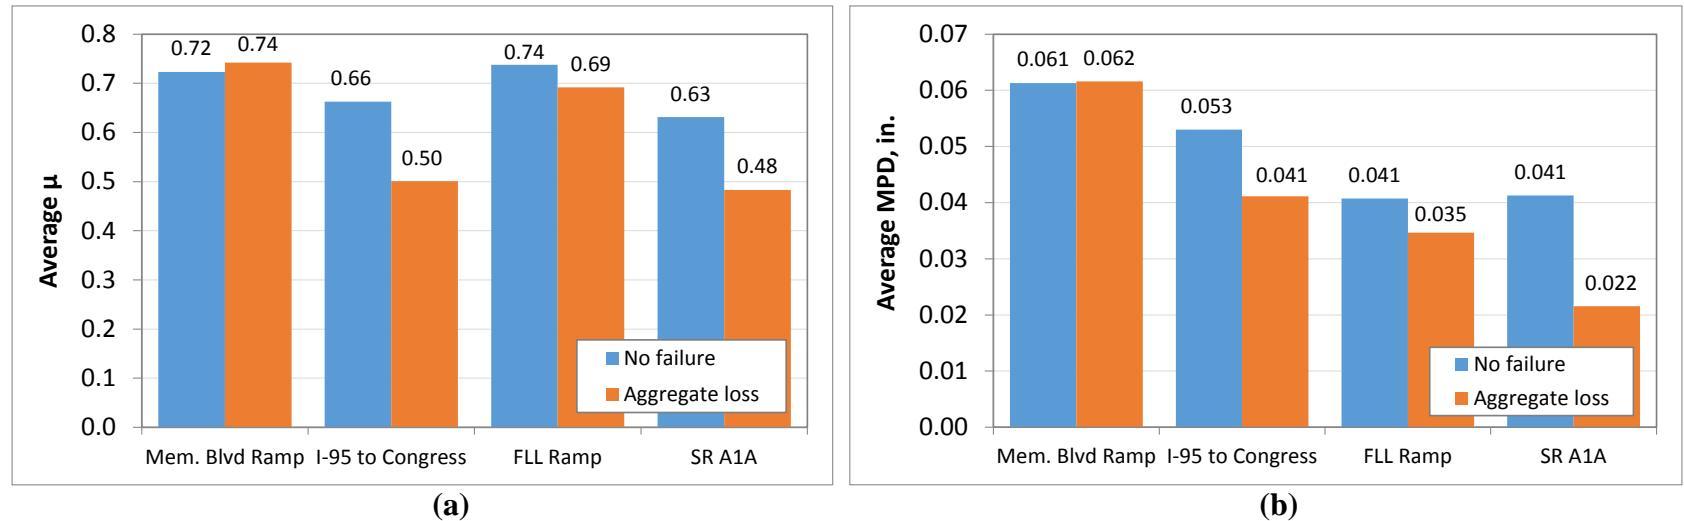
Figure 4.5 – Friction results in areas with and without raveling: (a) DFT and (b) CTM

The effect of aggregate loss on friction is illustrated in Figure 4.5. Thought the amount of aggregate loss varied from project to project and considered in this analysis. The average decrease in friction (μ) was 13 percent and for MPD was 21 percent.

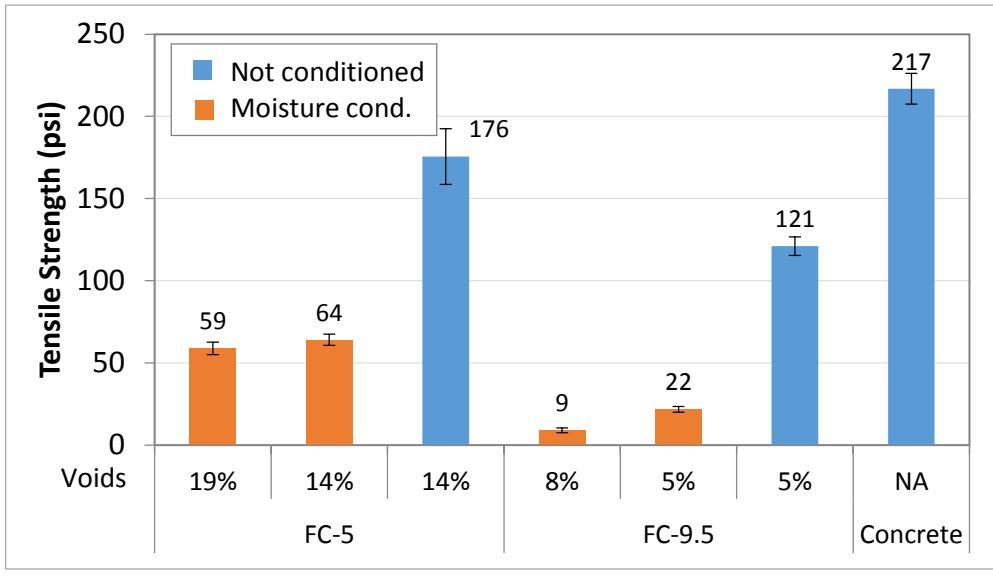
Figure 5.9 – Pull-off test results

The pull-off test results are shown in Figure 5.9. The moisture conditioned samples had tensile strengths ranging between 9 and 65 psi. The un-conditioned HMA samples had tensile strengths of 121 and 176 psi, and concrete of 217 psi. These effect of moisture conditioning is very clear. FC-9.5 had a lower strength than FC-5, which is due to the lower-grade asphalt binder in the mix. This trend of FC-9.5 being weaker than FC-5 is evident in many of the experiments. The

Based on this graph and results from previous field tests, the researchers may consider a minimum substrate tensile strength criteria. A specific minimum value cannot be determined based on these results, but it would be somewhere between 75 and 120 psi.

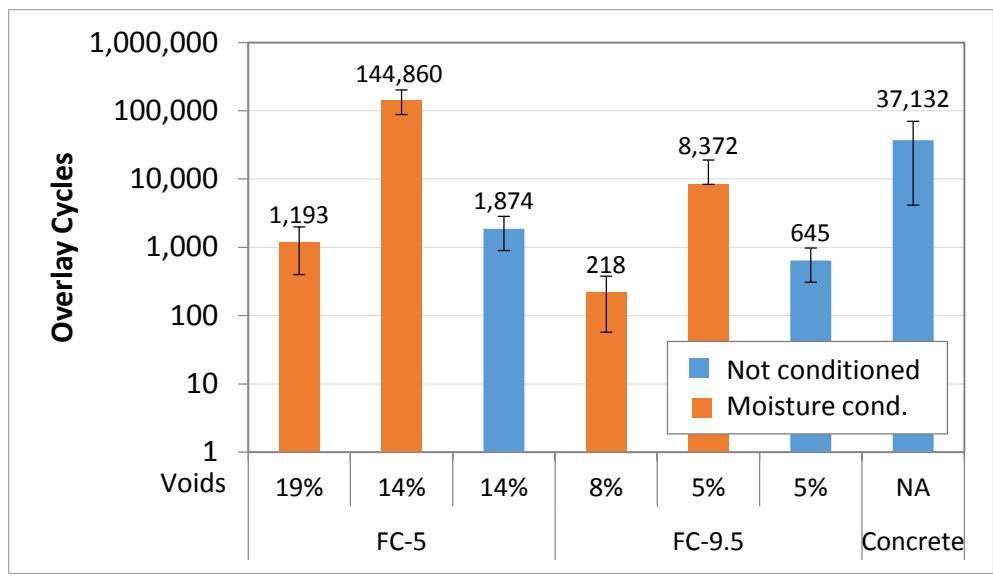
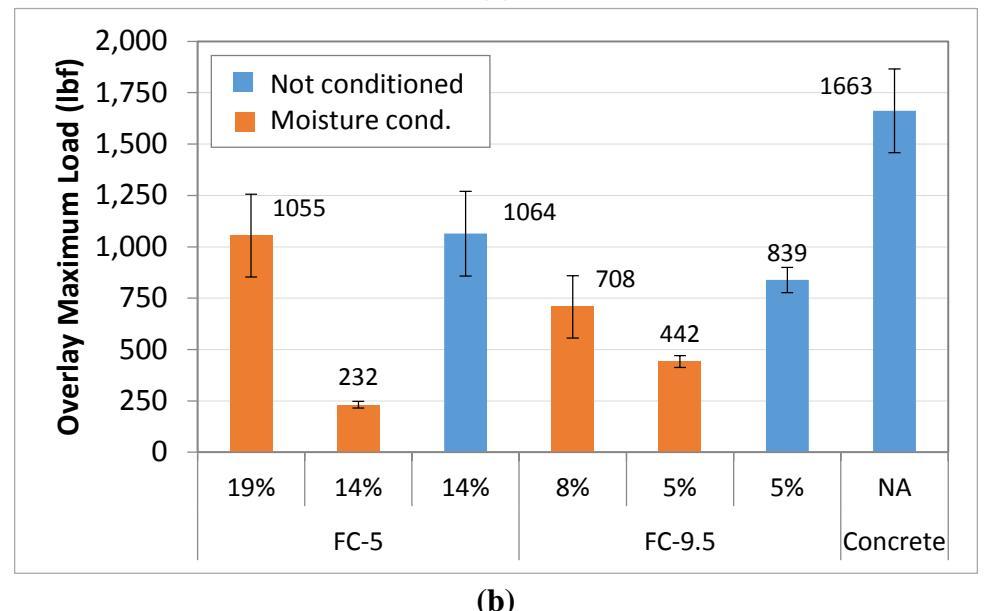
Figure 5.10 – Cyclic shear test results: (a) cycles to failure and (b) maximum load

The cycling shear test results (overlay cycles and maximum load) are shown in Figure 5.10. FC-5 had the most cycles to failure. This is because the mix is inherently more flexible with a high void content and higher-grade asphalt. Concrete had the highest strength which was also expected. Other trends with mix type, void content, and moisture conditioning are not clearly evident. Overall, the researchers found this test to be inconsistent and a poor predictor of field performance. The sample preparation and test procedures require further refinement to improve the accuracy and repeatability of the test.

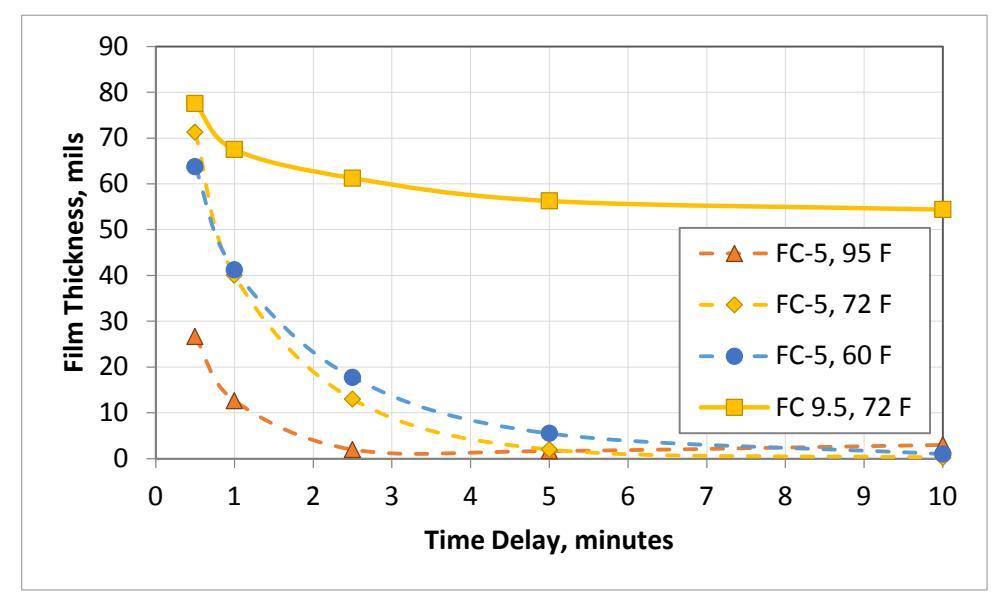
Figure 5.11 – HFST binder drain down vs. time and temperature (laboratory)

The most common distress in HFST is aggregate loss (Figure 2.6). This is caused by inadequate binder thickness. In Florida, this has been a particular problem for HFST constructed over opengraded HMA, where the first application of binder drains into the pavement and does not contribute to holding the HFST aggregate. This concept is illustrated in Figure 5.11, where the binder film thickness over FC-5 (OGFC) and FC-9.5 (dense-graded) decreases over time,
especially when the binder is at an elevated temperature. The decrease in thickness is most dramatic in the FC-5, arriving at less than 10 mils after just 5 minutes.

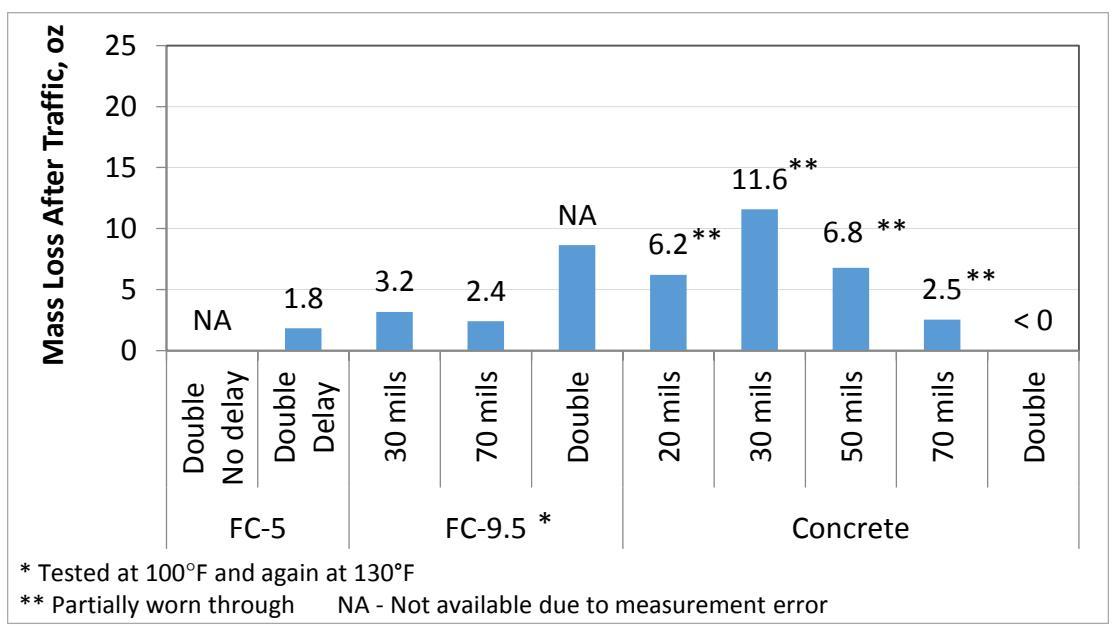
Figure 5.13 – Mass loss of HFST (different substrates and binder thicknesses)

The mass loss of the samples is shown in Figure 5.13. In a few instances, the researchers noted problems with making reliable mass-loss readings due to damage of the HMA substrates during handling. Mass loss was noted most extensively on the concrete slabs at 20, 30, and 50 mils where the polisher had begun to wear through to the concrete. The wearing away was top-down and, therefore, not indicative of a bond failure between the HFST and the concrete. FC-9.5 samples had minimal wear, though these were tested at a lower temperature. The double-lift FC-5 samples also had very good performance, even the sample with the delayed aggregate application. The delay sample had a binder thickness of ~10 mils for the first layer, which had virtually no effect once it was covered by another layer. In all cases, double layer HFST samples had very good performance.

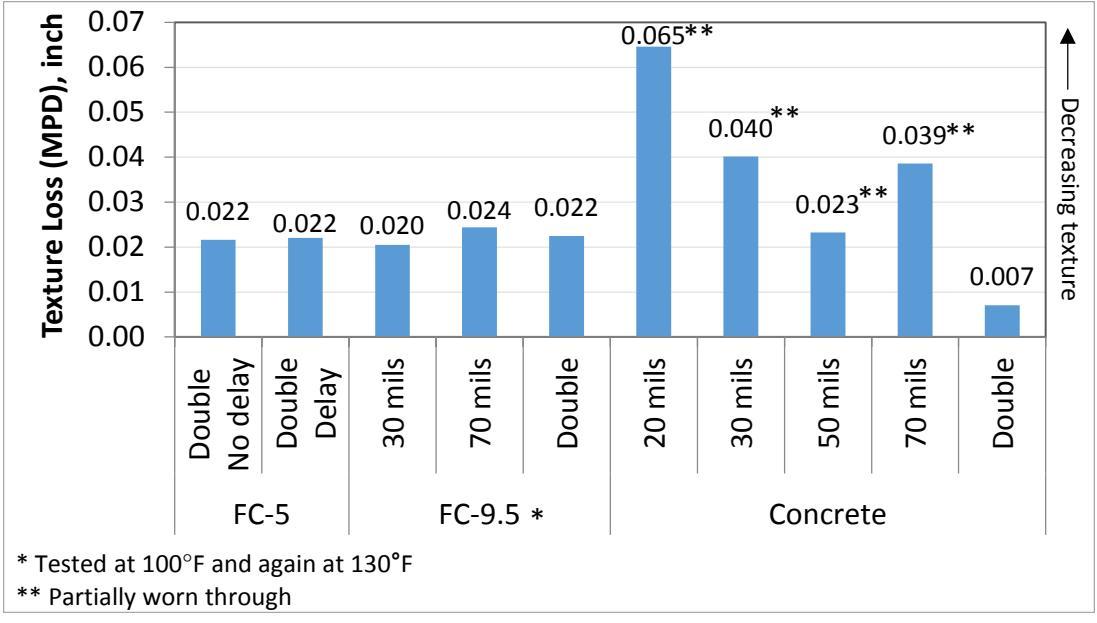
Figure 5.14 – Texture loss of HFST (different substrates and binder thicknesses)

The change in texture is illustrated in Figure 5.14. These measurements were more reliable than the mass loss measurements. Texture loss was most noted on the single-layer concrete samples. Texture losses on the FC-5 and FC-9.5 samples were essentially identical. The texture loss here was less related to aggregate loss and more to the softening of the HMA and epoxy and subsequent embedment of the aggregate.

One theory for why the HFST on concrete wears faster is that because the slab is stiffer, the shearing forces under the tire are absorbed directly by the HFST aggregate and resin binder. The stiff substrate enables a more effective abrading action. Asphalt substrates, however, help to absorb the stress and even deform under traffic. For this reason, a double-lift HFST may be better suited for concrete surfaces when severe turning and breaking and accelerating traffic are present. On the other hand, the lab conditions are not a perfect representation of field conditions and there is little evidence in the field for or against using a single-lift HFST on concrete. Due to cost, the single-lift is the recommended method at this time.

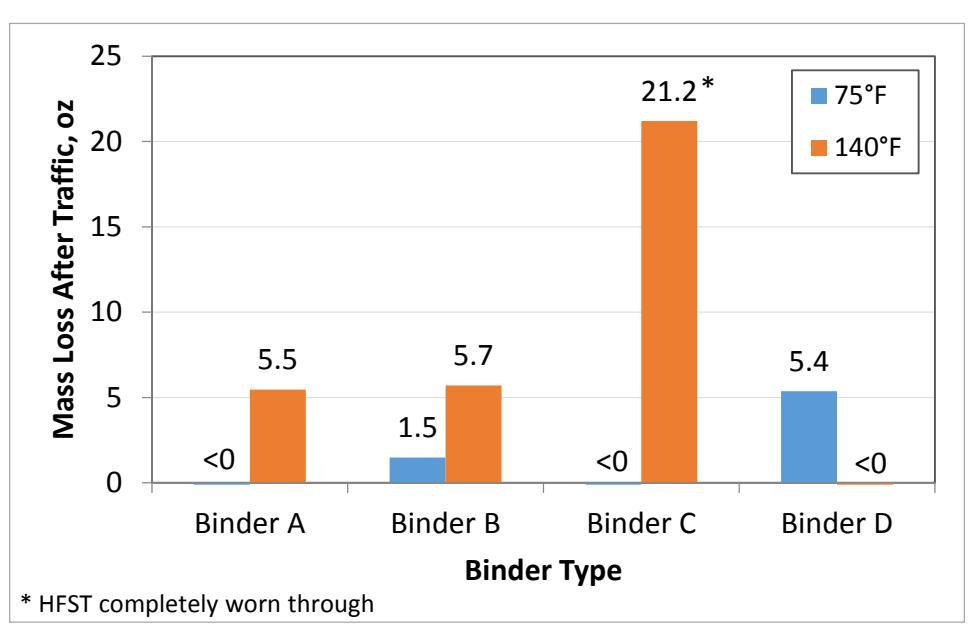
Figure 5.15 – Mass loss of HFST (four binder types and two temperatures)

The mass loss results are shown in Figure 5.15. Mass loss was negligible (less than 4 oz) at 75°F for all binder types, except Binder D, at 75°F. Mass loss of Binder D was slightly above 5 oz, but the researchers expect this is an error in the measurement method. When raising the temperature to 140°F, the sample mass loss increased and for Binder C, and the polishing wheels wore completely through to the concrete (Figure 5.16). The high temperature was above the glass transition point for this particular epoxy. This result, however, is not a direct indication of poor performance in the field, especially since Binder C has good performance at the lower temperature. This is still a point to consider for the high summer temperatures observed in Florida.

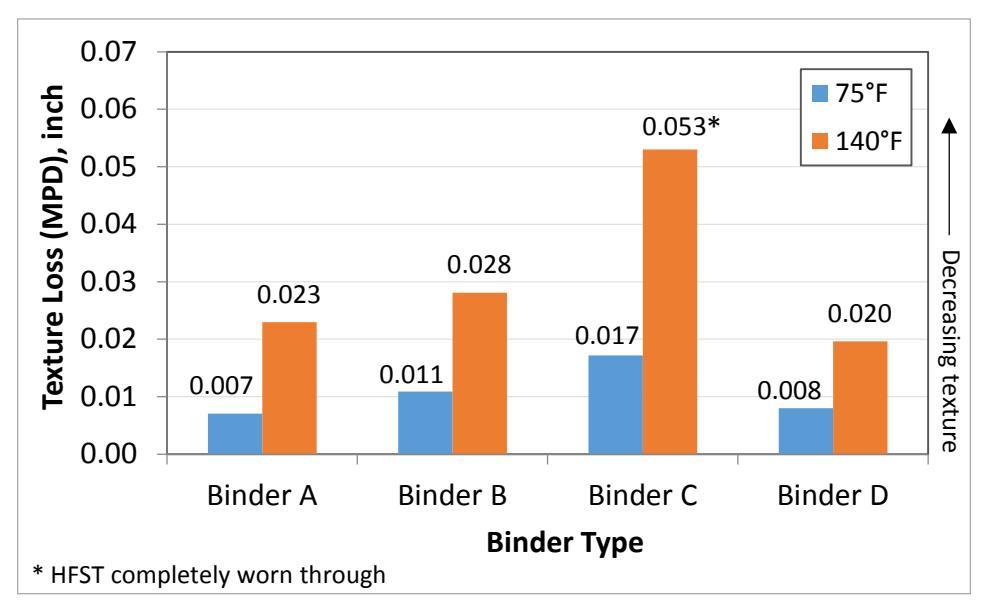
Figure 5.17 – Texture loss of HFST (four binder types and two temperatures)

The surface texture (mean profile depth) for HFST, before trafficking, was 0.078 inches for all samples, and ranged between 0.075 and 0.082 inches, respectively. The change in surface texture after trafficking is shown in Figure 5.17. In every case, texture loss increased at the higher temperature. Texture loss at 75°F was 0.011 inches on average, and at 140°F was 0.024 inches on average for resin Binders A, B, and D. The HFST was completely worn through for Binder C and had a resulting texture loss of 0.053 inches. The average texture after trafficking for all samples (excluding the failed Binder C sample), was just above 0.05 inches, which is still considered high macrotexture.

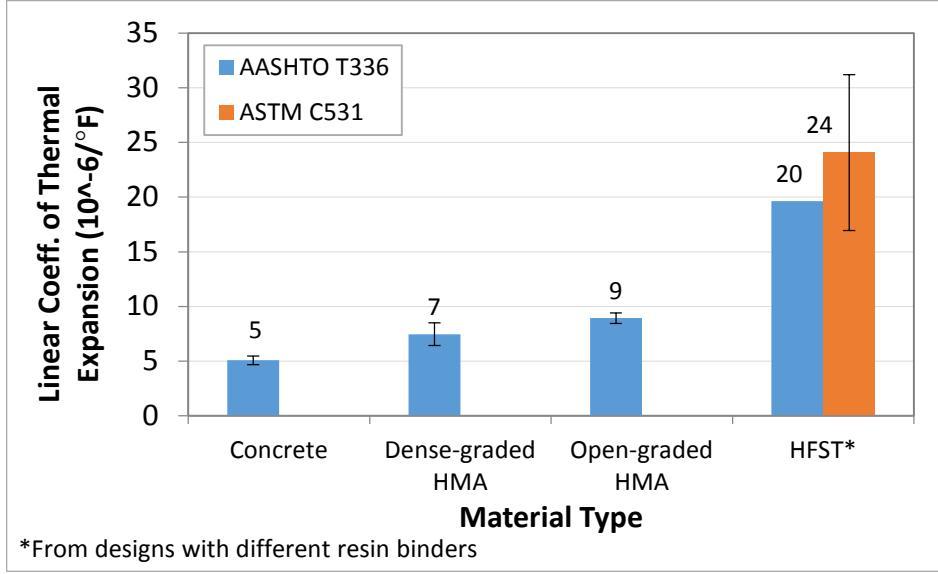
Figure 5.21 – Coefficient of thermal expansion results for different materials

The test results for the substrates and average of all HFST samples is shown in Figure 5.21. Concrete had the lowest COTE of 5 x 10^{-6} /°F. Dense- and open-graded HMA had similar COTE values of 7 and 9 x 10^{-6} /°F. The HFST had considerably higher average COTE values of 20 and 24 x 10^{-6} /°F, depending on the test method. Because of the drastically different COTE values, HFST bonded to these substrates will induce stress with thermal cycling.

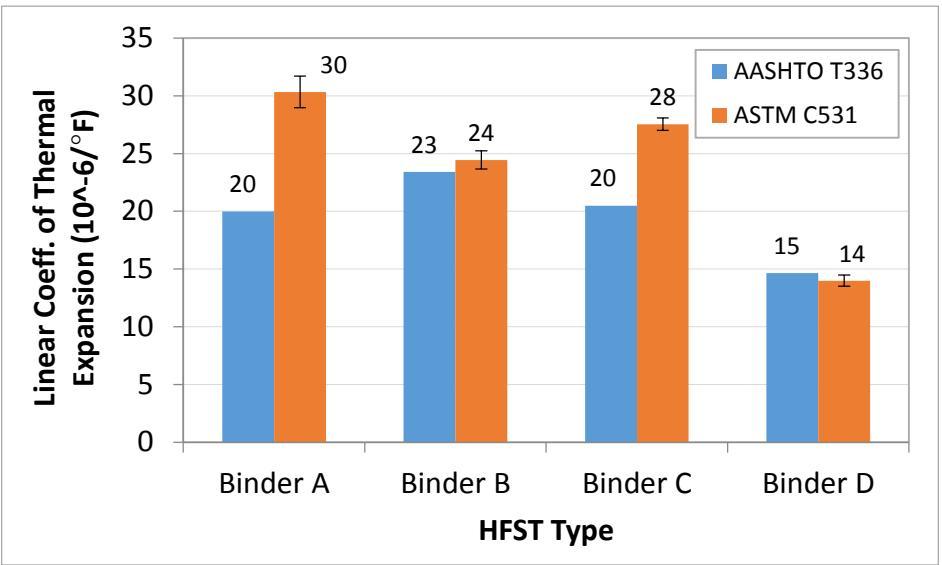
Figure 5.22 – Coefficient of thermal expansion results for HFST types

Figure 5.22 shows the COTE results for each HFST type. The AASHTO test yielded lower COTE values on average, ranging from 15 (Binder D) to 23 x 10^{-6} /°F (Binder B). The ASTM procedure, on the other hand, had a range between 14 (Binder D) to 30 x 10^{-6} /°F (Binder A). Binder D is a polyester acrylic resin while other binders are epoxy type resins. The researchers are unsure why the COTE rankings are different for the two test types, but it is most likely due to

differences in the sample densities or errors with material proportions. Still, it is clear that HFST has a considerably higher COTE than substrate materials and that the COTE for HFST binder types are not the same.

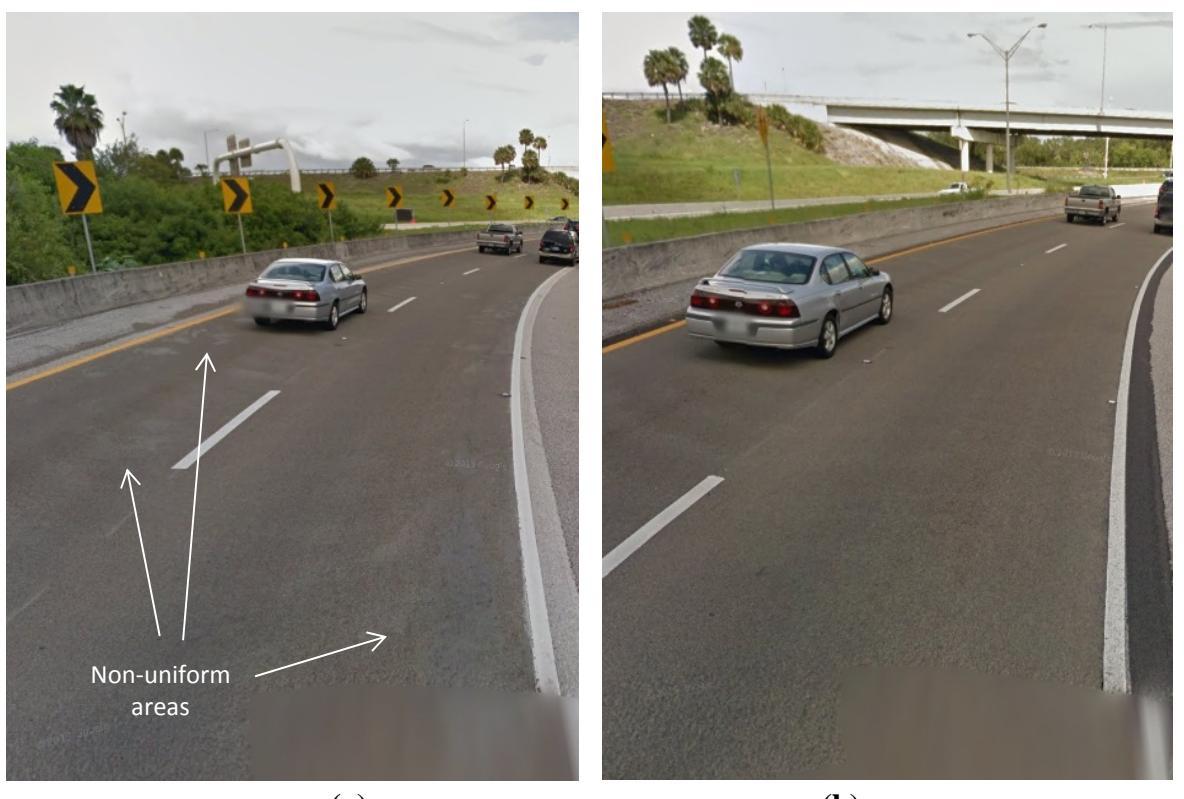
The final surface in Figure C.2 shows with locations without and with milling/resurfacing, respectively. The HFST in Part A was non-uniform and splotchy, a result of poor epoxy mixing and possibly incorrect binder thickness. The image in Part B is notably more uniform.

(a) (b) Figure C.2 – Completed HFST (July 2012): a) over existing surface, b) over milling/resurfacing. (www.google.com/maps/)

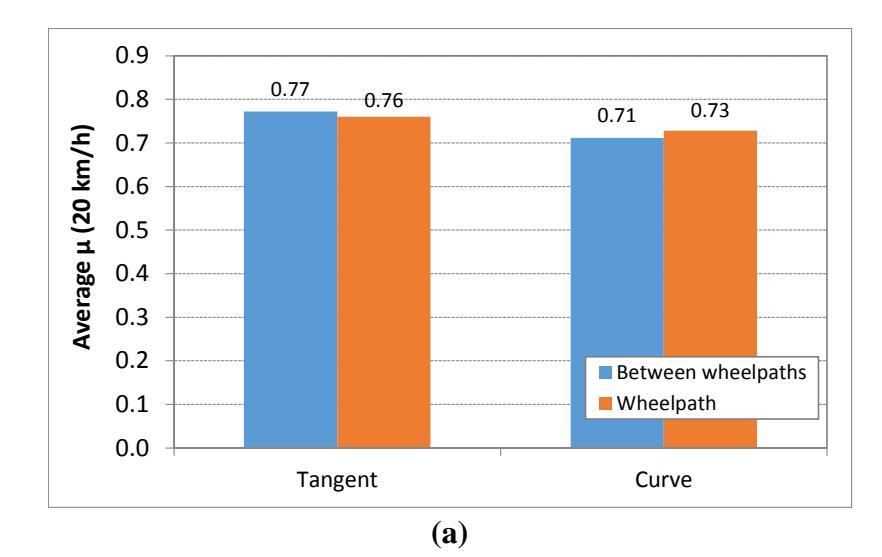
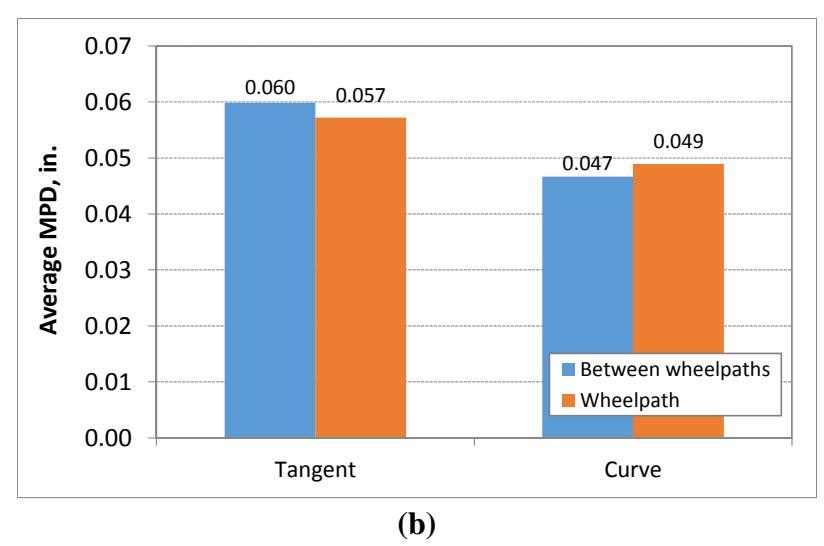
Figure C.8 – Results of DFT and CTM testing: a) Friction and b) texture.

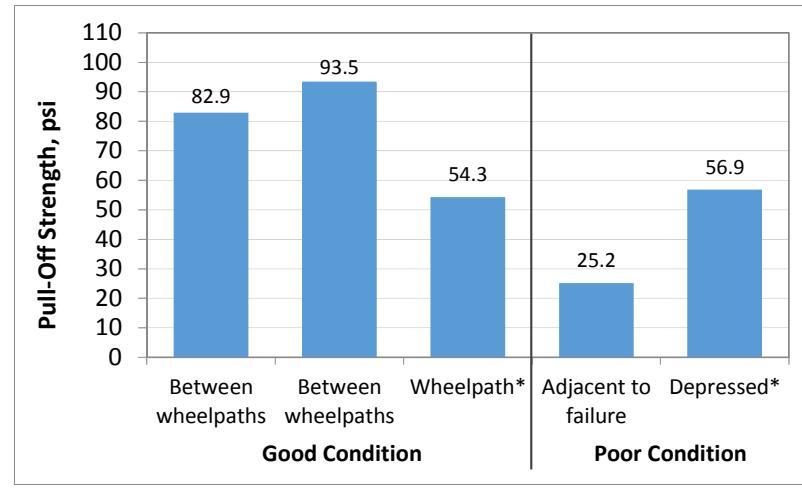
Three cores were taken in good locations and two from poor locations for pull-off testing. The results of the test are shown in Figure C.9. All results are the average of three readings, expect those marked by an asterisk which experienced some failures during sample preparation. "Good Condition" samples between the wheel paths had high bond strengths above 80 psi. The "Good" sample in the wheel path had low strength, under 55 psi, and also had two readings that failed in sample preparation. The "Poor Condition" samples had average strengths around 25 and 55 psi. All failures were in the FC-5 substrate.

Figure C.9 – Pull-off test results.

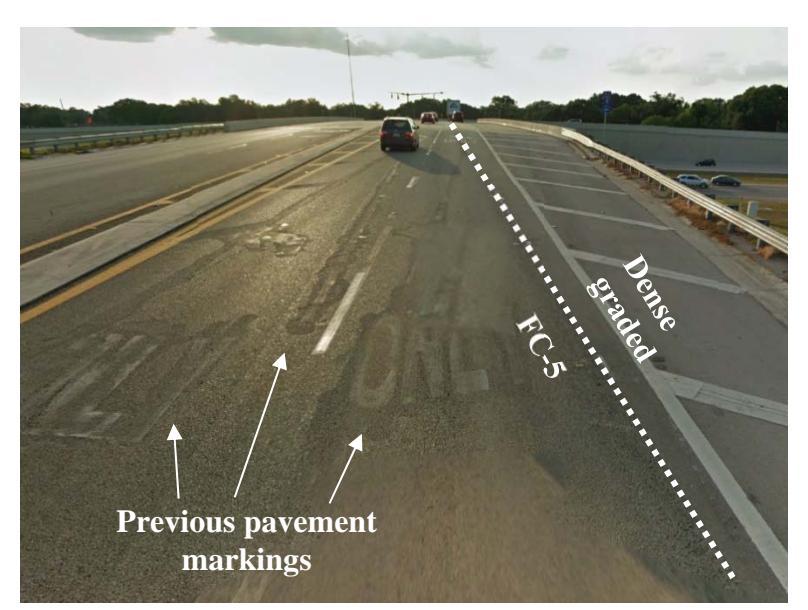
Figure C.11 – Uneven texture of existing surface before bridge deck (May 2011). (www.google.com/maps/)

The project is generally performing well. Most of the HFST is intact with uniform texture. There is a 190 ft portion just before the bridge that is raveling and corresponds to the preexisting area with pavement marking removal. It is likely that the uneven texture made it difficult to achieve the correct epoxy thickness, which lead to the aggregate loss. Portions of the shoulder are also raveled, which was likely caused by lower attention to construction quality in a non-critical area. The double application on the bridge is performing very well, even under heavy turning traffic.

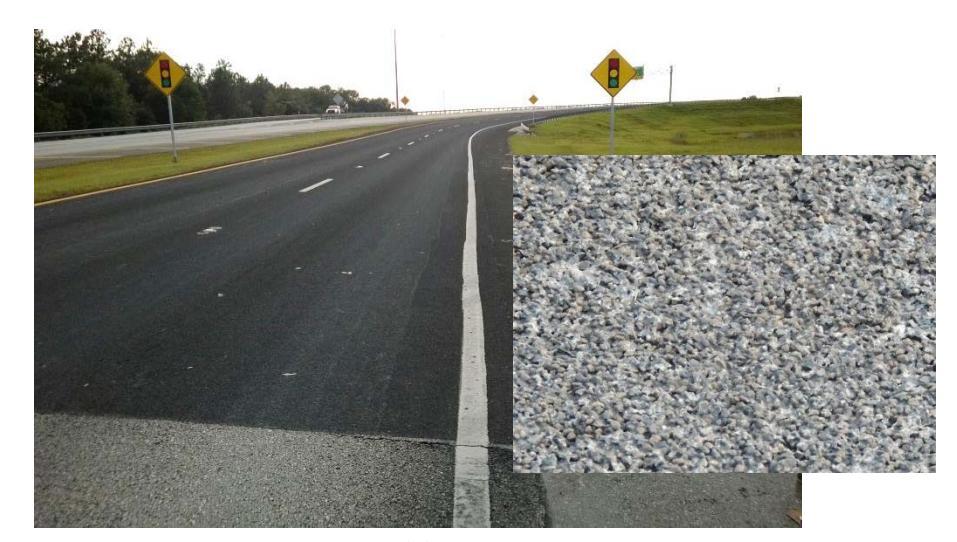
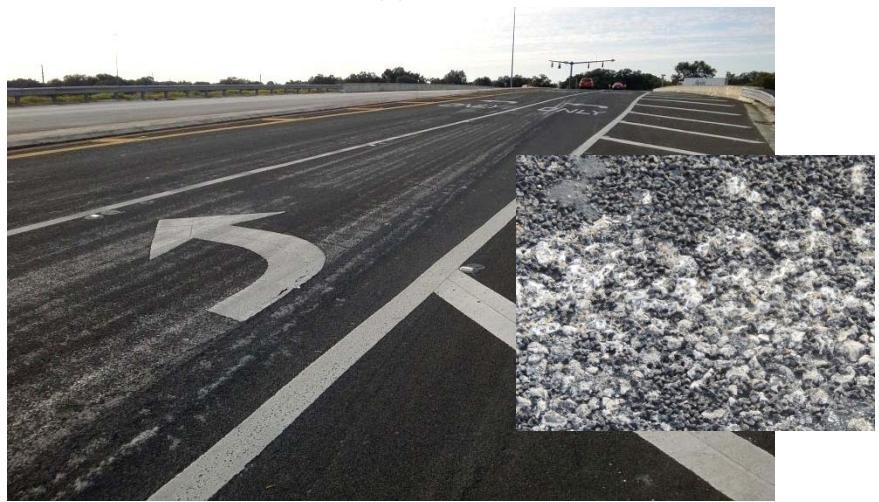
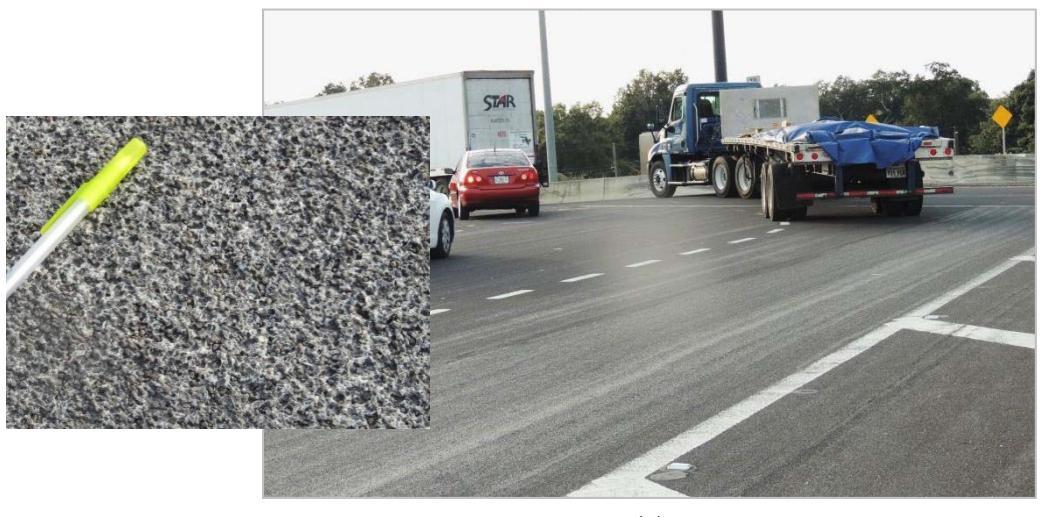
Figure C.12 – In-service HFST (November 2014): a) Intact over asphalt, b) raveling over asphalt, c) intact over concrete.

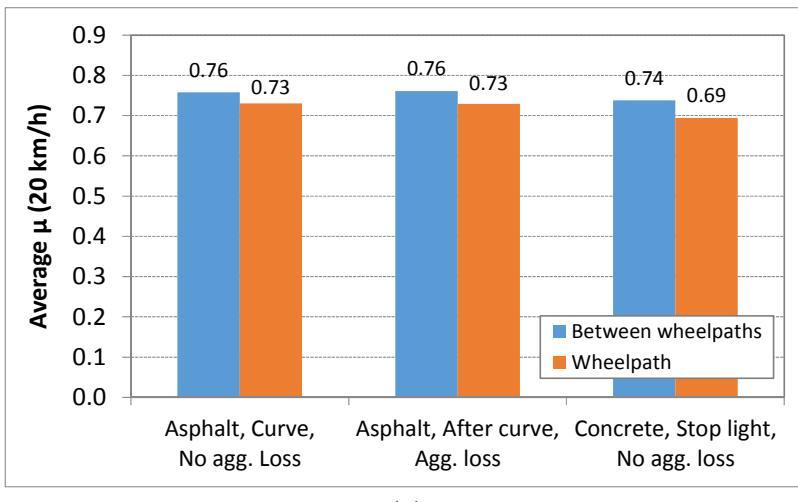
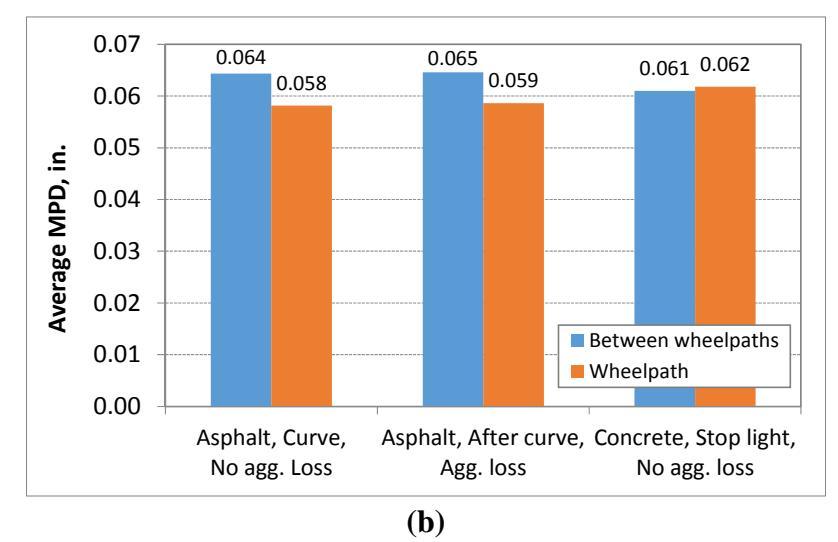
In January 2015, testing was performed at different locations both in and out of the wheel path. The first location was in the curve where there was no aggregate loss. The second location was after the curve on a raveling section. The last location was on the bridge deck just before the stop light and had no aggregate loss. The results are shown in Figure C.13. In all cases friction was lower in the wheel path. Friction is over asphalt areas with and without aggregate loss was not different. And friction in front of the stop light was lower than in the curve. In all cases, friction in this project is very high. Texture depth over asphalt was highest outside the wheel path. All other values were essentially the same. Surface texture on this project was high all around.

Figure C.13 – Results of DFT and CTM testing: a) Friction and b) texture.

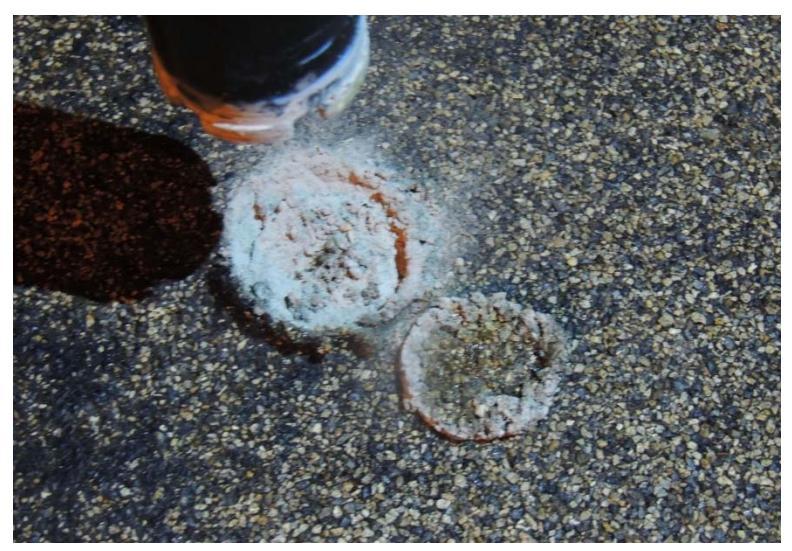
Construction was done with an automated epoxy mixer and applicator followed by hand distribution with serrated squeegees. The aggregate was spread using a mechanical blower. Construction went smoothly for most part except for an epoxy mixing malfunction on the southbound exit ramp. This left random splotchy areas that did not set up, as will be discussed shortly

Figure C.17 – Weak bond of splotchy area.

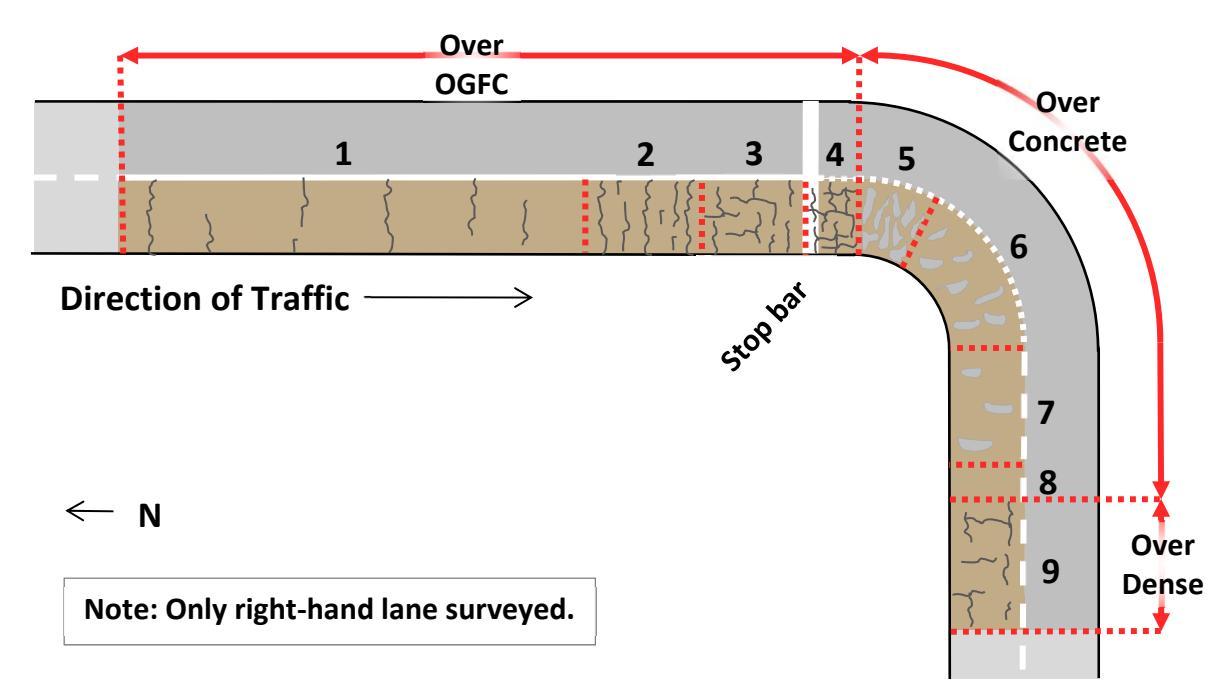
Figure C.20 – Distress map.

This project has some interesting distresses, as shown in the diagram in Figure C.20. Distresses include transverse cracking, random cracking, and raveling. Descriptions and our hypotheses of the causes for each distress follow.

The HFST approaching the stop light is transversely cracked, with crack severity and frequency greatest near to the stop bar (Figure C.21). The cracking pattern becomes more block-like after the stop bar, heading into the turn. Before the HFST, there is no sign of cracking, except an occasional longitudinal crack. To confirm that the distress was not reflective cracking from the existing pavement, cores were taken at the edge of developing cracks to see if the cracks originated from the top or bottom. Pull-off strength tests on the approach broke within the OGFC and failed during sample preparation, confirming the very weak condition of the substrate. After the stop bar, where distress was more severe, the average strength was 74 psi. These samples, however, failed at both the epoxy-asphalt interface and in the OGFC. This was not expected but suggest the repeated high-shear forces at the intersection have also weakened the HFST bond.

Around the turn, traffic moves onto the concrete bridge deck. The first section here has significant HFST raveling and wearing away (Figure C.22); roughly 30% of the HFST is gone. This is only apparent in the right-hand lane, which has a tighter turning radius and more traffic. Initially, the aggregate is raveled/plucked out of the epoxy, after which the exposed epoxy also wears away. After the turn, the wearing away of the HFST on the bridge deck is much less severe. We believe this problem was caused by 1) using a single-lift HFST, and 2) possibly no shot-blasting. This does not appear to be a traditional delamination issue.
