ALTERNATIVE AGGREGATES AND MATERIALS FOR HIGH FRICTION SURFACE TREATMENTS

Final Report Project BDR74-977-05

Performed in cooperation with the Florida Department of Transportation and the Federal Highway Administration

Published May 2016

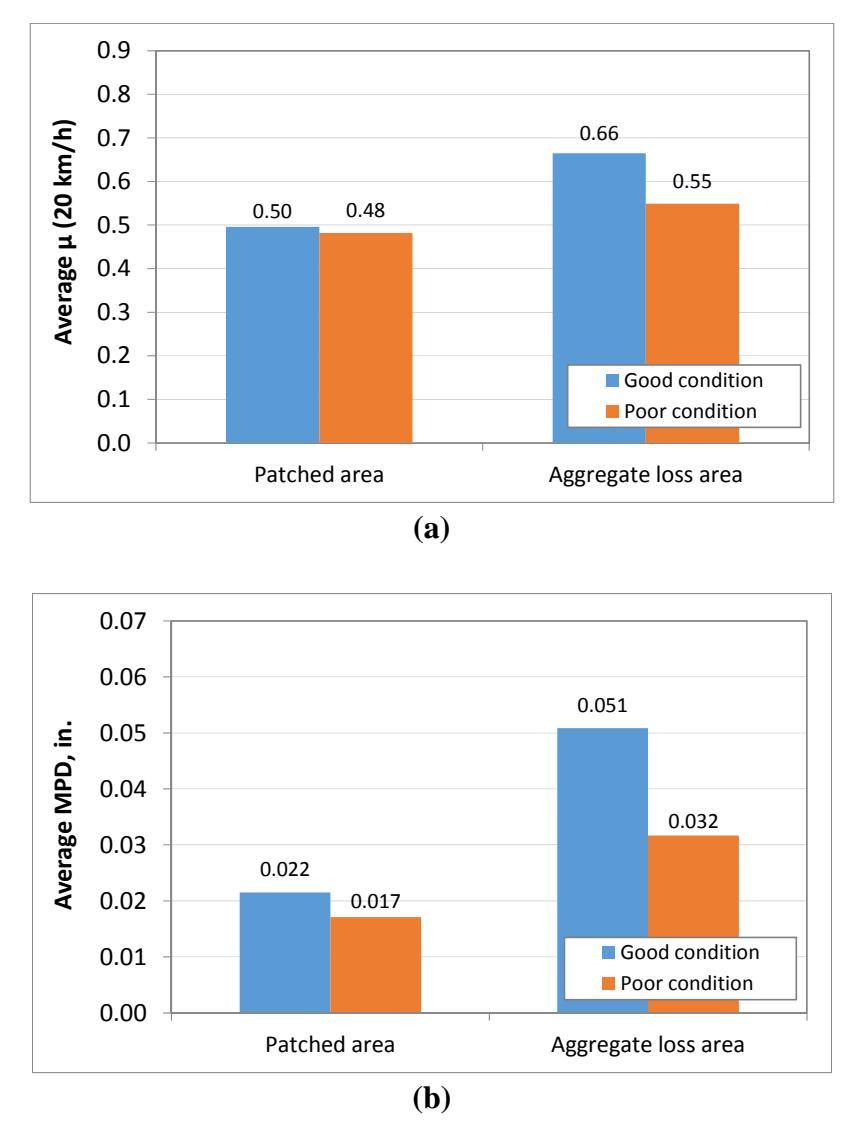
Figure C.25 – Results of DFT and CTM testing: a) friction and b) texture.

The average skid number (FN30R) before construction was 36. In 2012, a few months after construction, the SN was 69. The following year, the SN was 57 and the MPD was 0.028 (quite low for an HFST). In the 2014 site visit, the friction and texture were measured with the DFT and CTM (Figure C.25). Measurements were made on an area with patching and on an area with aggregate loss. In both cases, tests were made on "good" and "poor" condition surfaces. Friction was highest (0.66) where the aggregate was intact and not patched. This spot was also outside the wheel paths. Areas with patching and experiencing aggregate loss had a friction

coefficient around 0.5. Texture was also much higher in the "good" non-raveled area (0.051 inches). The patched areas had low texture (~ 0.02 inches).

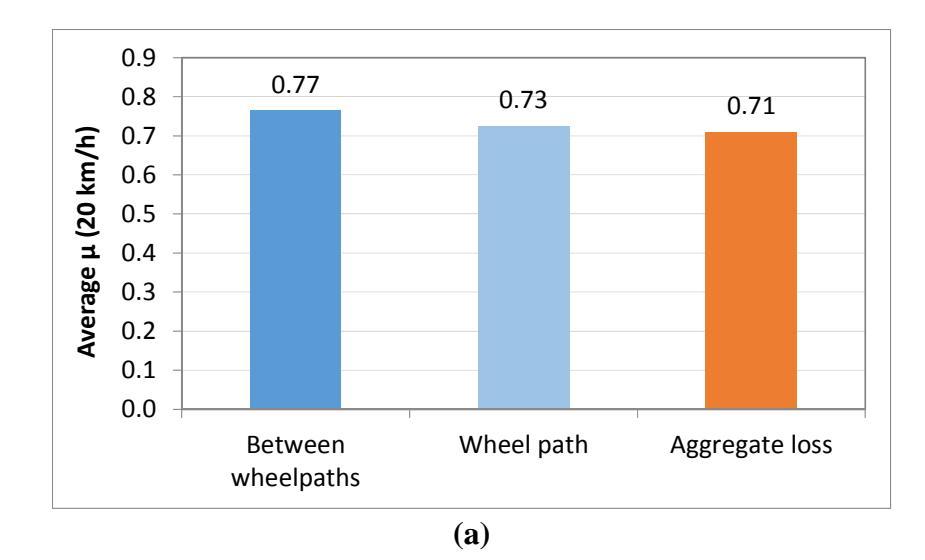
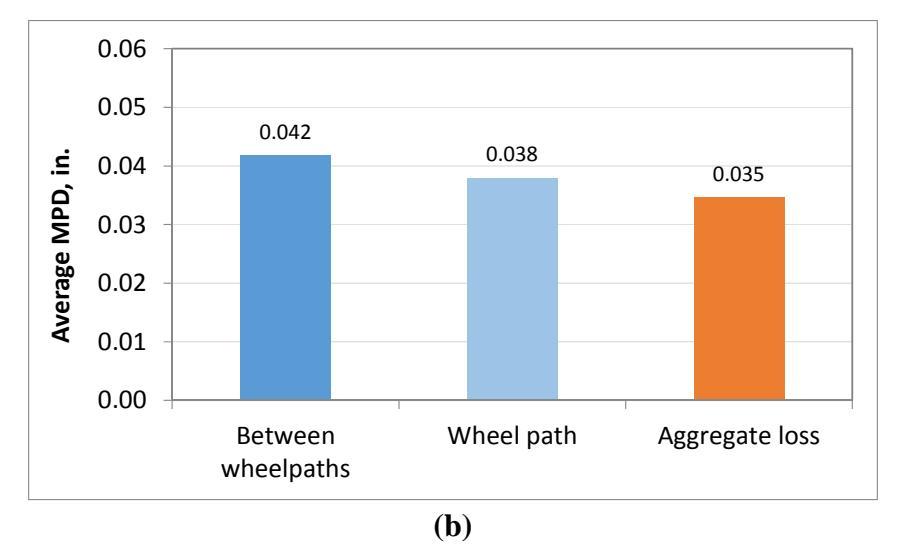
Figure C.30 – Results of DFT and CTM testing: a) friction and b) texture.

The average skid number (FN40R) in 2008 was 44. Immediately after construction, the average SN was 88 and the MPD was 0.047 inches. The following year (2013), the SN was 77 and MPD was 0.043 inches, and in 2015 FN40R was 69. In the 2014 site visit, the friction and texture were measured with the DFT and CTM. Measurements were made on an asphalt section in a good area and an area with aggregate loss. More measurements were made over the bridge in and between the wheel paths. The highest friction (0.77) was located between the wheel paths. Locations in the wheel path and experiencing aggregate loss had lower friction (0.73 and 0.71, respectively). This is still exceptional. Texture depth was greatest between the wheel path (and also over the asphalt) (0.042 inches). The lowest texture was in an area with aggregate loss (0.035 inches). These trends are reasonable and expected.

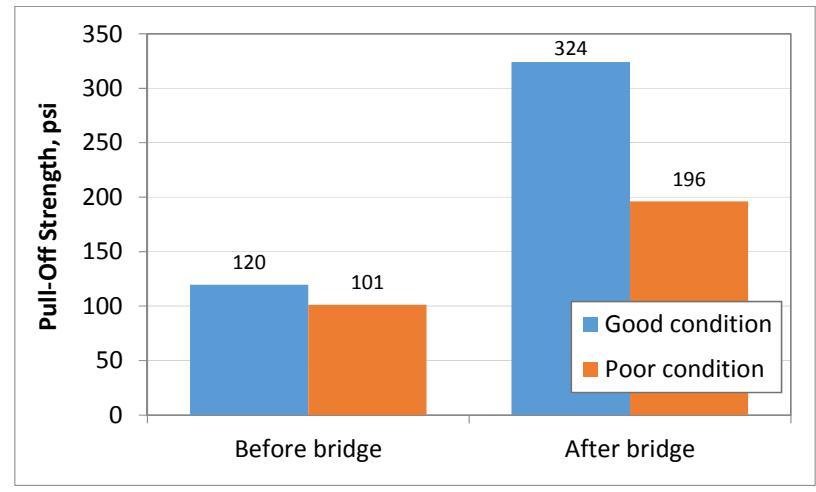
Figure C.31 – Pull-Off Strength Results.

Pull-off testing was attempted in the field on concrete sections and done on asphalt cores in the lab. Field testing was not successful due to precipitation and cold temperatures. The pull-off results from the asphalt sections are shown in Figure C.31.In nearly every case, the FC-5 substrate failed before the HFST bond. Before the first bridge, the average strength was between 100 and 120 psi. After the bridge, the strength was much higher, between 200 and 325 psi. These values help us understand what kind of tensile strengths we can expect from FC-5.
