INITIAL SITE ASSESSMENT

US 70: From SH 3 in Broken Bow to the Oklahoma/Arkansas State Line McCurtain County, Oklahoma

**Preliminary Engineering Project No. HPPY-1031(002)HP
Job Piece No. 17427(05)**

**INITIAL SITE ASSESSMENT
US 70: From SH 3 in Broken Bow
to the Oklahoma/Arkansas State Line Project
McCurtain County, Oklahoma**

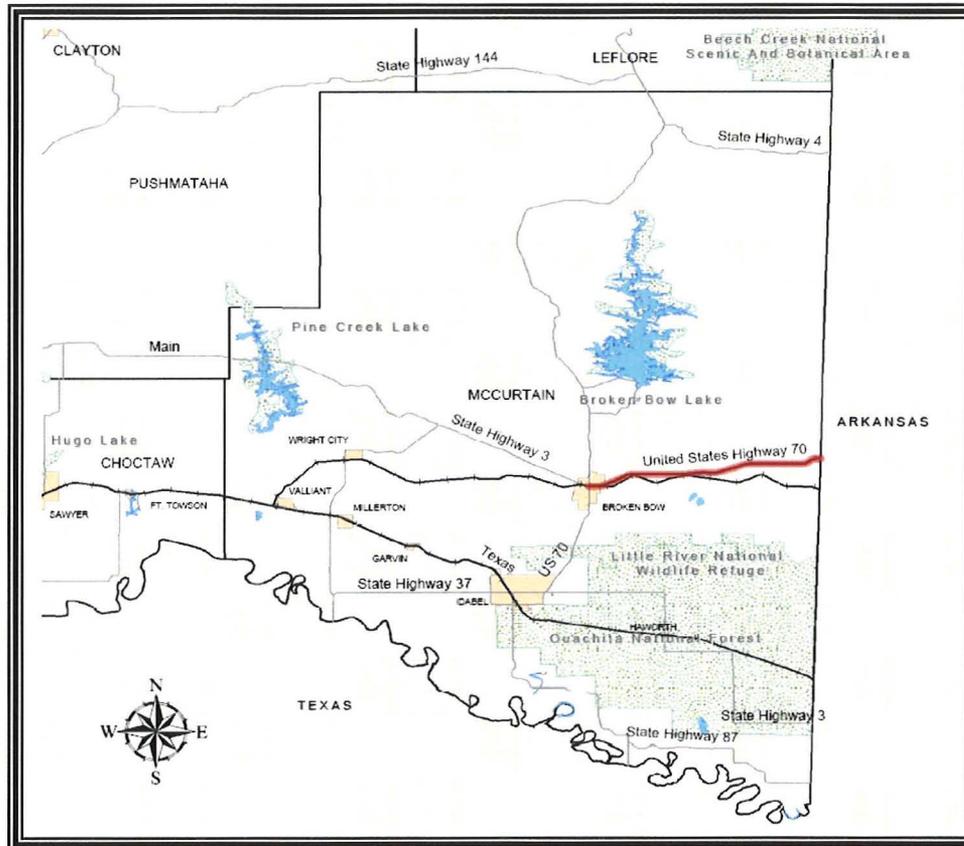
Figure 1.1 Corridor Study Area

The proposed project corridor is located within McCurtain County, Oklahoma between Broken Bow and the Arkansas state line along US 70. McCurtain County borders the Texas state line to the south and Arkansas state line to the east in southeastern Oklahoma. Broken Bow is located in southeastern Oklahoma in McCurtain County along US Highway 70/259 south of Broken Bow Lake and the Ouachita National Forest. Figure 1.1 shows the location of the corridor study area.
