# GUIDE TO THE PREVENTION AND RESTORATION OF EARLY JOINT DETERIORATION IN CONCRETE PAVEMENTS

DECEMBER 2016

This guide is a product of the National Concrete Pavement Technology Center (CP Tech Center) at Iowa State University. Its goal is to help Iowa's transportation agencies and contractors benefit from the latest research about the causes and prevention of premature joint distress when they are designing and building concrete pavements.

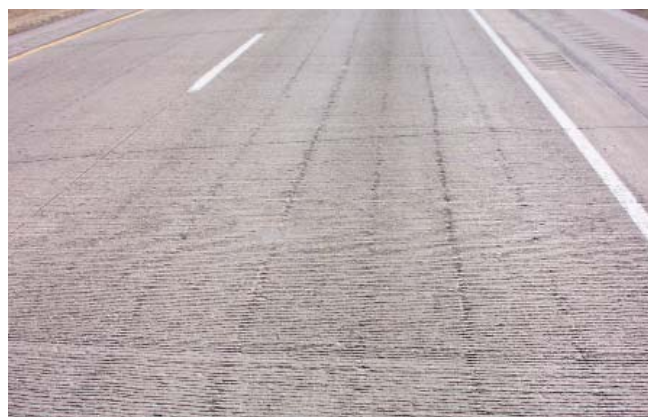
Figure 1-3. Vibrator trails

In 1991 a section of U.S. 20 in Hamilton and Webster counties, which was placed in 1987, began to show visible deterioration at the joints and along vibrator trails (Figure 1-3). Similar deterioration began to appear on several other paving projects placed between 1986 and 1994. Several research projects identified the cause as a loss of air at the joints and in the vibrator trails, increasing the pavements' exposure

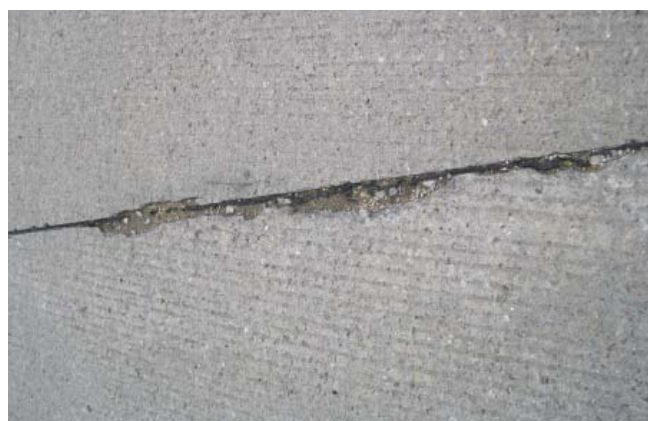
Figure 1-4. Joint deterioration (Photo courtesy of Jim Grove, FHWA)

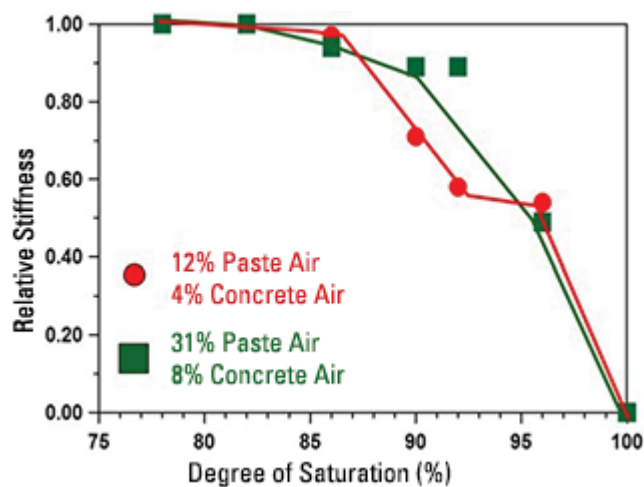
Figure 2-1. Influence of the DOS on stiffness degradation due to freeze-thaw damage (Li et al. 2011)

For degrees of saturation below the critical DOS (e.g., 85 percent in Figure 2-1), freeze-thaw damage is generally not observed to occur even after a large number of freeze-thaw cycles. As soon as the DOS exceeds the critical DOS (in this case 85 percent), damage initiates in the material, regardless of the quantity and quality of the air system. This implies that once the critical DOS is reached, even a single freezing

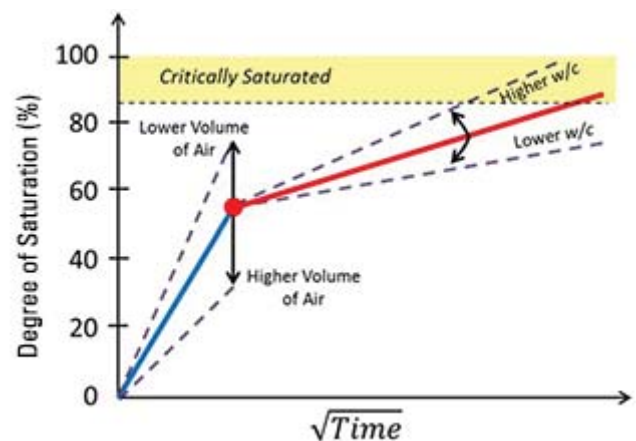
Figure 2-2. A conceptual illustration of the sorption-based freeze-thaw model

Entrained air can improve freeze-thaw durability by reducing the DOS in concrete (Li et al. 2011, 2016). Air-entraining admixtures stabilize air bubbles generated during mixing to add large (approximately 0.002 to 0.050 in.), stable, air-filled voids to the paste portion of the concrete (Mindess and Young 1981). These entrained air voids provide air-filled voids that reduce the initial DOS, as shown in Figure 2-3 (i.e., the initial saturation is the saturation that occurs during the first 24 hours, as denoted by the nick point or transition from the

blue to the red line in Figure 2-2). Figure 2-3(a) shows that both air content and water-to-cement (w/c) ratio contribute to the initial DOS when the same amount of cement is used in a mixture. As the w/c ratio increases and air content decreases, the concrete is closer to critical saturation after only a short time of exposure to water. The mixture composition can also impact the slope of the secondary absorption (red line in Figure 2-2), with data shown in Figure 2-3(b) for a straight cement mixture. Preliminary data have shown that this can

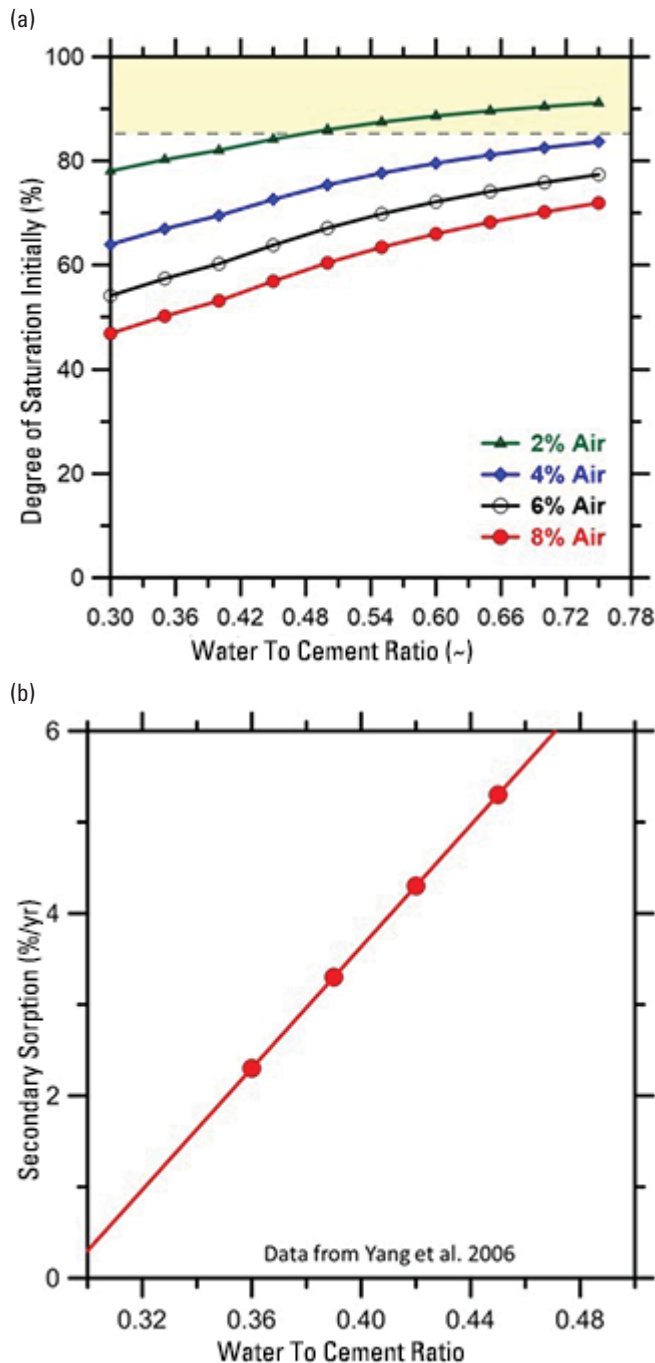
Figure 2-3. Influence of (a) the w/c ratio and air content on SMatrix and (b) the w/c ratio on the secondary sorption (Todak et al. 2015b)

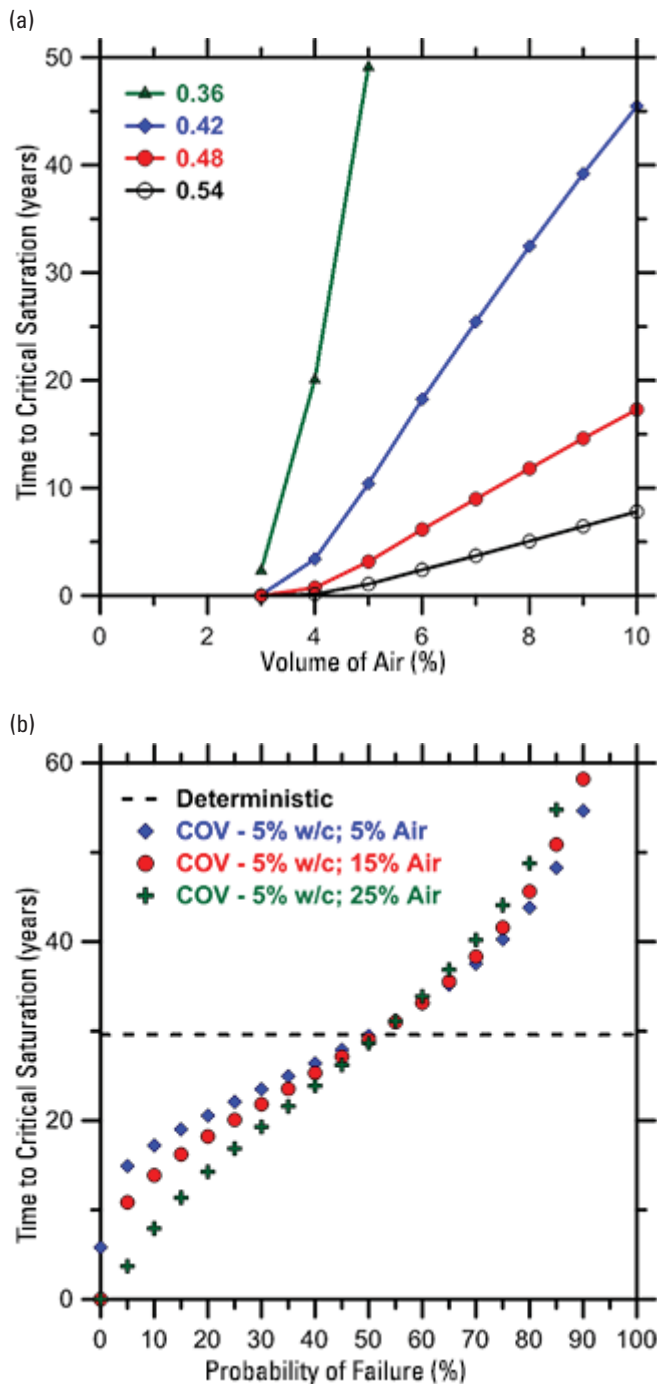
Figure 2-4. The influence of w/c ratio and air volume on the time required for 20 percent of the concrete to reach critical saturation (assuming 5 percent COV in w/c ratio and 15 percent COV in air content)

Variability in the concrete mixture can impact the life-cycle performance of the concrete. The Monte Carlo simulation model was used to indicate the influence of variation in w/c ratio (fixed at 5 percent coefficient of variation, COV) and variation in air content (5 percent, 15 percent, and 25 percent COV). The variation in the air content corresponds to 95 percent of the data ranging between 5.4 percent and 6.6 percent for the case with 5 percent COV, 4.2 to 7.8 percent for 15 percent COV, and 3.0 to 9.0 percent for the 25 percent COV. It can be noted from Figure 2-4(b) that the deterministic prediction of the time to saturation is similar to the time predicted for 50 percent of the elements to fail. It is interesting to note, however, that higher variability in air content (5 to 15 to 25 percent COV) results in time of failure of 17.2, 13.8, and 7.9 years, respectively. This would imply that despite the average air content, which is the same for each of these cases, repairs would need to be performed at an earlier age for systems with a higher variability. This clearly indicates the importance of controlling the variation in the air content during production. This needs to be balanced, however, with an understanding of how accurately the air content can be measured (Pellinen et al. 2005).

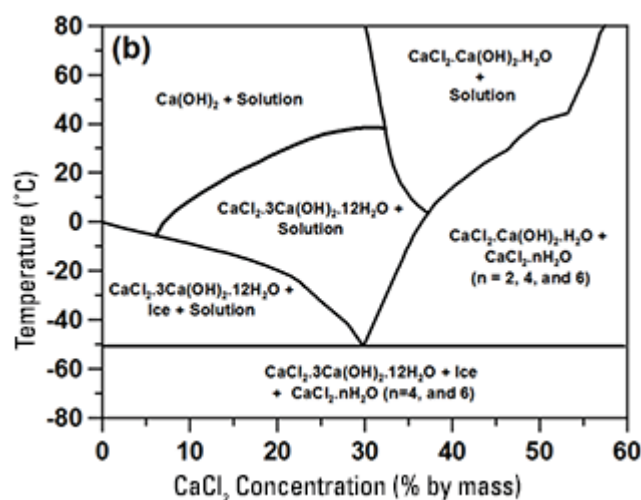
Figure 2-5. Phase diagrams illustrating the temperature for calcium oxychloride formation when hydrated cement paste is brought into contact with calcium chloride solution (Farnam et al. 2016)

The second type of reaction that may be observed, and that can cause more damage to concrete, occurs between calcium chloride and calcium hydroxide ( $\text{Ca}[\text{OH}]_2$ ) (CH in cement chemistry shorthand) to result in calcium oxychloride ( $\text{CaCl}_2 \cdot 3\text{Ca}[\text{OH}]_2 \cdot 12\text{H}_2\text{O}$ ), as shown in Equation 4. Calcium oxychloride is expansive and can result in damage to the cement matrix. Greater amounts of calcium oxychloride form at higher concentrations (Farnam et al. 2014; Farnam et al. 2015a) and at temperatures greater than freezing, as shown in Figure 2-5 (Farnam et al. 2016).

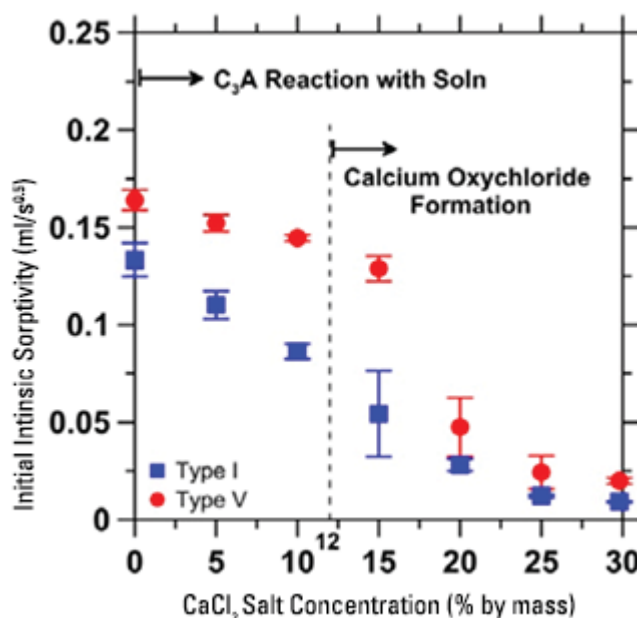
Figure 2-6. Reduction in the rate of water absorption due to salt reactions

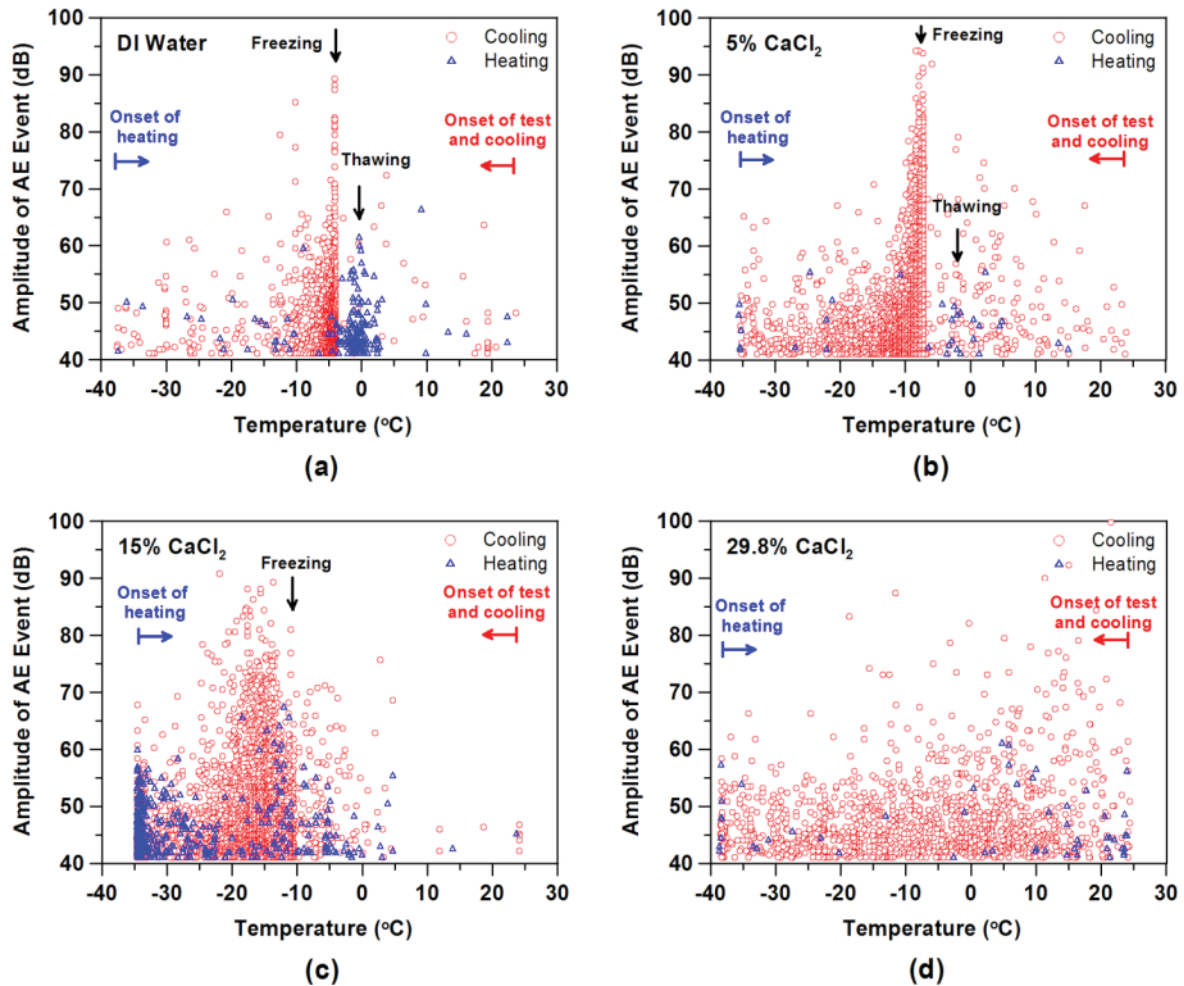
Figure 2-7. Passive AE events versus temperature during cooling and heating for mortar specimens saturated with (a) deionized water; (b) 5 percent  $\text{CaCl}_2$  solution; (c) 15 percent  $\text{CaCl}_2$  solution; and (d) 29.8 percent  $\text{CaCl}_2$  solution (scattered AE activity can be seen for the 29.8 percent concentration)

Acoustic emission (AE) was used by Farnam et al. (2015a) to listen for crack development in samples saturated with 0, 5, 15, and 29.8 percent  $\text{CaCl}_2$  solutions (Figure 2-7). For the lower concentrations, a small amount of cracking was noticed as the temperature decreased from room temperature. These cracks are due to the difference in the coefficient of thermal expansion between the aggregate and the matrix. When the freezing begins to occur ( $-5^\circ\text{C}$  for 0 percent  $\text{CaCl}_2$ ,  $-8^\circ\text{C}$  for 5 percent  $\text{CaCl}_2$ , and  $-12^\circ\text{C}$  for 15 percent  $\text{CaCl}_2$ ), however, the acoustic activity increases dramatically, indicating that cracking is taking place because of the expansion caused by the ice formation inside specimen pores (Figure 2-7c). Cracking, however, begins at higher temperatures for samples with a higher concentration upon contact with solution for specimens saturated by 20, 25, and 29.8 percent  $\text{CaCl}_2$  (shown in Figure 2-7d). It should be noted that the samples in Figure 2-7 were stored at  $23^\circ\text{C}$  (which is consistent with calcium oxychloride; see Figure 2-5), because the formation of calcium oxychloride can cause cracking due to volume expansion.

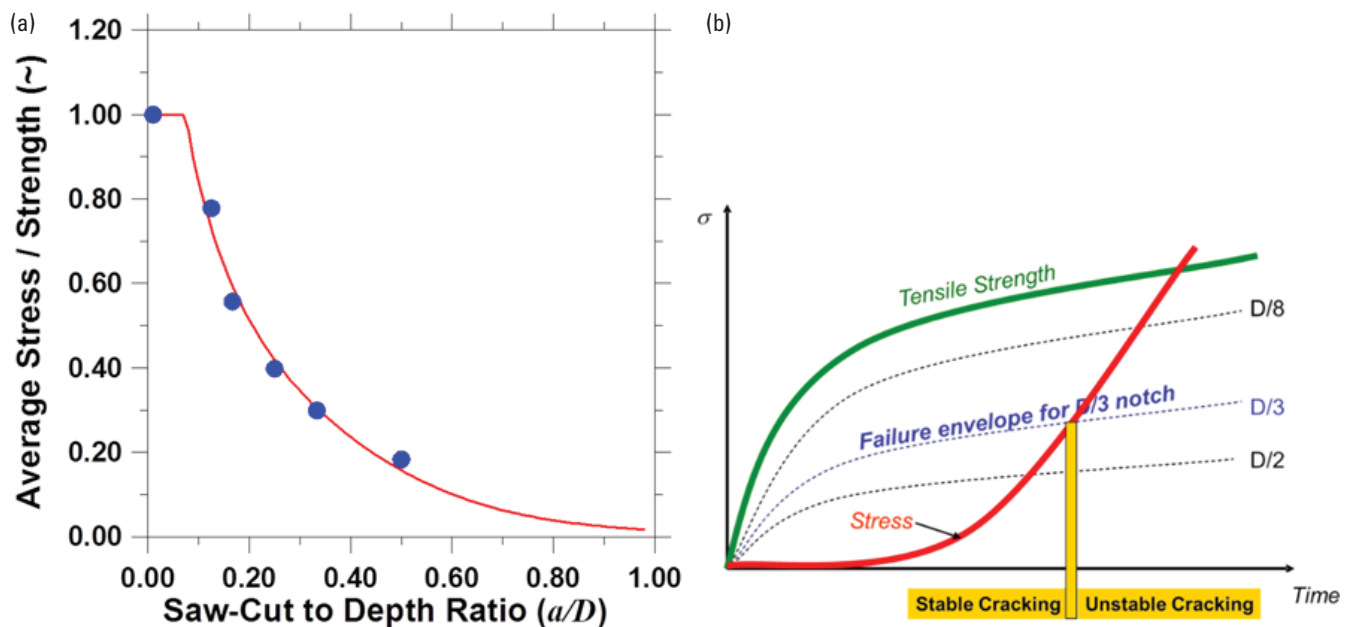
Figure 2-8. (a) Strength and stress development for concrete pavements as a function of saw-cut depth, and (b) the saw cut stress-to-strength ratio

as shown in Figure 2-8 in the previous chapter. Taylor and Wang (2015) discuss a device (P-wave propagation) that can predict the sawing window for early-entry and conventional saws.

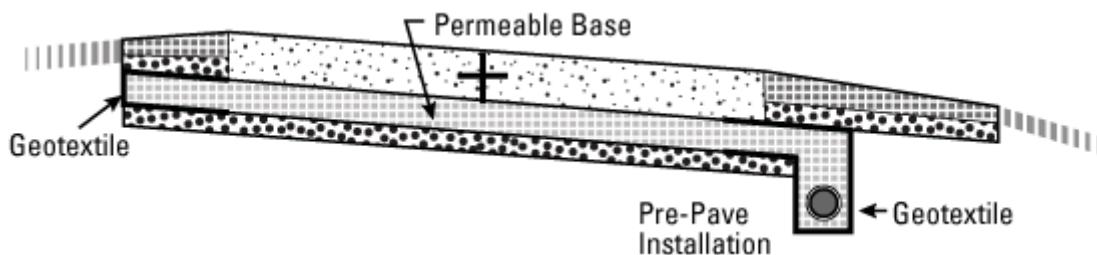
Figure 3-1. Typical cross section of subsurface drainage system

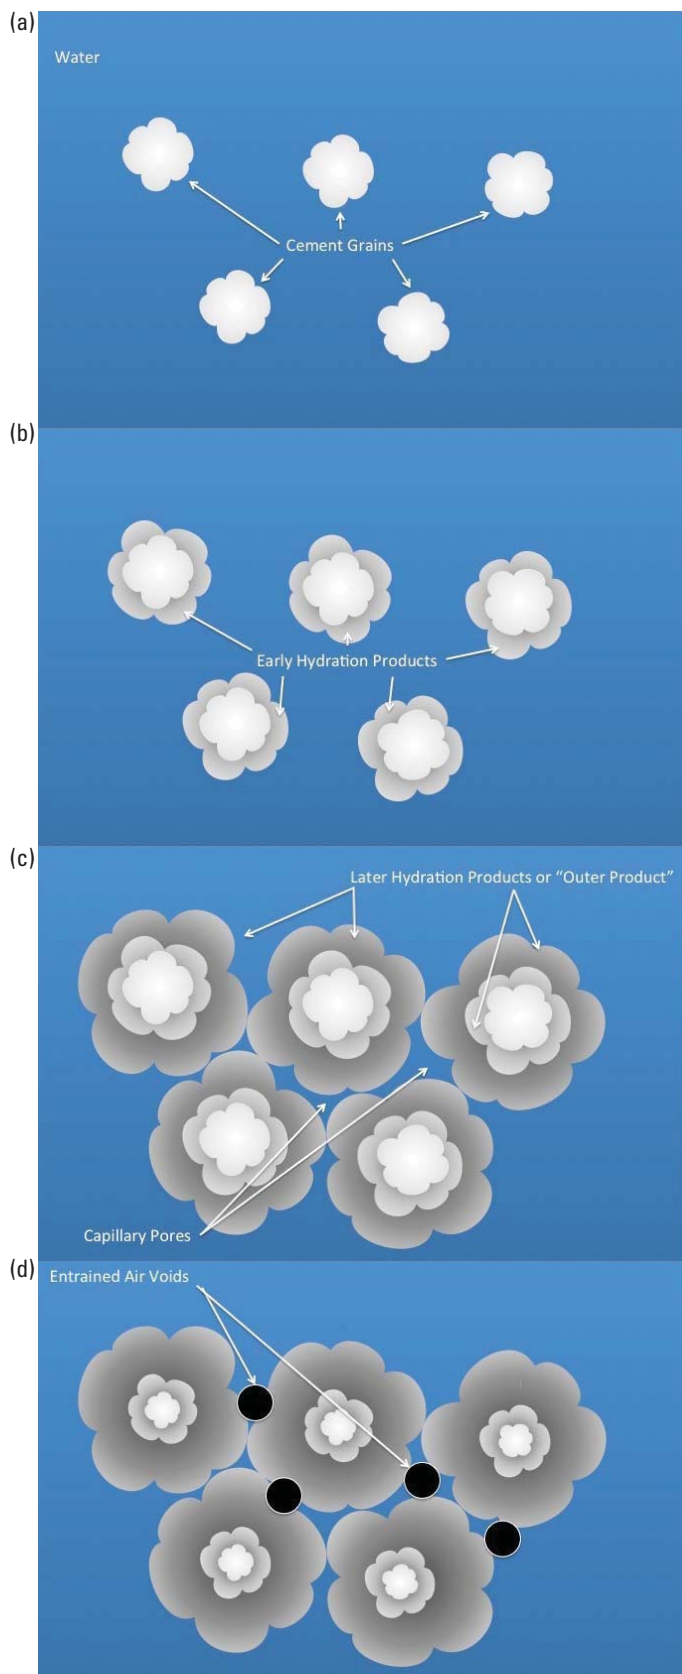
Figure 3-2. Cement grain dispersion and development of hydration products and capillary pores

The hydration of cement essentially produces two principal phases, CSH and CH. The C-S-H phase is considered to be the "cementing" phase whereas the CH phase is present but has little cementing value. The CH forms in platelike crystals that easily fracture. More important, CH is soluble in water. Further, the solubility of CH increases as the temperature decreases. This means when concrete is exposed to water at a temperature near the freezing point, the CH will dissolve more readily. Some of the dissolved CH may re-precipitate within the concrete, but some will exude or otherwise be lost. This process creates an increased permeability and more water ingress, and the process accelerates. As described in chapter 1, the CH is a reactant in the calcium oxychloride

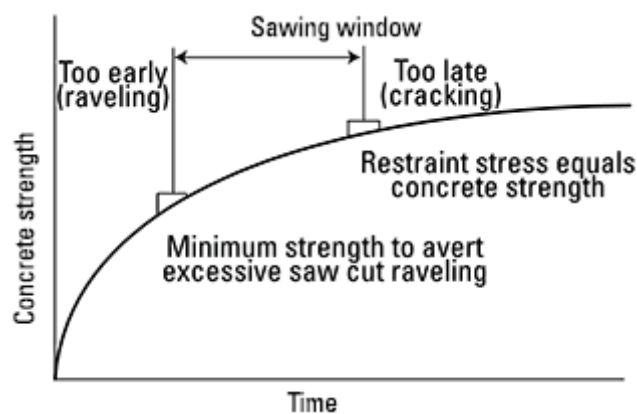
Figure 3-3. Sawing window

Most important, select the correct sawing window. There is no one correct answer for when to saw. The window is determined by the mixture and conditions of placement. In general, the sawing window begins when concrete strength is sufficient for sawing without excessive raveling along the cut; see Figure 3-3. Taylor et al. (2006) propose that the sawing window ends when random cracking starts to occur. Raoufi et al. (2007) have suggested that the sawing window ends as cracking transitions from stable to unstable at the saw cut,

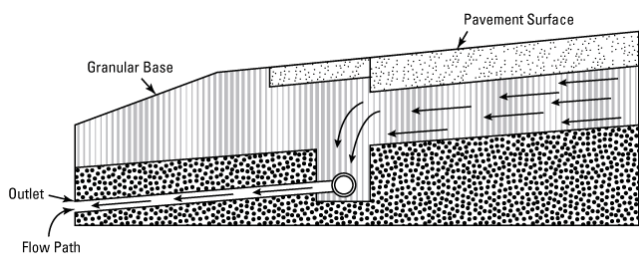
Figure 4-1. Example of shortening drainage path to an outlet

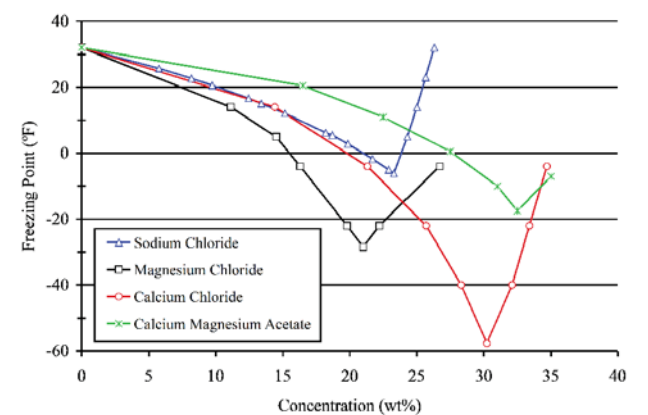
Figure 4-2. Partial phase diagrams for mixtures of water and common deicing/anti-icing salts. The freezing point of the water-salt solution (brine) is plotted as a function of the concentration of salt, in weight percent. Note that for all salts, a minimum freezing point is shown (Sutter 2008)

concentrations or rates will result in less damage to concrete structures. Note in Figure 4-2 that, as the brine solution concentration decreases to a relatively lower value (i.e., less than 5 percent by weight), the freezing points of the solutions become quite similar. This means that, as the brines become more diluted (which occurs as snow and ice melt), the relative difference in effectiveness (i.e., freezing point) diminishes. Therefore, using higher melting point solutions (i.e., brines of  $\text{MgCl}_2$  and  $\text{CaCl}_2$ ) at lower temperatures accomplishes little in terms of maintenance, yet it exposes the concrete to the chemicals most known to cause deterioration.

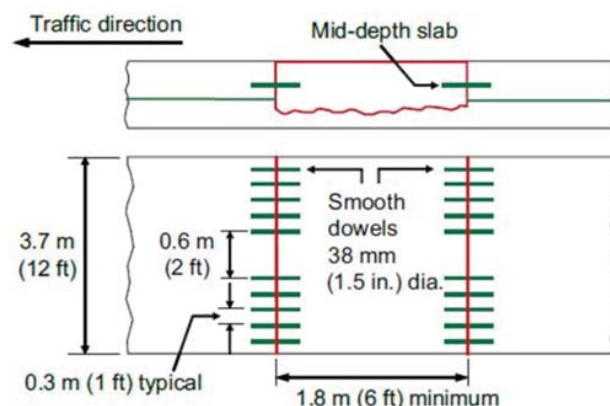
Figure 5-4. Example of FDR (plan view showing dowel bar layout)

Although FDRs can be designed and constructed to provide good long-term performance (see Figure 5-4), the performance of FDRs is very much dependent on their appropriate application and use of effective design and construction practices. Many FDR performance problems can be traced back to inadequate design (particularly poor load transfer design), construction quality, or the placement of FDRs on pavements that are too severely deteriorated.

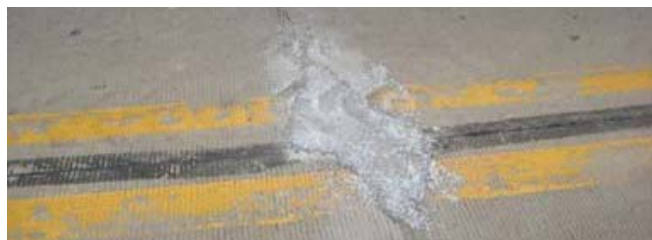
Figure 5-6. Pre-overlay repair of spalled joint (photo courtesy of Todd LaTorella, MO/KS ACPA)

spalled joints were milled and patched with a flowable mortar to fill the void (Figure 5-6). Bonding agents were not used for the patch, and the joints were not re-established.

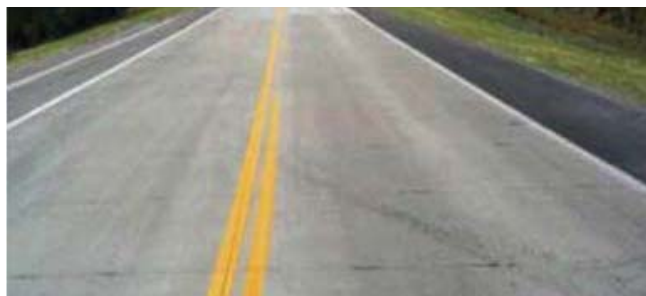
Figure 5-7. Completed unbonded concrete overlay (photo courtesy of Todd LaTorella, MO/KS ACPA)

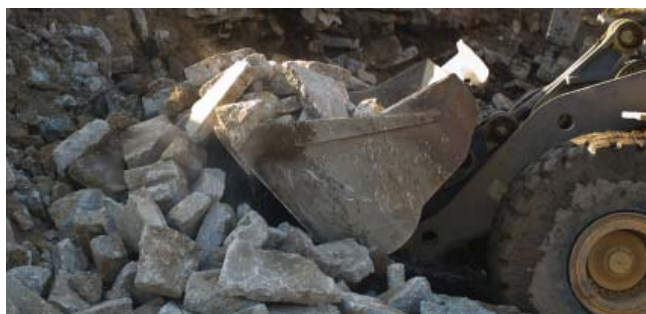
Figure 5-8. Concrete pavement for recycling (photo courtesy of Michigan State University)

In some instances in which pavement deterioration is beyond the state of feasible repair with PDR, FDR, or unbonded concrete overlay, appropriate option is reconstruction in place. Recycling concrete pavements into a base for the new pavement has proven to be a successful option. Recycled concrete aggregate (RCA), as a rule, is a high-quality material for unbound or stabilized applications such as bases compared to conventional new aggregate. An RCA has a rougher surface texture, higher shear strength, higher rutting resistance, and higher resilient modules (Van Dam et al. 2012) (see Figure 5-8).

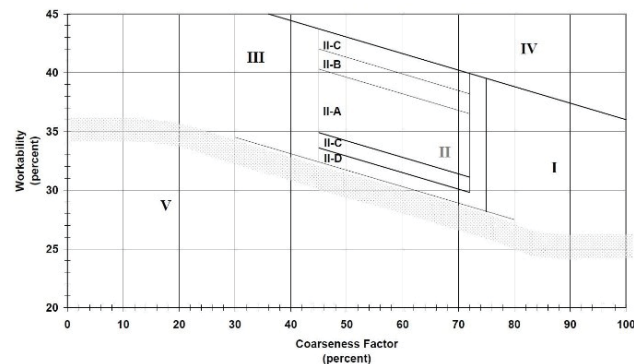
Figure 6-1. Workability factor vs. coarseness factor for combined aggregate

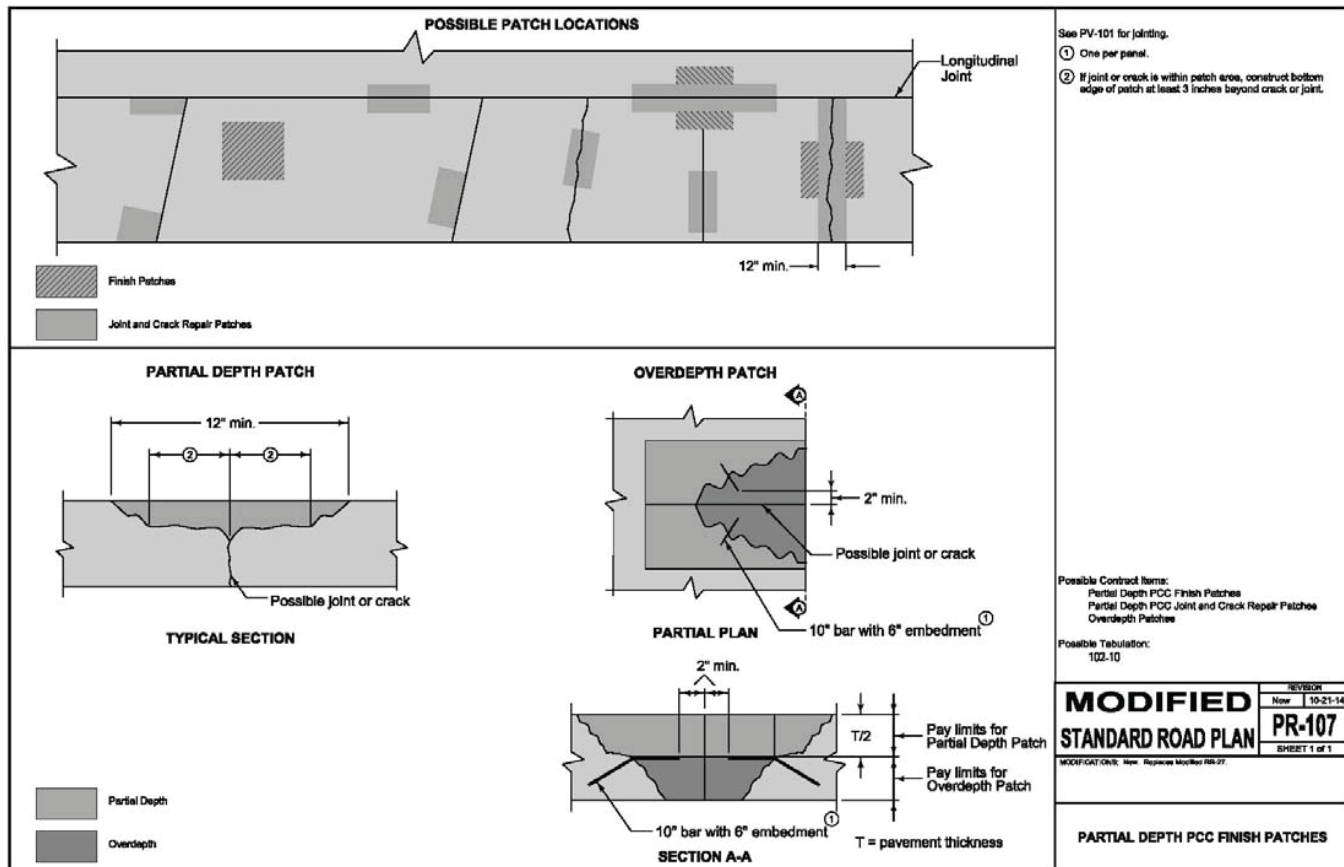
Figure 6-2. Modified Standard Road Plan PR-107

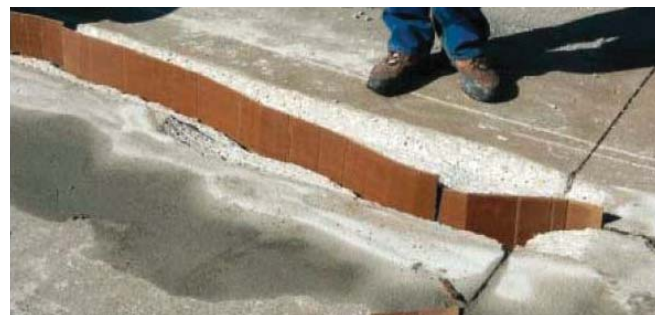
Figure 6-3. Joint board

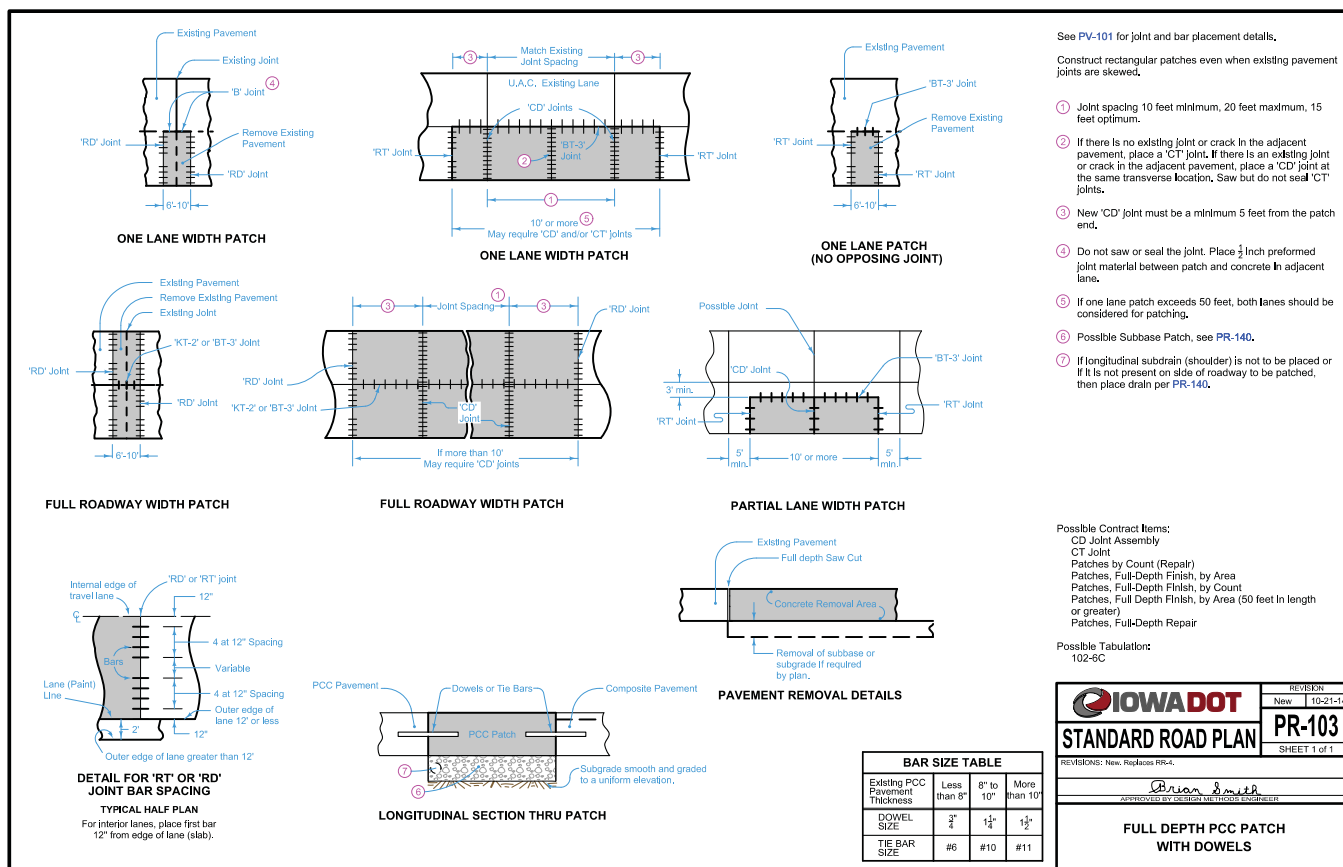
Figure 6-4. Standard Road Plan PR-103 for full-depth patches

Figure 6-4 is the Standard Road Plan PR-103 for full-depth finish patches with dowels. The Iowa DOT includes Standard Road Plans PR-101 through PR-105 for related technical details. Iowa DOT Specification Section 2529 covers Full Depth PCC Finish Patches for several applications including those listed here.
